Photos-5/22/13

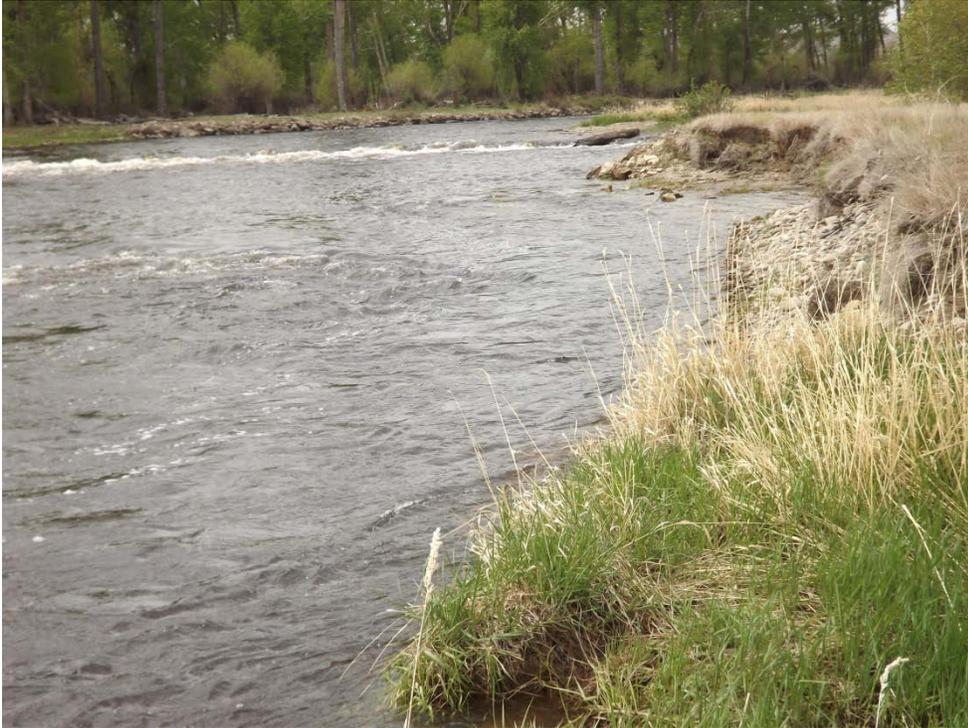
**View along Bank toward Main Diversion from Weir 3
Weir 2 is Visible**

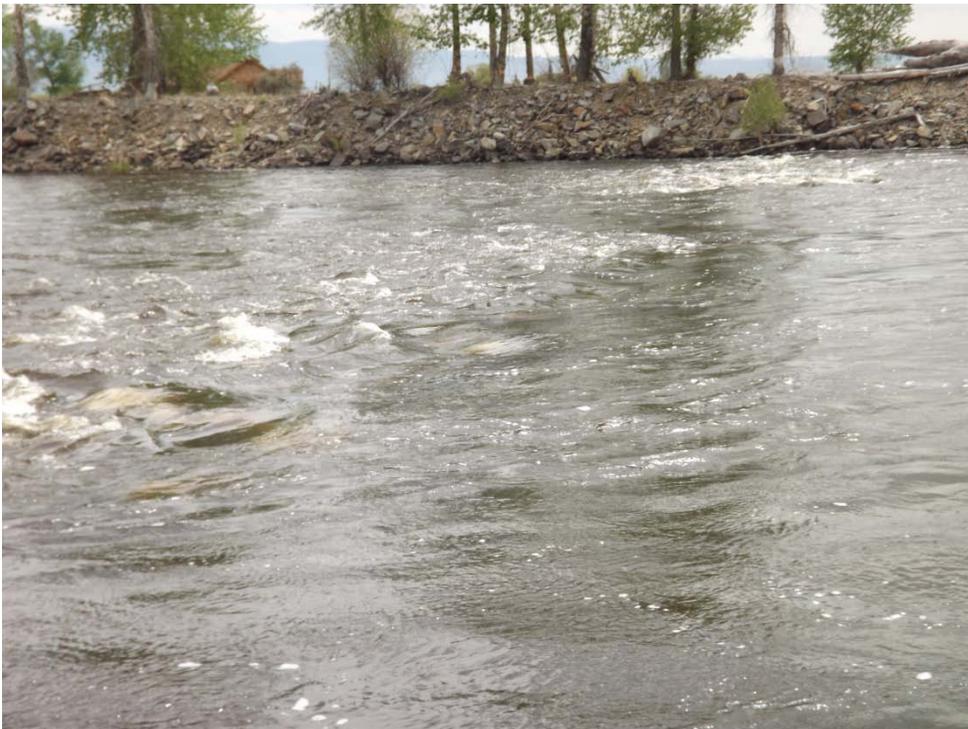
Weir 3-End of Existing Weir Rock in Foreground

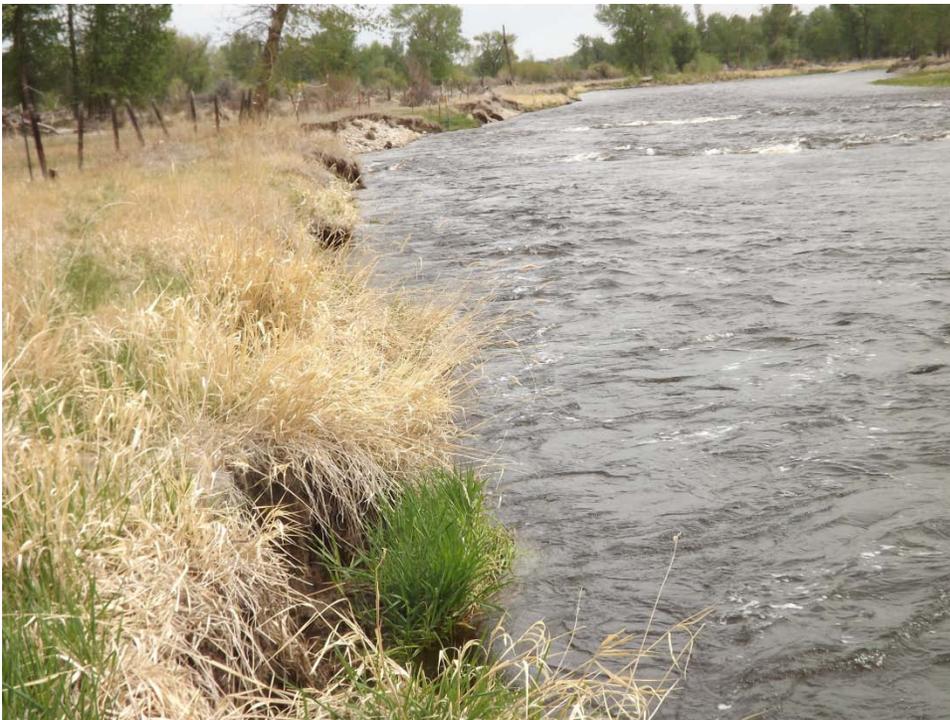
View Downstream along Bank toward Weirs 4 & 5 From Weir 3

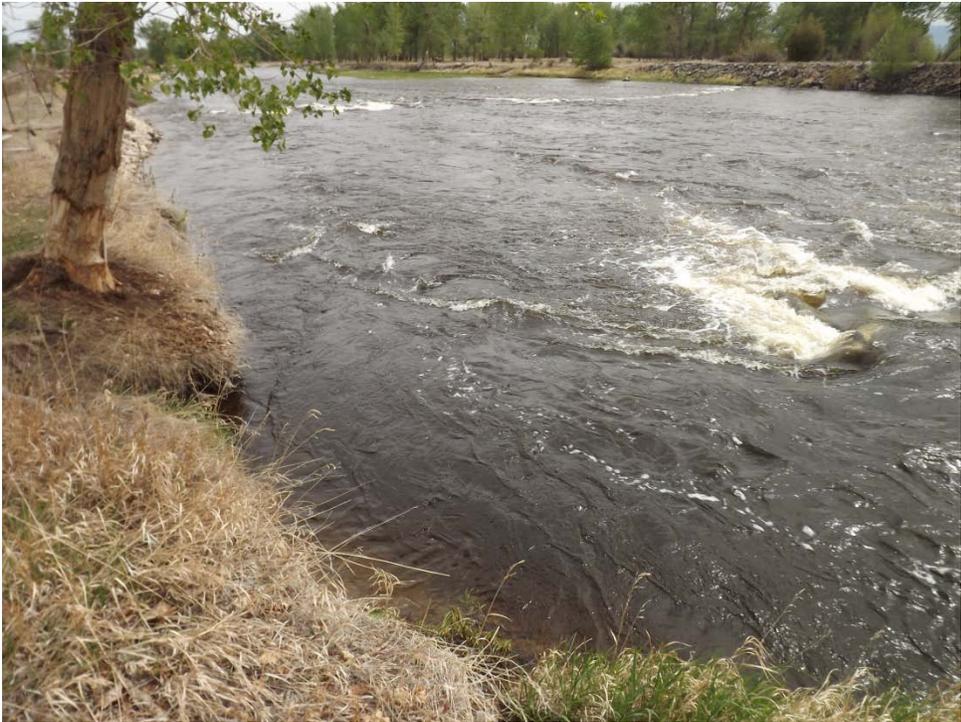
View of End of Weir 4- Note Weaker Bank Material-More Likely to Erode

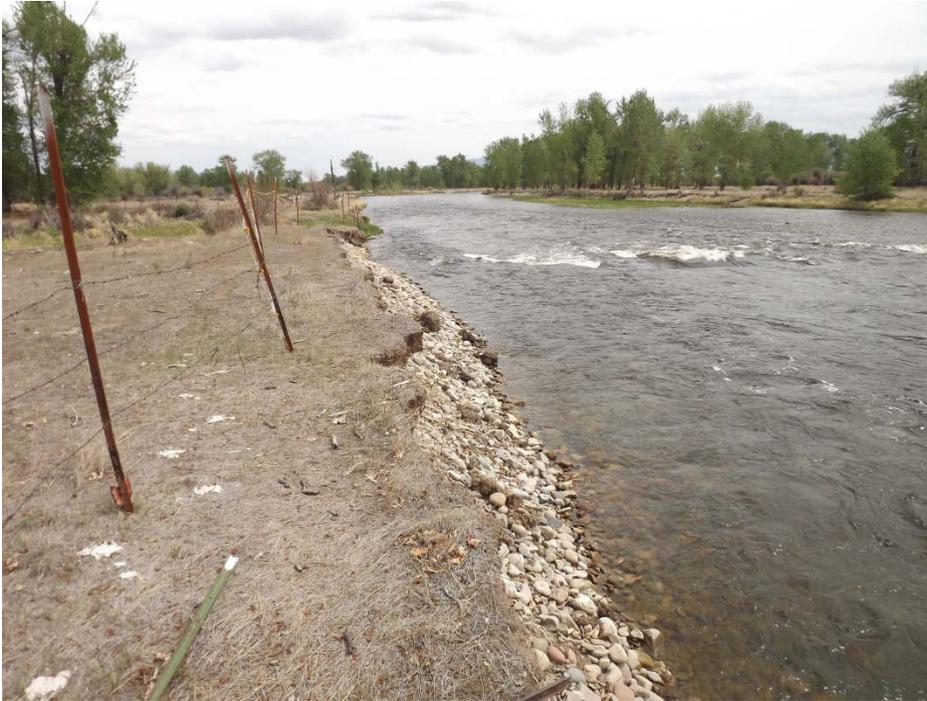
View from Weir 4 Downstream to Weir 5 along Bank

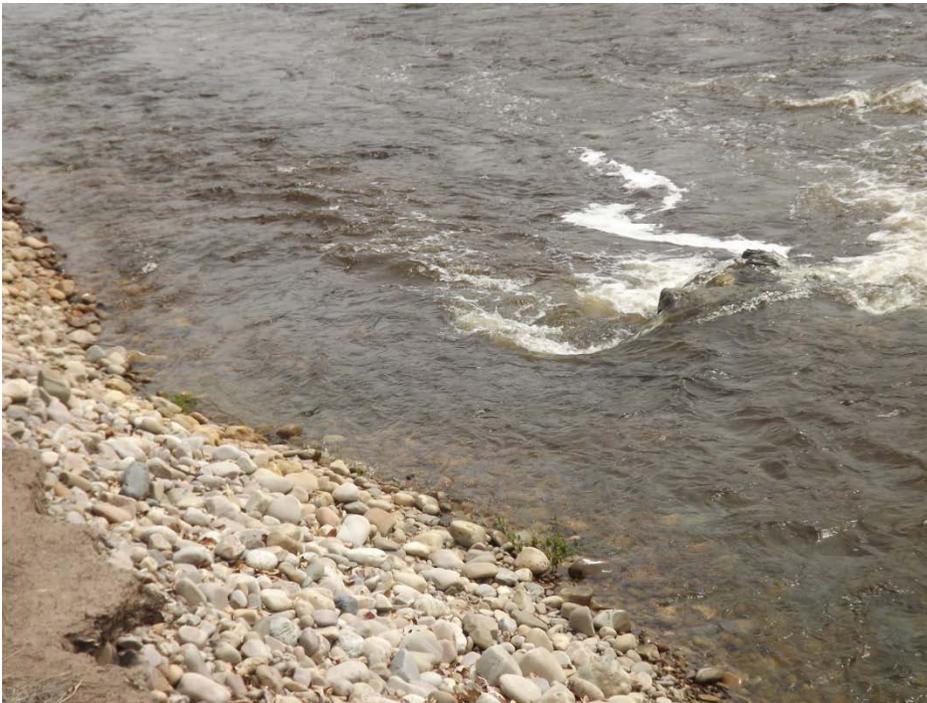
Current around Edge of Weir 5

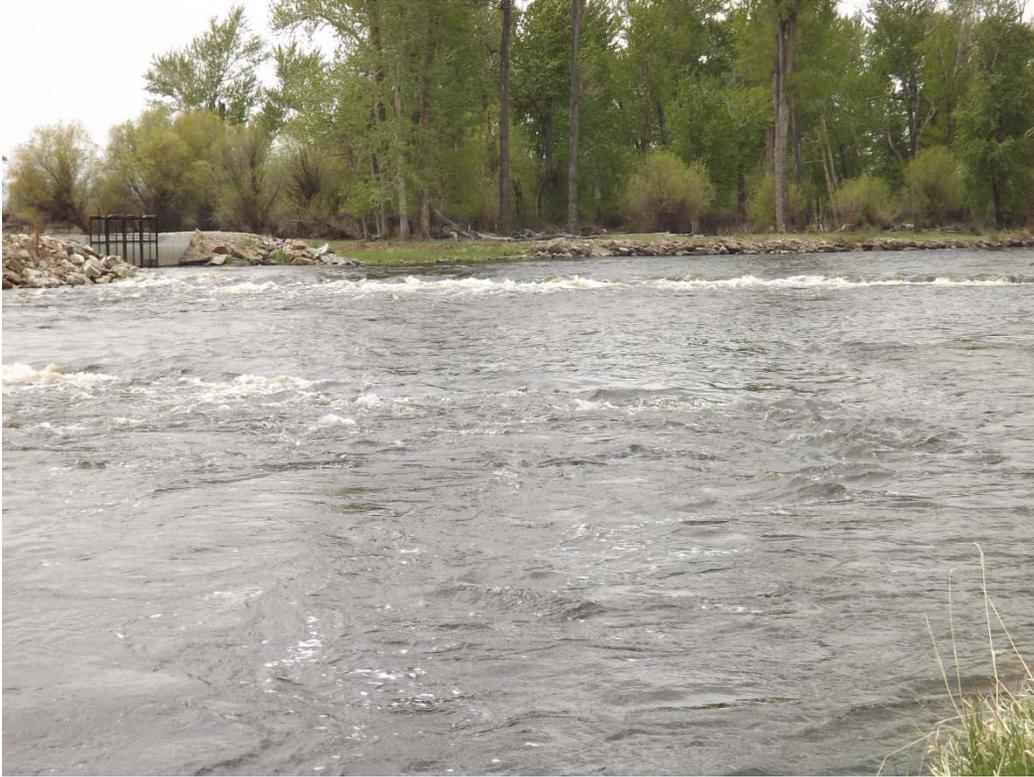
View of Weirs 1 & 2 Looking Toward Diversion Structure
