# River Assessment Triage Team (RATT) Site Report

**Site: Eggie Diversion /Jim Ballard**  
**Impact: Flanked Irrigation Diversion Structure**  
**Date of Field Visit: October 18, 2011**  
**Latitude: 46.28524° Longitude: 108.84353°**

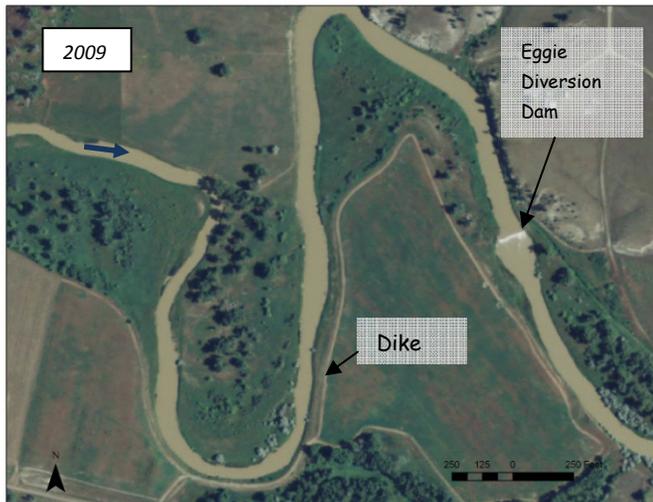
The main impact at the site is the breaching of a concrete irrigation diversion dam around its right abutment (Figures 1 and 2). The dam structure is still in place, but the flanking has rerouted the river around the structure creating a new 120 foot wide channel. The structure feeds approximately 2 miles of ditch on the left (east) bank that irrigates about 150 acres. The flood also damaged portions of the ditch downstream. There is currently no power at the dam site, but it is nearby.

Figure 1. Pre-flood (2009) air photo of site.

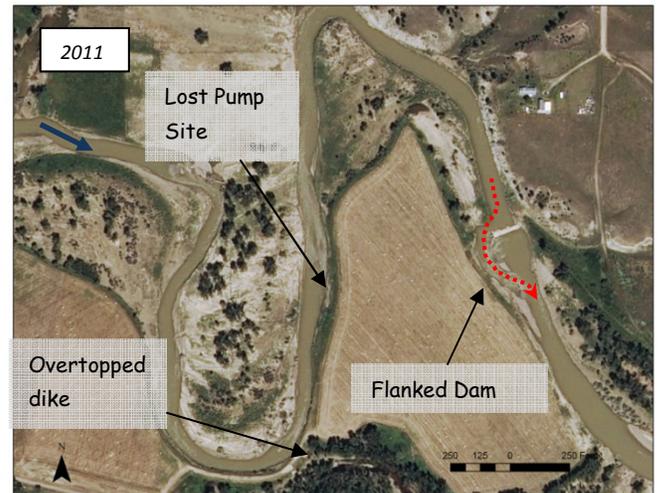
The dam is located on the downstream limb of a large meander bend. In the core of this bend, a field that is bound by a dike was irrigated by a pump site located on the upstream limb, approximately 1400 feet upstream of the dam. The pump was eroded out by the flood. Also, floodwaters overtopped the dike south of the pump site, sending water through an old river channel south of the field.

Figure 2. Post-flood (2011) air photo of site.

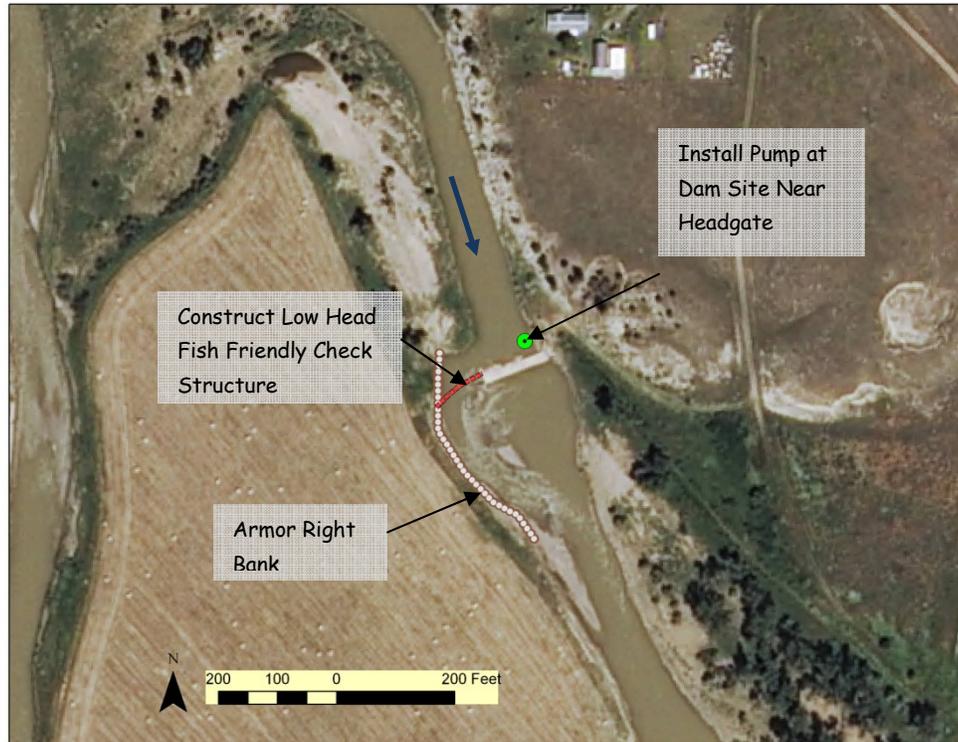
The flanking of Eggie Diversion Dam has resulted in extensive erosion around its right flank, downcutting of the channel, and perching of the headgate above the dam. Rerouting of the river back over the dam would require extensive reconstruction of the channel to its pre-flood configuration. Because of the severity of the flooding on the Musselshell, the system will continue to respond to the flood impacts over at least the next several runoff seasons, including adjustments in channel shape, and downstream gravel movement. Because of these ongoing responses, the reconstruction of instream structures will likely require substantial maintenance over the next several years. Reconstruction of the dam will also re-create a fish passage barrier and fish entrainment issue at the site that was removed by the flanking.

**Figure 3. Conceptual schematic drawing of Alternative 1.**

Another alternative for diverting water into the ditch at the site is to install a pump at the dam site (Figure 3). The hard dam structure will provide backwater and create local scour holes, and a portable pump could be easily moved to adapt to changes in the channel. A pump site would require power, which is not currently on-site although nearby. The costs of such bringing in power should be considered in selecting alternatives. The conversion to a pump on site may also require some erosion control on the right bank of the flanked channel section, and potentially a fish-friendly, low-head check structure that could be installed as either a permanent or seasonal structure. It would extend from the current dam across the new channel to ensure backwatering at the pump site during the irrigation season.

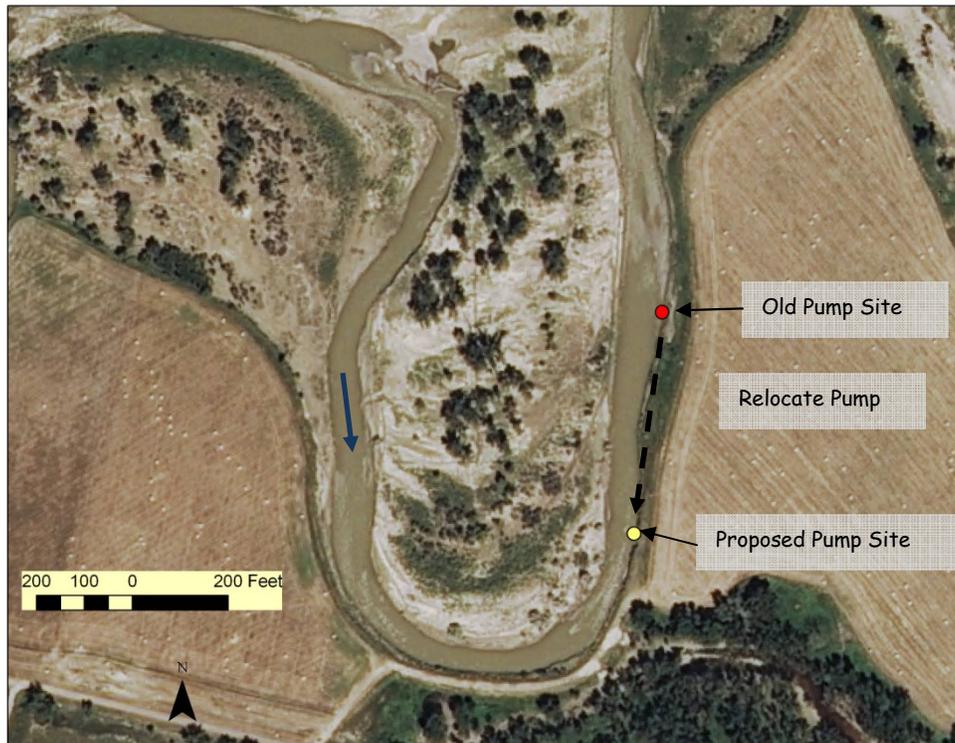
The pump site located approximately 1400 feet of the dam was damaged by right bank erosion of the river towards the field dike. Fortunately, there appears to be an excellent pump site location a few hundred feet upstream. At this location, a hard bedrock shelf is exposed in the bed of the channel, and local scour on the downstream side of this shelf has created a deep, stable scour hole that would support a pump. The existing power line is close to the new site.

**Figure 4. Conceptual schematic drawing of Alternative 2.**

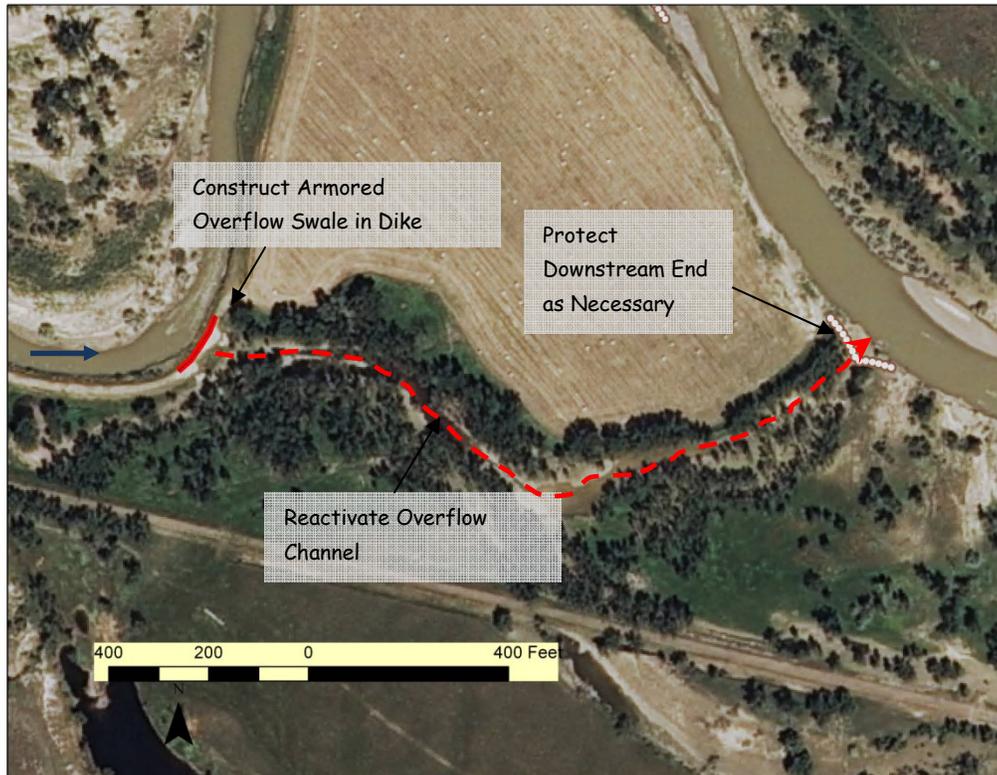
The flood event of 2011 resulted in overtopping of the field dike near the proposed new pump site, and flow of that water through an old channel path. As the route of these overflows across the core of the meander is much shorter than the channel path, the overflow path is steep, and flow velocities are higher than in the channel. This condition causes a risk of avulsion, or relocation of the main river channel into that shorter abandoned channel segment. If this were to happen, the irrigated field in the core of the bend would become isolated.

Figure 5. Conceptual schematic drawing of Alternative 3.

The floods of 2011 were so extreme that overtopping of the dike may be an extremely rare occurrence that does not create any concern at the moment. On the other hand, if there is concern that major flooding may occur again, or that changes in the river channel may cause more frequent overtopping of the dike, it may be appropriate to construct a controlled overflow at the head of the abandoned channel, to allow some flood water to go down that channel, but to prevent that channel from capturing the main river channel. This would consist of constructing an armored swale in the dike at the head of the overflow channel, the elevation of which would be designed to overtop at some acceptable flood condition (for example, the 10-year flood). It would also be important to determine if the lower end of the overflow channel, where it re-enters the Musselshell River, would require some grade control to prevent headcutting during floods.

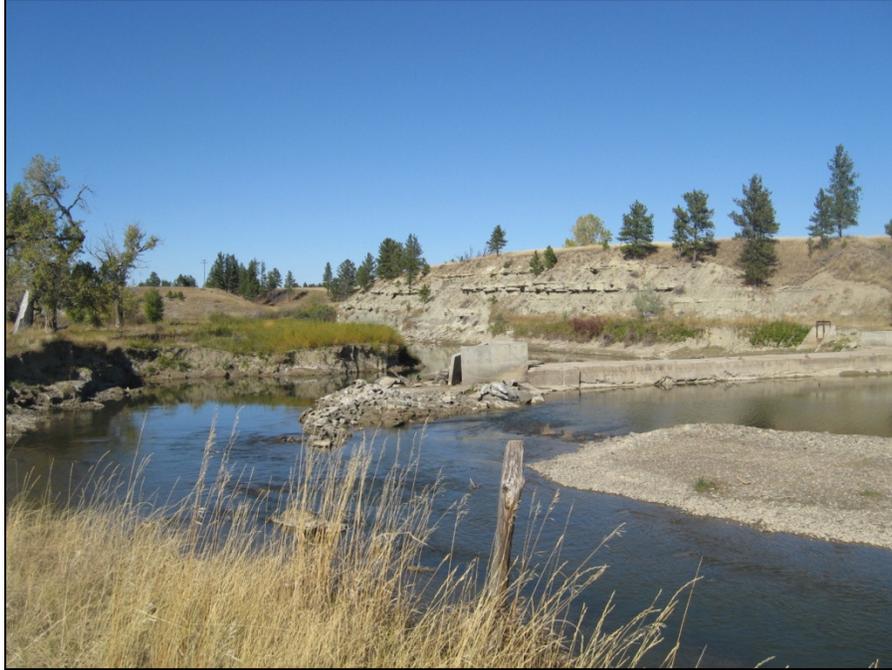
**View upstream showing flanked dam and right bank erosion.**

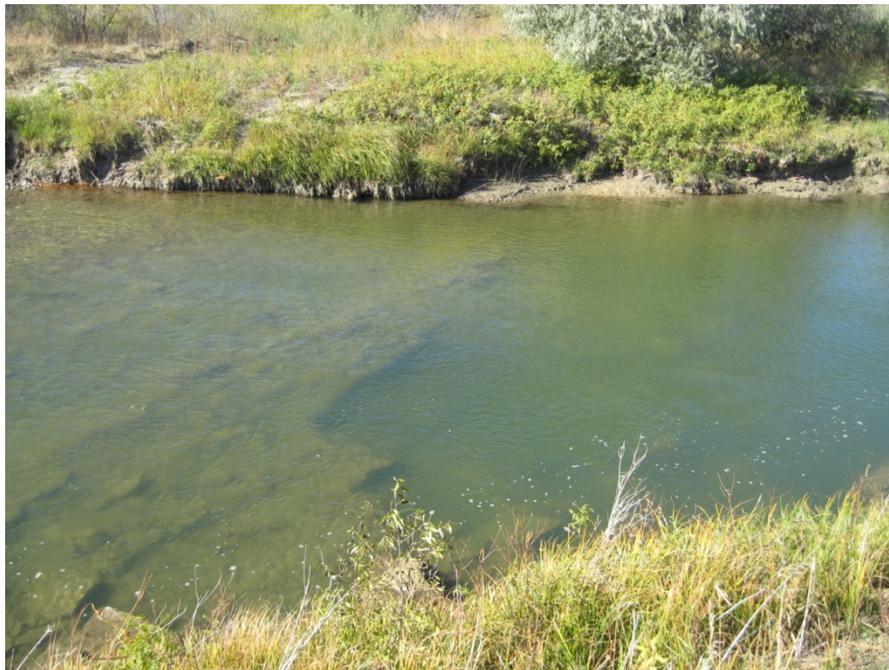
**View of scour hole at proposed pump site (Alternative 2).**

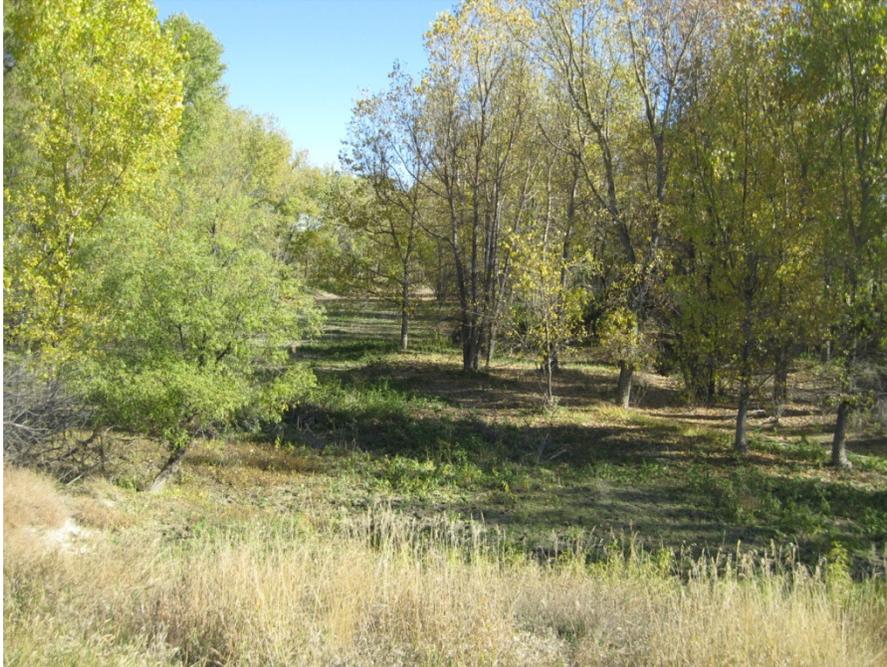
**View east down high flow channel.**
