# Crow Creek Restoration Project

## As-Built Monitoring Report – November 2007

River Design Group, Inc.  
5098 Highway 93 South  
Whitefish, Montana 59937

March 2008

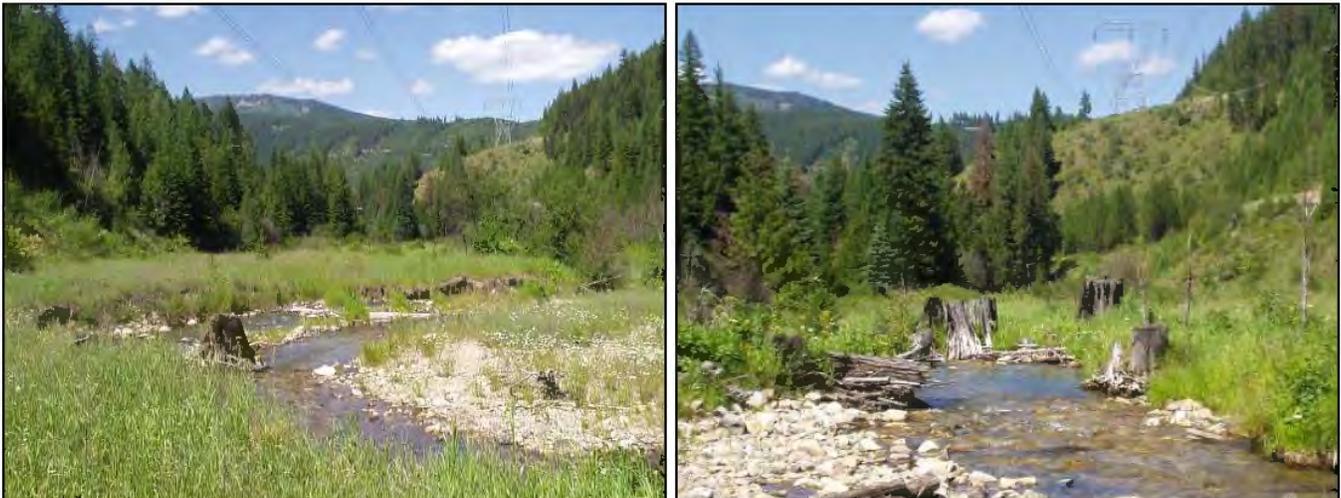
**Figure 1-1.** Representative channel and riparian conditions in the project area. Note the BPA transmission line, lack of wood riparian species, and remnant cedar stumps.

There is marginal riparian vegetation in the project area due to the presence of the BPA transmission line. Prior to construction, the reach classified is an over-widened C stream type transitioning to an F channel type. The post construction condition is characterized by a moderately entrenched, riffle-pool, gravel-cobble dominated B3/4 stream type.

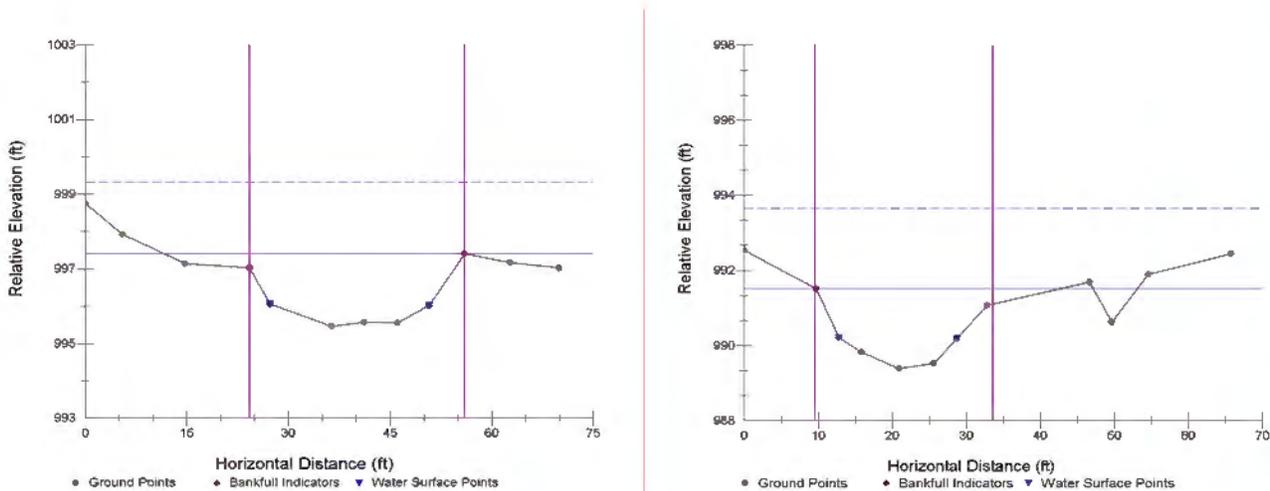
Riffle cross-section 2 was located along the existing Crow Creek channel alignment. Restoration actions specific to this section included raising the channel invert by as much as 2.0 ft from existing conditions to reconnect the adjacent floodplain feature. As described in the RDG design report, this section of Crow Creek had downcut in response to downstream channelization of the creek. Construction techniques included raising the bed elevation with coarse cobble to fine gravel and installing a series of boulder clusters to increase bed roughness, stabilize the channel profile, and create pocket water habitat.

Riffle cross-section 4 was located along the reactivated meander sequence which had been physically disconnected from the main Crow Creek channel due to downstream channelization. Construction activities included re-excavating the historical channel alignment and importing coarse rounded alluvium to increase bed roughness, stabilize the channel profile, and improve aquatic habitat for the target fish species. Numerous wood and rock-based structures were constructed to create pool habitat, increase channel margin complexity, and stabilize the vertical channel alignment.

**Figure 3-1.** Monitoring riffle cross-sections 2 (left) and 4 (right) in the project area. The solid line denotes the design bankfull elevation and vertical lines provide limits for bankfull hydraulic calculations.

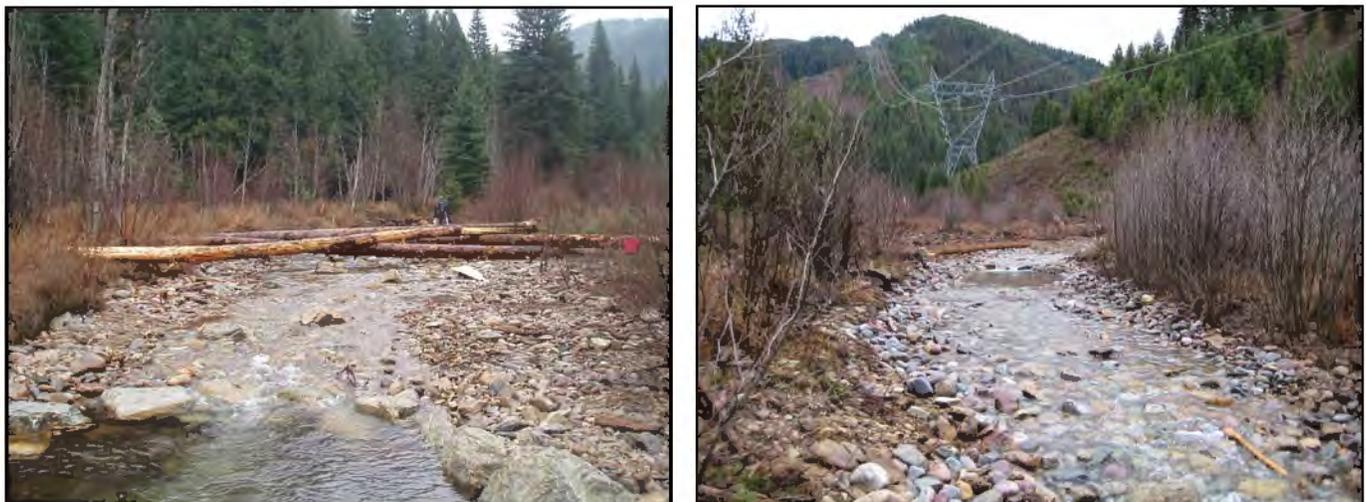
**Figure 3-2.** Monitoring riffle cross-sections 2 (left) and 4 (right) in the project area.

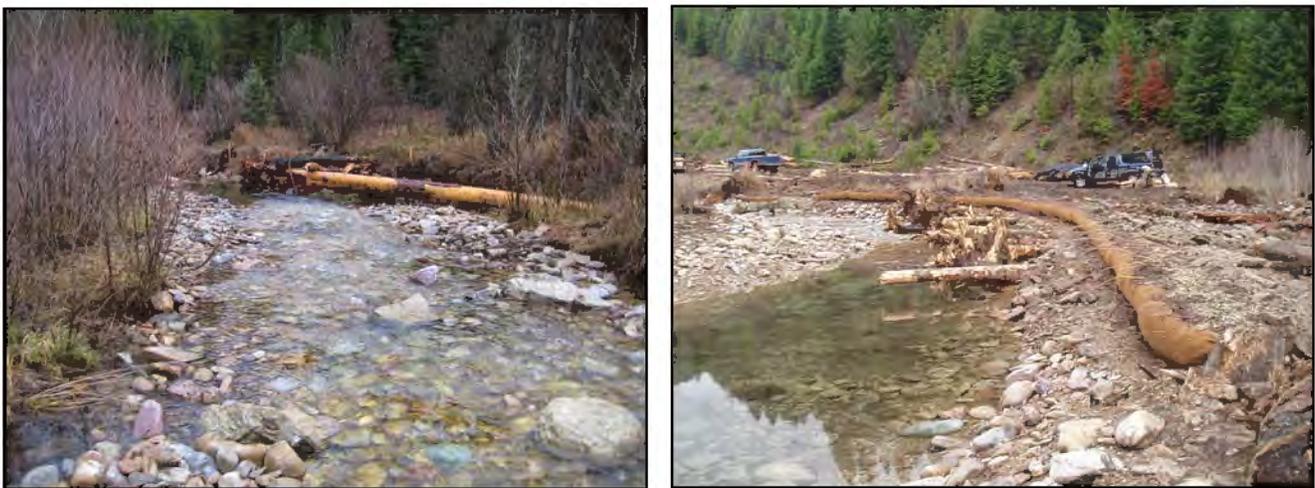
**Figure 3-4.** Monitoring pool cross-sections 1 (left) and 3 (right) in the project area.

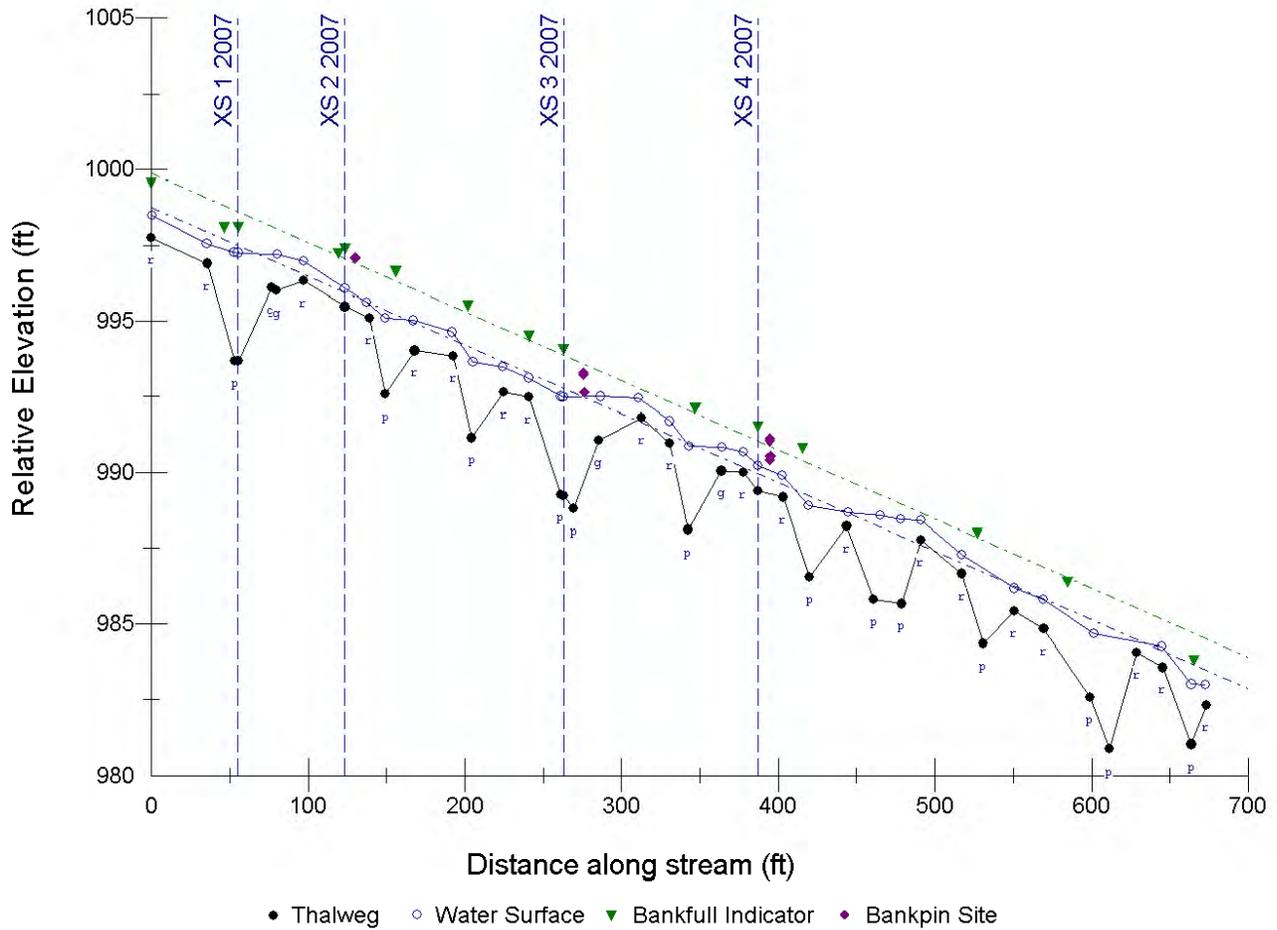
The as-built longitudinal profile in the project area encompassed approximately 675 ft of reconstructed channel and is presented in Figure 3-5. Profile data including channel unit slopes, maximum depths, pool frequency and channel unit lengths are summarized in Table 3-3. Data are reported for actual values and in dimensionless ratio form.

Channel unit facet slopes were derived from the longitudinal profile (Figure 3-5) and reported as minimum, mean and maximum values for riffle, pool, run and glide features. Within the designed B4c channel, typical profile slopes occur in a range of values according to feature type. The predicted ranges of dimensionless ratios have been established based on measurement of stable, reference streams of similar valley, channel type and parent material. For this project, design ratios were established from the downstream reference reach in the Crow Creek watershed.

**Figure 3-5.** The as-built longitudinal channel profile of the Crow Creek project reach, a B4c stream type. The profile included measurement of approximately 10 pool and riffle channel sequences.

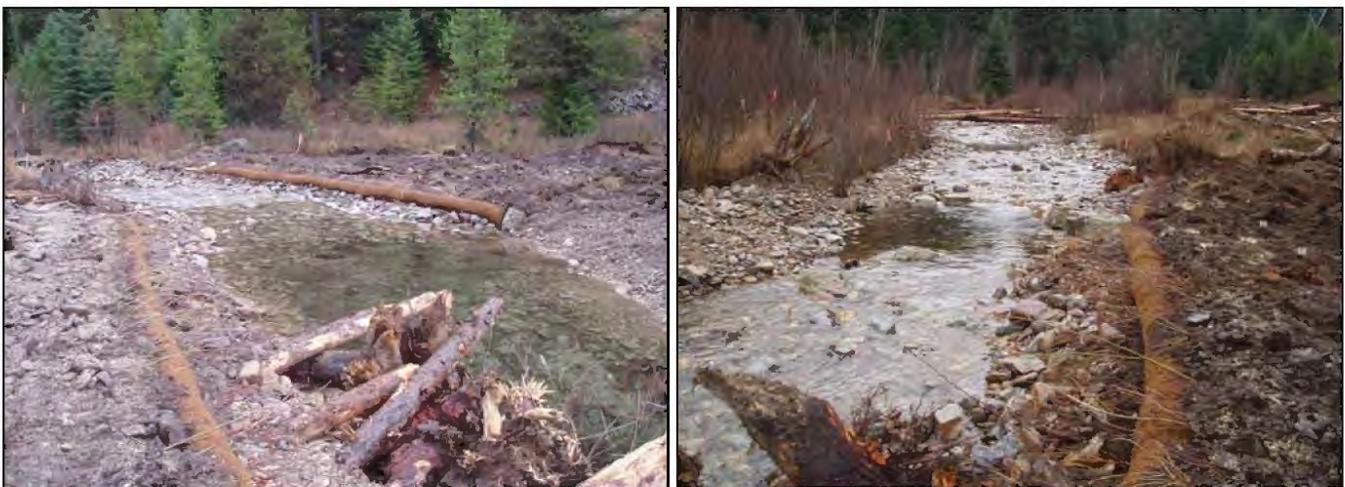
**Figure 3-6.** Typical photo points of the as-built channel conditions and restored channel and floodplain. A variety of habitat-forming and revegetation techniques are shown including large wood complexes, vegetated soil lifts, willow fascines and boulder clusters.

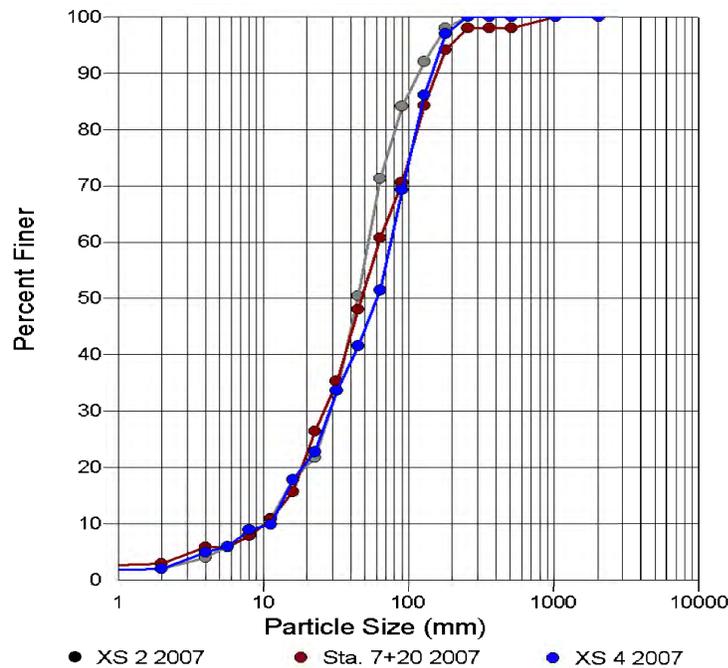
**Figure 3-7.** Channel particle size distributions for three as-built riffle features in the Crow Creek project area.

Figure 3-7 graphically displays the particle size distribution curves for the monitoring sections. Table 3-4 reports the actual values and the degree of variation between size classes. Results from the particle size analyses indicate less than 20% variation between samples. The exception is the D100 size particle. This may be reflective of the medium to large boulders at station 7+20 that were imported and utilized during construction of the new channel.

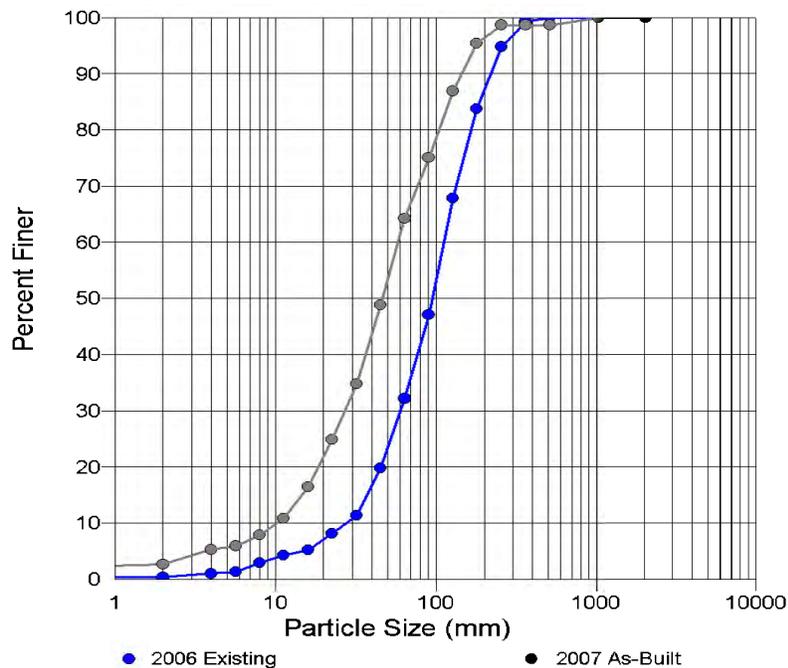
Pre-construction and post-construction substrate particle size analyses are displayed in Figure 3-8. Sample populations for riffles were grouped and reported as a single sample to evaluate changes in channel substrate composition for the pre and post construction condition.

**Figure 3-8.** Substrate particle size distribution comparison for 2006 pre construction and 2007 post construction conditions (n=300).

Summary results are reported in Table 3-5. A general fining trend can be discerned for all size classes with the exception of the D100 class. As previously discussed, coarse boulder material was used to construct a variety of structures in the project area including boulder clusters and rock cross vanes. The increase in the D100 particle size is likely attributed to this factor.

Bed sediment data collected in the project area indicate a general fining trend in the post construction condition relative to the pre-restoration condition. As described in the RDG design report, one of the primary objectives of this project was re-establish hydrologic connectivity between the active channel and floodplain. This required raising the channel bed elevation by as much as 2.0 ft in locations along the profile with a graded mixture of boulders, cobble, gravel and sand. Due to the lack of pools and energy dissipating features associated with the pre-restoration condition, channel substrate was largely characterized by coarse particle sizes and limited finer substrate. Reintroducing pool and riffle sequences should result in a general fining of channel substrate over time as sorting processes are re-established and promote gravel retention in pool tailout areas.
