PROJECT NAME: German Gulch channel restoration demonstration

PROJECT NAME: Upper Willow Creek channel restoration

PROJECT NAME: Willow Springs Creek channel restoration

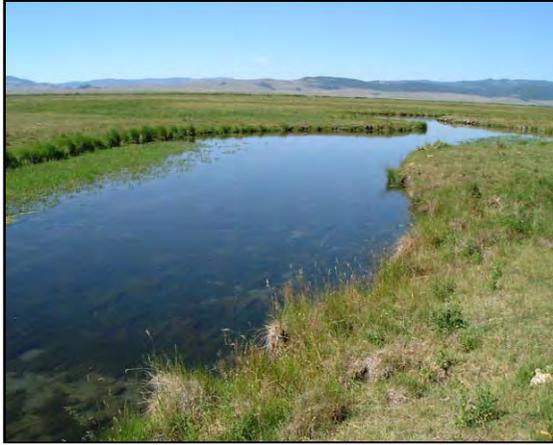
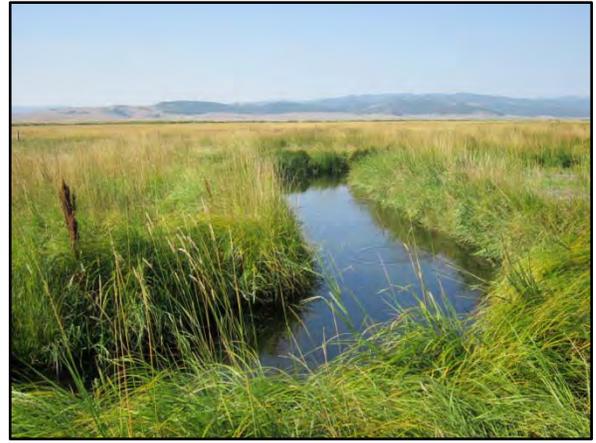
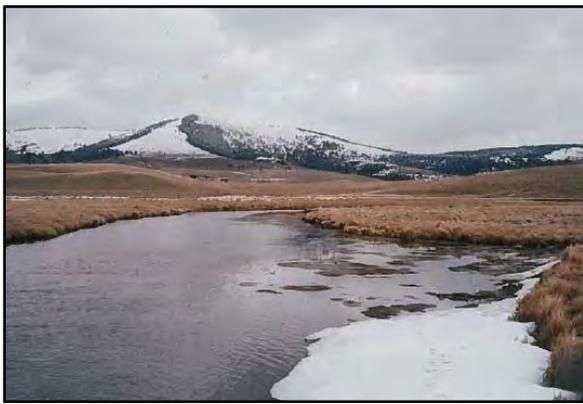
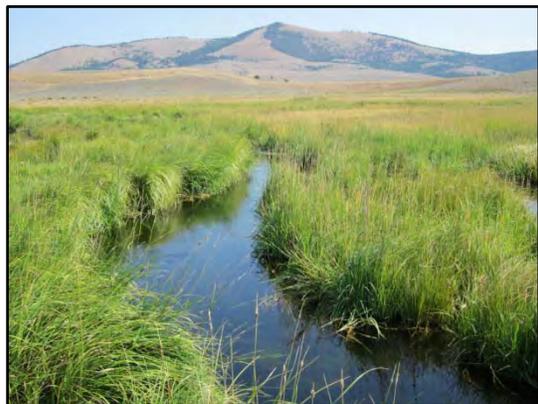
Summer 2000

8/30/12

Spring 1999

MONITORING CONCLUSIONS: The restored channel is relatively stable, with classic narrow and deep dimensions exhibited by “E” type channels. However, at least one meander bend was observed flowing into a wetland pond. Likely, there will need to be additional work done to prevent portions of the new channel from further capturing wetland ponds. Westslope cutthroat trout were observed in the stream, but no viable spawning habitat was observed. Channel substrate lacked gravel and was composed of silt/mud. Monitoring has documented westslope cutthroat trout migrating through Nevada Spring Creek (now nearly fully restored) to spawn in Wassan Creek, a headwater tributary. The restored spring creek is providing a migratory corridor and resident habitat for adult fish.

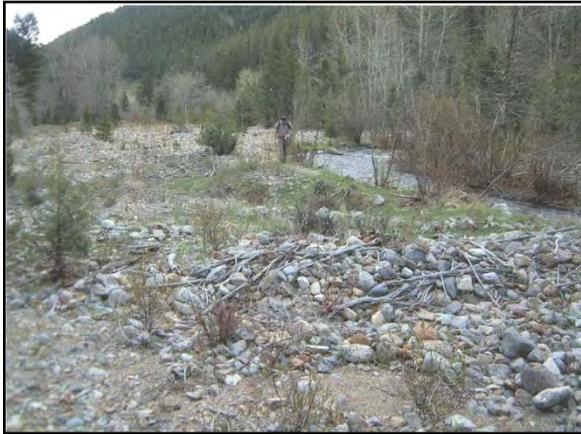
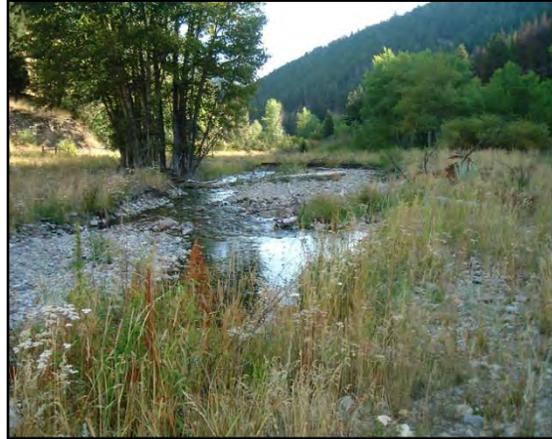
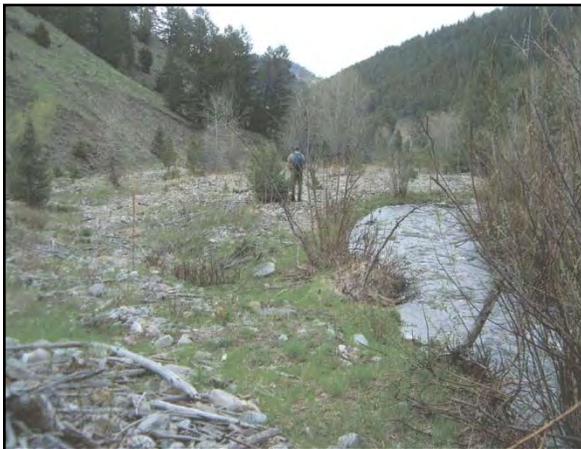
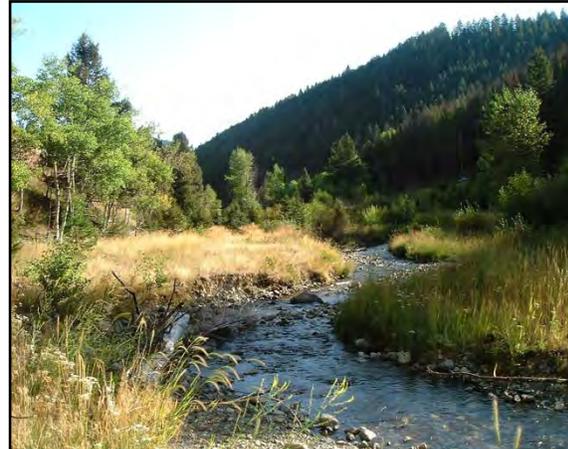
COMMENTS: 9/17/09 – This work was done on a short section of stream as a demonstration project. The riparian area appears relatively healthy and the livestock enclosure fence remains fully functional. The seeding of the placer mined floodplain shows good survival. Riparian shrub establishment appears minimal. Weed infestations are minimal. The channel work

appears to be less than successful, with portions of the restored channel returning to an over-widened and shallow cross section. The relatively small-sized woody debris placed in the restored channel appears to have been completely washed away. The restored channel also appears to show some signs of incision. Note that the project was completed in 2007 and, as a result, the follow-up was less than four years as stated in the methods.

German Gulch before (2002)

German Gulch after (9/2009)

MONITORING CONCLUSIONS: This project proved to be a poor demonstration of channel restoration techniques. The goal for the project did not appear to be well defined. The re-vegetated floodplain, composed primarily of gravel bars with grass cover, appears susceptible to flood stripping in future years. The channel work has not remained stable. The project appears to have provided no benefits to the fishery.

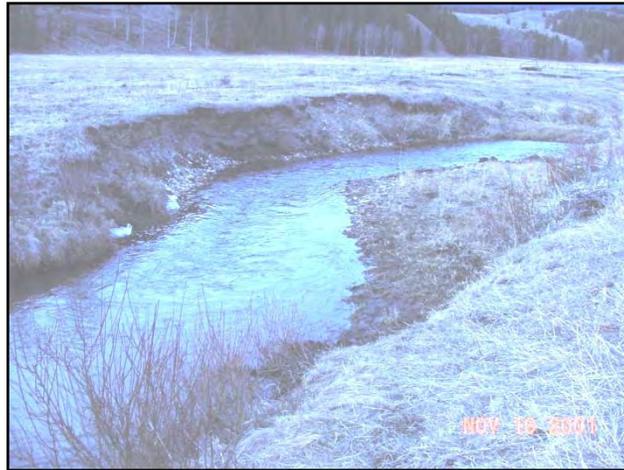
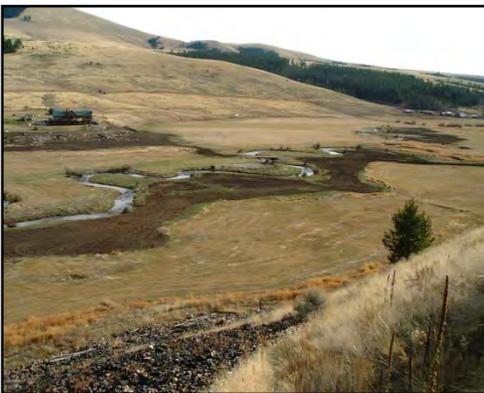
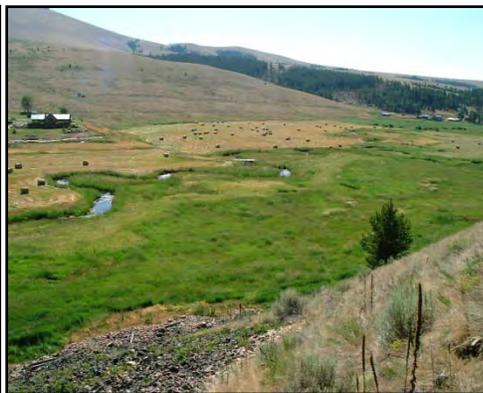
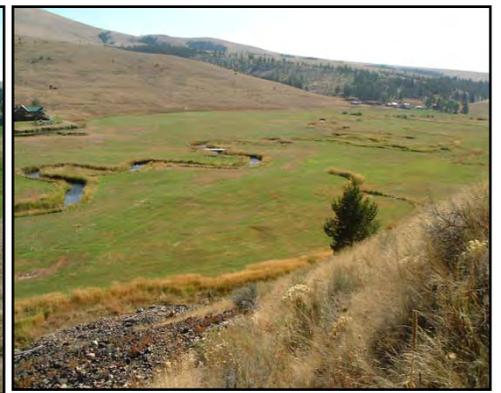
COMMENTS: 9/24/09 –The riparian corridor has been, and continues to be, dominated by Garrison foxtail. Nearly all of the willow clumps transplanted at the time of channel construction (August) display complete stem die-off but new willow stems continue to sprout from root crowns on almost all plants. The extensive willow sprigging efforts associated with the project are difficult to monitor because of the dominant grasses. Some willow sprigs have survived but percent survival is unknown. Haying operations by the lessee continue to encroach ever closer to the active stream channel. It’s likely this behavior is motivated by a combination of the lessee wanting to maximize hay production and the landowner wanting unfettered fishing access to the stream. No signs of livestock grazing were observed in the riparian corridor. Weeds do not appear to be a great concern, although there are small patches of thistle scattered along the entire reach. The reconstructed channel has remained relatively stable. The outsides of several meander bends have continued to expand and the inside bends are showing some increased deposition of cobble. An extensive photo point series revealed a stable plan and profile, with one exception, where a series of two adjacent meander bends located within the middle of the restored reach have shown fairly significant deposition of cobble on the point bars with lateral migration of the outside bends.

Upper Willow Creek #1 (11/2001) Before

Upper Willow after (Spring 2006)

Upper Willow after (Fall 2006)

Upper Willow after (9/2009)

MONITORING CONCLUSIONS: This restoration project has remained relatively stable and the riparian vegetative community is showing recovery. Compliance with the grazing enclosure has been good, but farming practices (by the lessee) have encroached into the riparian corridor on portions of the stream. The resident fisheries have benefitted from the project, but the goal of improving recruitment to Rock Creek is unlikely. Public benefits appear to be marginal since the site is located on private land that is not readily accessible, although the landowner does allow some public fishing with prior permission.

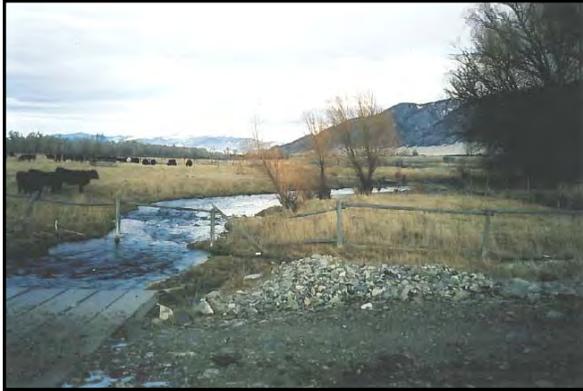
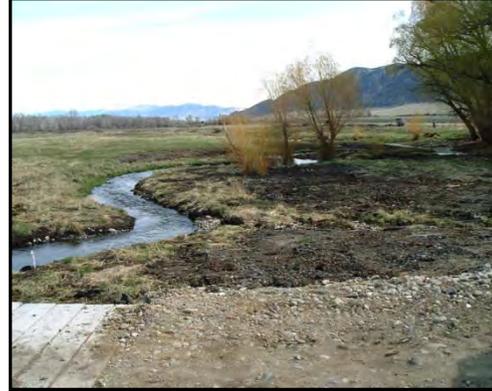
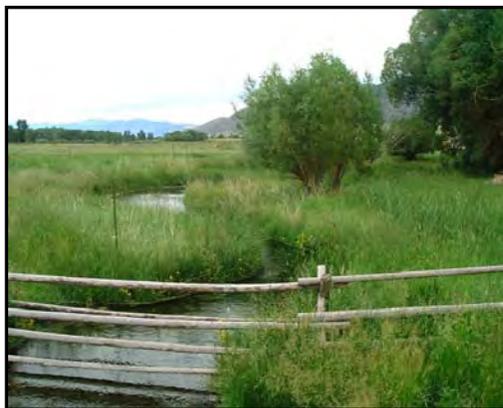
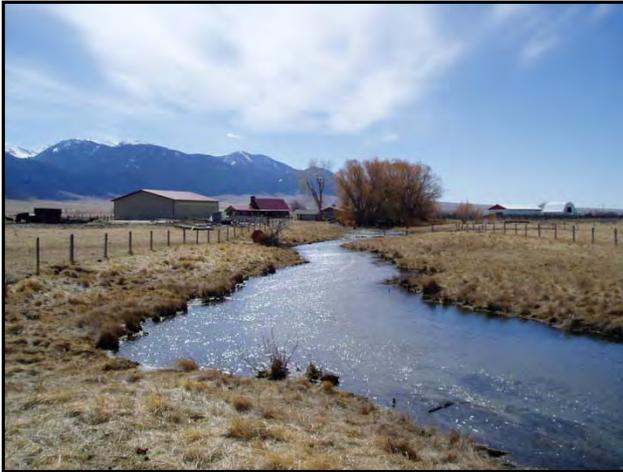
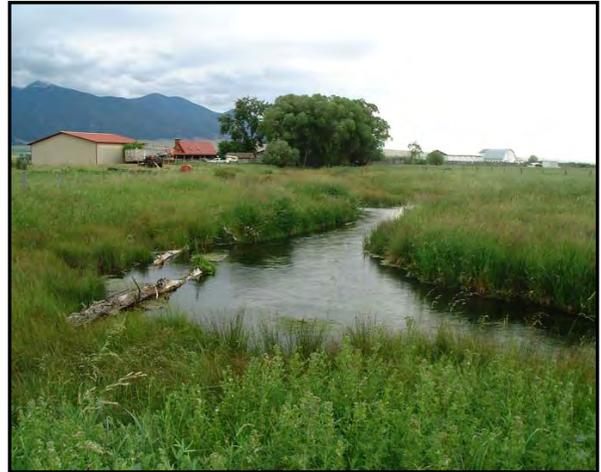
COMMENTS: 7/14/11 – Riparian fencing remains intact and the corridor has been managed as a livestock grazing enclosure. The riparian community looks healthy and willows are starting to regenerate. The local fisheries biologist is not interested in seeing willow regeneration due to the potential for beaver colonization and construction of beaver dams on spawning habitat. The stream channel currently is very stable and stream banks are dominated by heavily vegetated sods and sedges. Leafy spurge is prevalent in the riparian corridor. The first three photos are from the same vantage point.

Willow Springs Creek before (2004)

Willow Springs Creek after (Spring 2005)

Willow Springs Creek after (7/2011)

MONITORING CONCLUSIONS: This purpose of this project was to restore additional spawning and rearing habitat for rainbow trout and brown trout. The restored channel has remained stable and the riparian vegetation has recovered. The local biologist has well documented increases in spawning and rearing habitat within this restored stream reach. Overall, the fisheries significantly have benefited as a result of this project. Willow Springs Creek continues to be a major source of recruitment of trout to the Jefferson River.

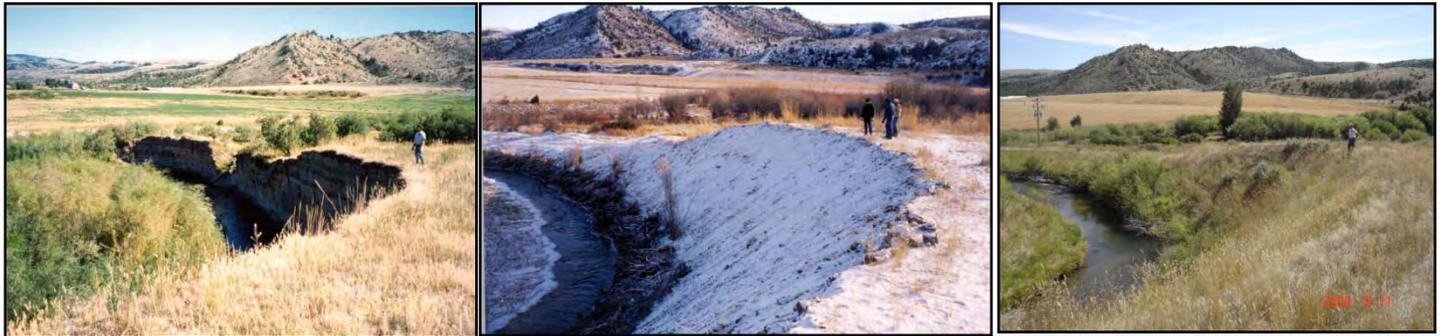
COMMENTS: 9/9/09 – The photos are just a representative of a much larger TMDL project completed on Deep Creek. Condition of the riparian corridor appears to be good, with no observed livestock use. Weeds also do not appear to be a problem. For the most part, stabilized banks appear to have remained so and willow recovery appears to be very good. Quite a few willow clump transplants appear to be thriving. One slump was observed on the steepest part of the highest stabilized terrace. This slump may allow the stream to start eroding around the cabled juniper and vegetated bank located just downstream. Several sites were treated with rock riprap. Landowners have tolerated beaver entering into the drainage and it appears this beaver activity (numerous dams) has acted to further stabilize the stream.

Deep Creek before (1996)

Deep Creek after (Winter 1998)

Deep Creek after (9/2009)

MONITORING CONCLUSIONS: This project has proven successful in stabilizing significant portions of Deep Creek. Compliance with livestock grazing in the riparian corridor has remained good and the riparian vegetative community is showing substantial recovery. The project likely benefitted the resident fishery, but the project goal of enhancing recruitment of fish to the Missouri River and Canyon Ferry Reservoir has not come to fruition.

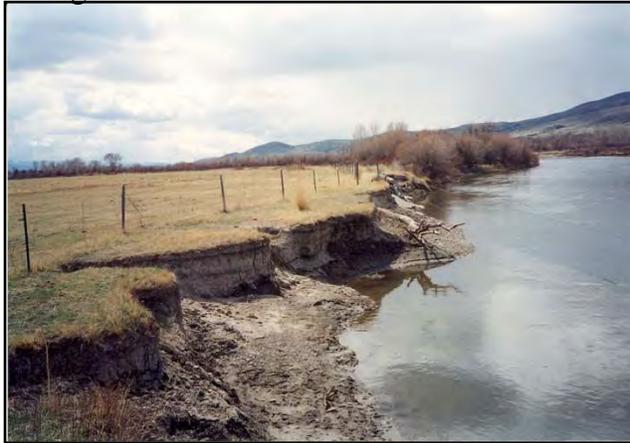
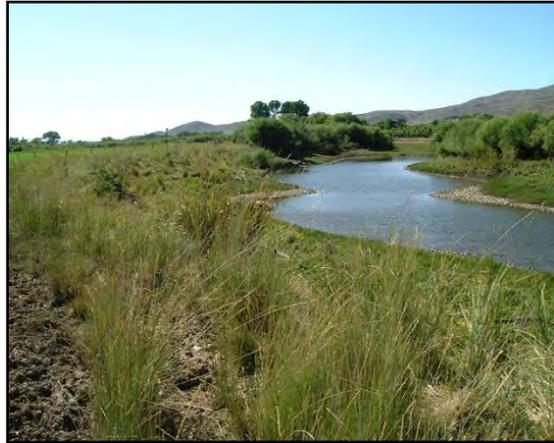
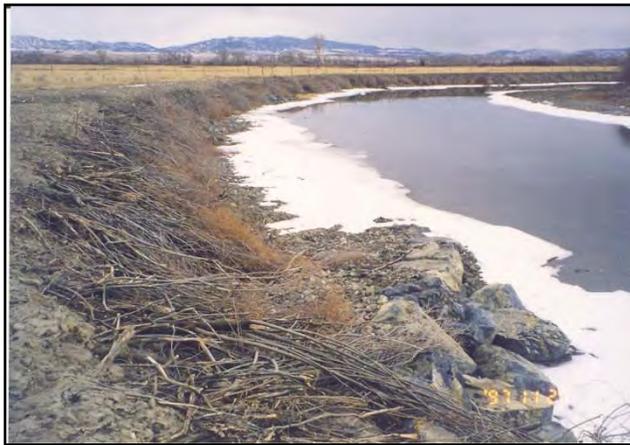
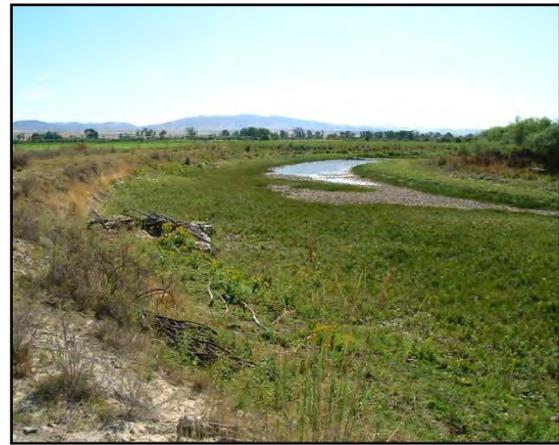
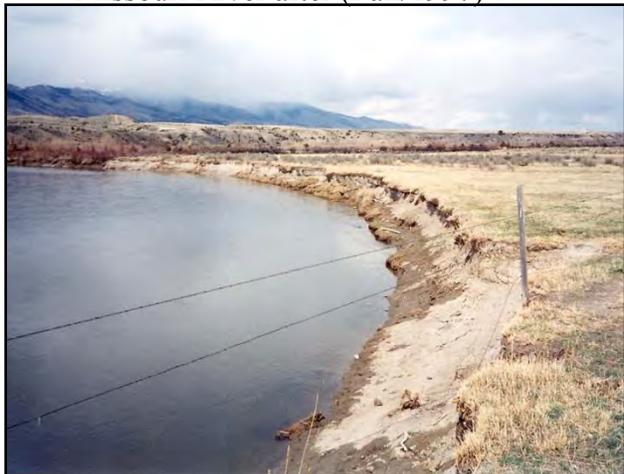
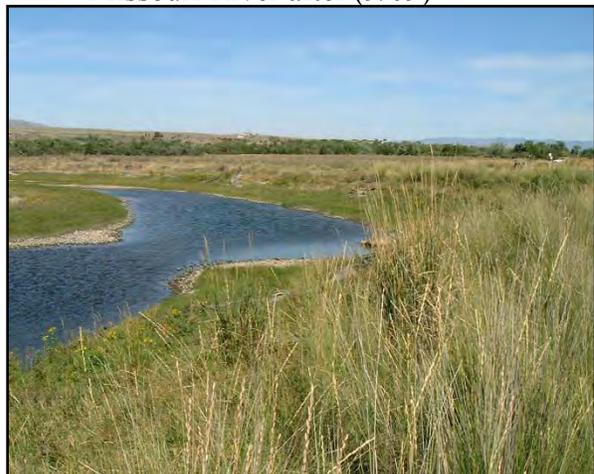
COMMENTS: 9/9/09 – The river has essentially abandoned this side channel, except during high water events. 2009 photos do not adequately show the severe grazing impacts on top of the existing bank and the cattle trampling down to water edge. Severe weed infestations (knapweed) were observed and there appears to be absolutely no survival of the large number

of willow cuttings placed on the stabilized bank in 1997. The rock vanes that were installed remain fully intact, but essentially abandoned. Although the value of future follow-up is questionable, the potential for the river returning to this side channel remains a real possibility. If and when this side channel becomes activated, it would be interesting to see how well the “restored” streambank would resist erosion in the face of little or no riparian vegetation.

Missouri River before (4/1996)

Missouri River after (9/09)

Missouri River after (Fall/1997)

MONITORING CONCLUSIONS: This project appears to have been undertaken more for the purposes of property protection than channel restoration. Grazing management within the riparian corridor appears to have remained poor. The bank stabilization work has remained stable, but the entire side channel has become inactive under most flow conditions. This project appears to provide no benefits to the fishery.

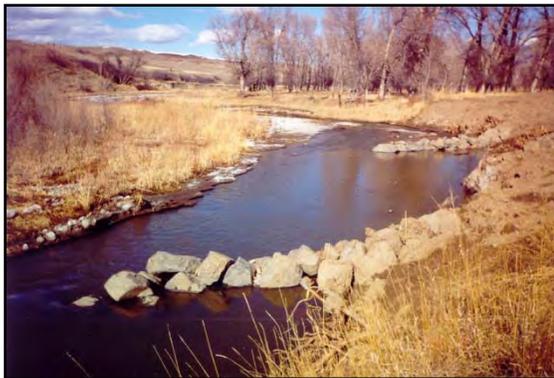
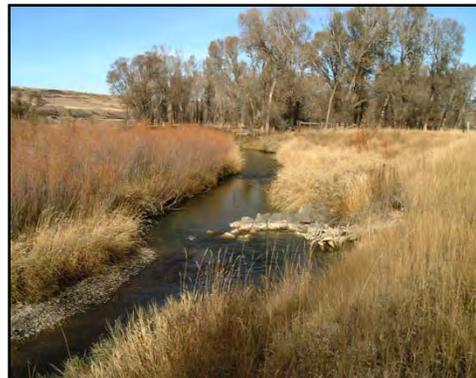
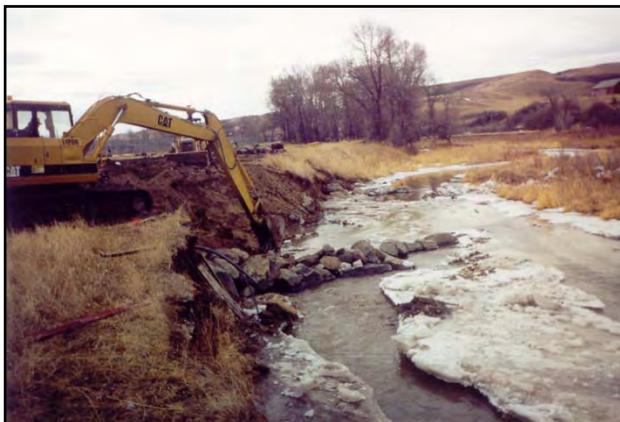
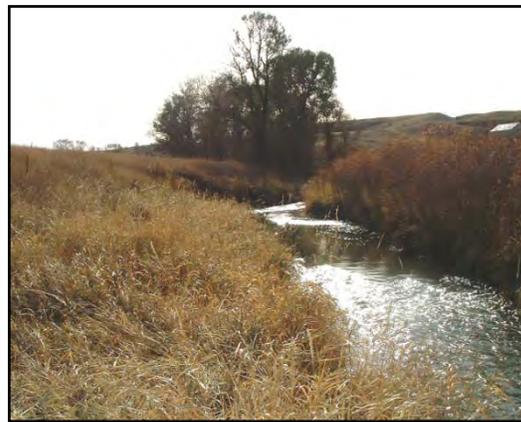
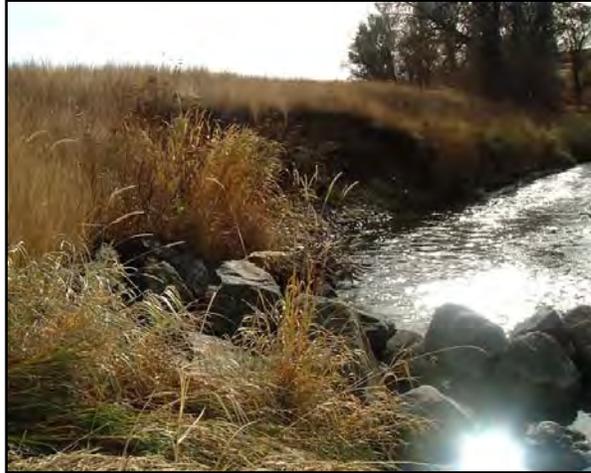
COMMENTS: 10-21-09 – Fencing remains in place and there are no signs of past grazing within the riparian corridor. The point bar shows strong new willow recruitment, but the treated bank shows little woody shrub regeneration. In-channel structures have remained in place for the most part and the constructed floodplain bench is well vegetated. Bank erosion was observed on the upstream end of the project and may eventually cut behind the rock jetty structure (see last photo).

Cottonwood Creek after (Spring/2000)

Cottonwood Creek after (10/09)

Cottonwood Creek during (Spring/2000)

MONITORING CONCLUSIONS: This project appeared to be more for the purpose of property protection than for channel restoration. The stream bank has remained relatively stable and riparian vegetation has exhibited good recovery. The project appears, at most, to have provided only minimal benefit to the fisheries.

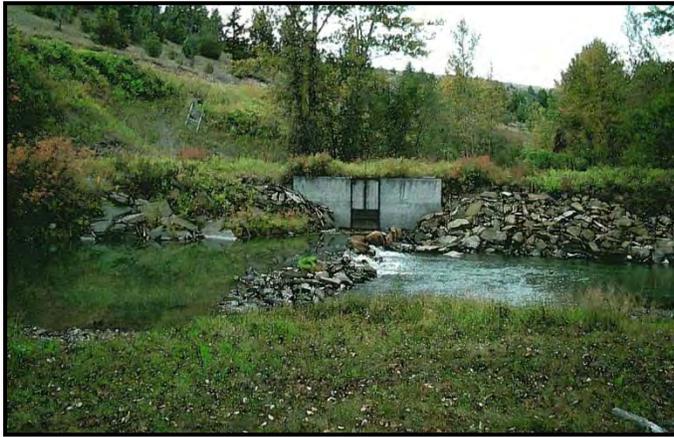
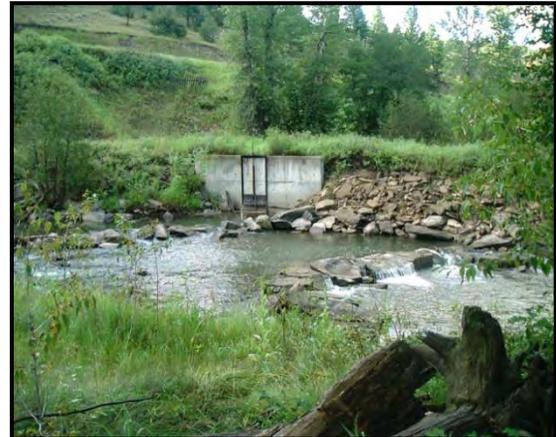
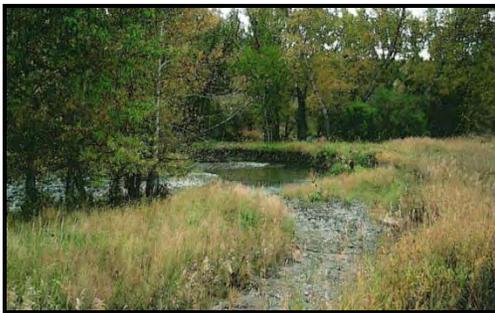
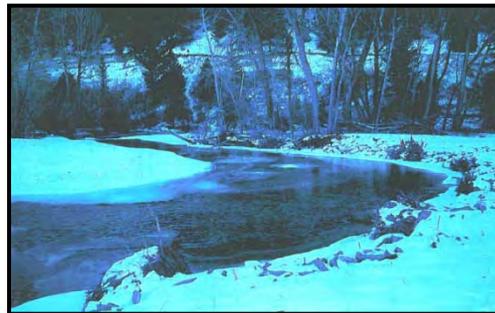
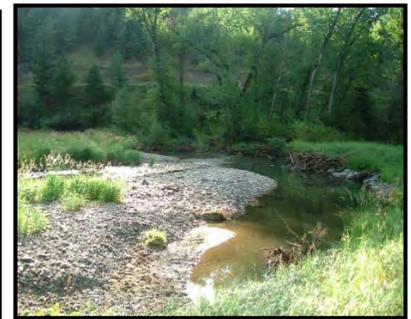
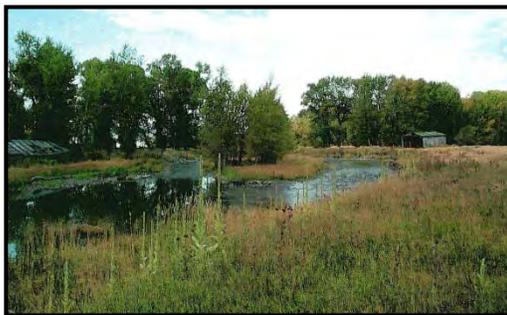
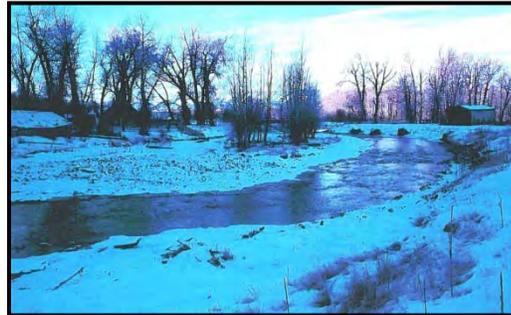
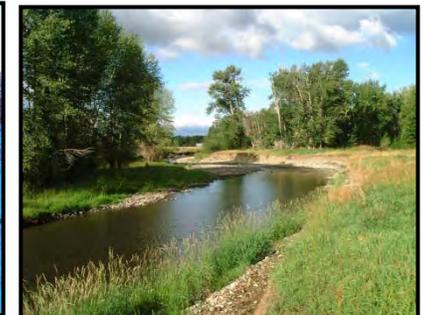
COMMENTS: This project involved the stabilization of several banks and an irrigation diversion. Grazing management appears to have been limited in the riparian corridor and riparian condition appears to be relatively good, although there didn't appear to be much recruitment of woody shrubs. Weed infestations do not appear to be a problem. According to the landowner, the irrigation weirs have self maintained since installation. The bank revetment (primarily rootwads) has not been effective for the most part and has been lost in a number of areas. Willow sprigging efforts, as were proposed in the application, did not appear successful; although it is unknown if sprigs were actually installed in the first place.

Shields River before (1999)

Shields River after (8/23/10)

Shields River after (2000)

Shields River after (8/25/10)

Shields River after 8/23/10

MONITORING CONCLUSIONS: The purpose of this project was three-fold. First, the project involved stabilizing a short reach of the river to prevent capture of the lower end of the Cole Creek channel; thereby potentially by-passing an irrigation diversion structure. Although not observed on the ground due to time constraints, the ranch manager indicated that the effort at avulsion protection has prevented the capture of the channel and maintained the irrigation diversion over the years. Second, the project stabilized an existing irrigation diversion structure. This diversion structure has self-maintained since completion in 2000. Third, the project stabilized a series of actively eroding stream banks using primarily rootwads in combination with some rock v-weirs and fabric wraps. For the most part, the

rootwads have proven ineffective, with many being lost over time. Overall, this project appeared to provide little to no benefits to the Shields River fishery.

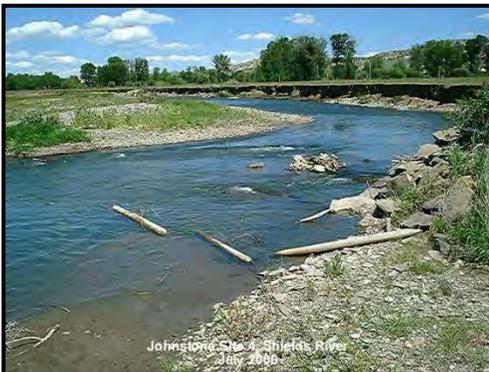
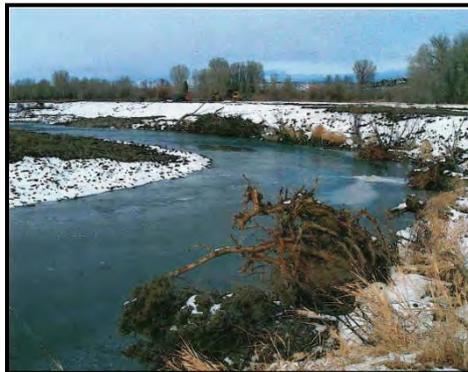
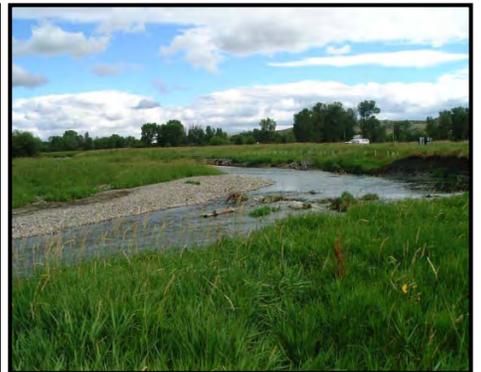
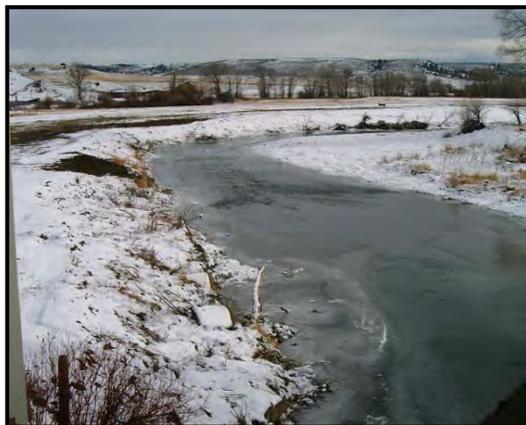
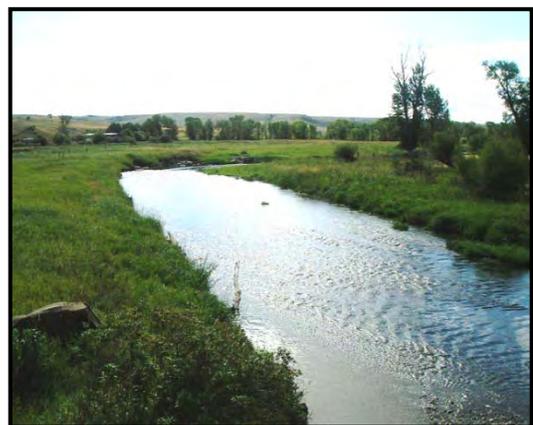
COMMENTS: 8/23/10 – The intent of this project was to stabilize approximately 600 feet of river bank and create a demonstration project for others to follow. Stabilization efforts have shown mixed results. The bank reach exhibiting the greatest erosion pressure has lost a fair number of rootwads and appears to be trending back to pre-project conditions (see first 3 photos). Other portions of stabilized river bank, under what appears to be less erosion pressure, have remained relatively stable (see last 2 photos). Grazing management appears to be adequate, but there is very little recruitment of new riparian shrubs. A number of past attempts at re-vegetation appear to have been relatively unsuccessful in enhancing woody riparian shrubs.

Shields River before (7/2000)

Shields River after (2002)

Shields River after (8/23/10)

Shields River after (2001)

MONITORING CONCLUSIONS: Stabilization efforts on the Shields River are challenging at best; due to highly variable flow conditions and alluvial conditions. Rootwads installed in this type of system appear to be relatively ineffective. Re-vegetation efforts also appear to be challenging due to variable flow conditions, high bankfull elevations and browse by wildlife. Overall, this project appeared to be more directed at property protection than fisheries enhancement. The project appeared to provide very little, if any, benefit to the Shields River fishery.

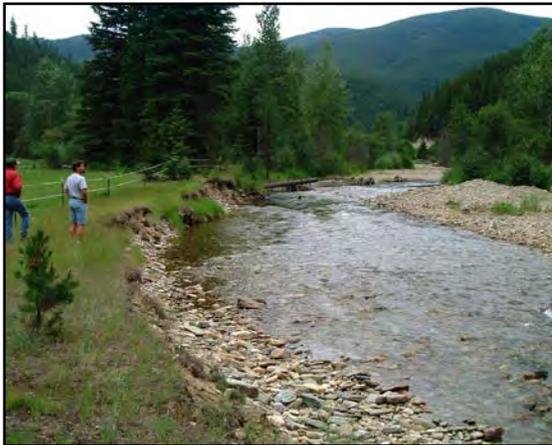
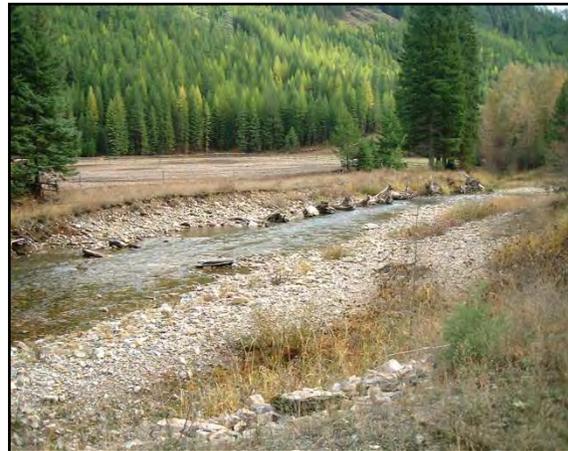
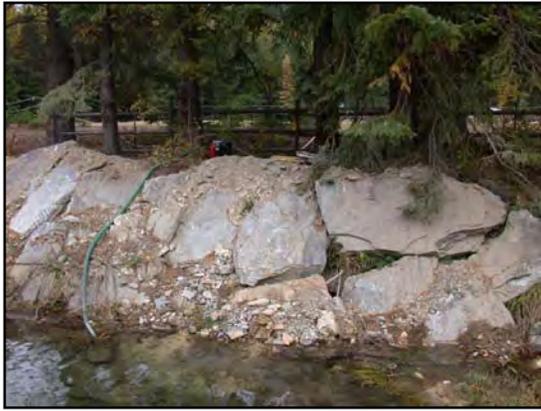
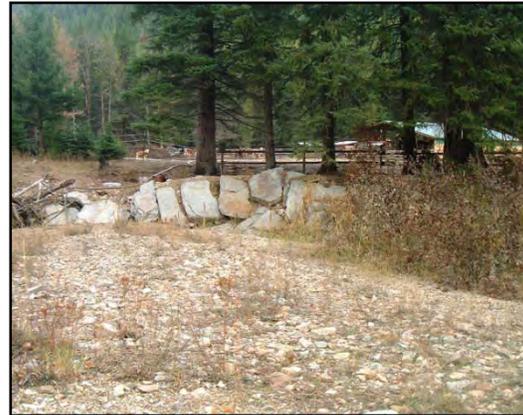
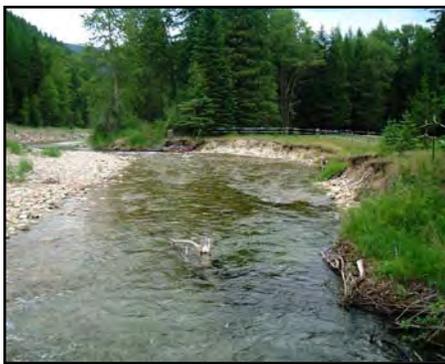
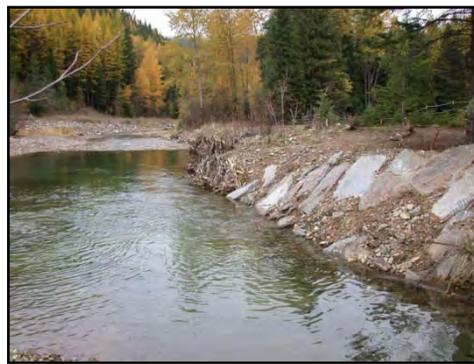
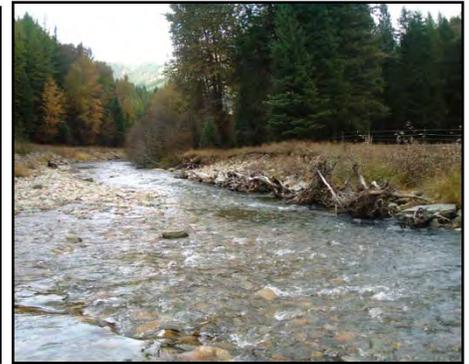
COMMENTS: 10/15/09 – This project, designed by NRCS, was originally touted as a demonstration project for alternative bank stabilization. The blanket rip-rap observed was not initially included in the project but was done by the landowner as part of the project. The stream has moved away from the head of the project but continues to flow along the lower 2/3's of the treated reach. The installed root-wads appear to have remained in place. Some of the large flat rock used for rip-rap located on the lower half of the project has floated downstream. All of the woody shrub transplants appear to have died. Woody riparian shrubs have not shown any natural recovery on the downstream 2/3's of the project, with some recovery visible on the upper 1/3. The landowner has a significantly over-grazed horse pasture adjacent to the project and the setback for the riparian fencing is very minimal. The riparian fencing has remained in place. This project appeared to be more for property protection than fisheries benefits. It is unlikely that this project is providing a benefit to the fishery, and it does not appear to be a viable demonstration project.

Silver Butte before (7/2002)

Silver Butte after (10/2009)

Silver Butte after (10/2002)

MONITORING CONCLUSIONS: The purpose of this project was to provide a demonstration of alternative bank stabilization. However, actions by the landowner and by the NRCS turned this into a poor demonstration project by armoring a portion of the bank with large rock and by creating a very minimal riparian setback. This project appeared to provide no benefits to the fishery.

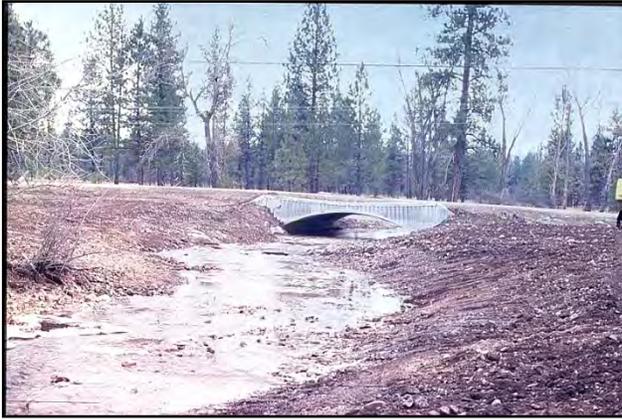
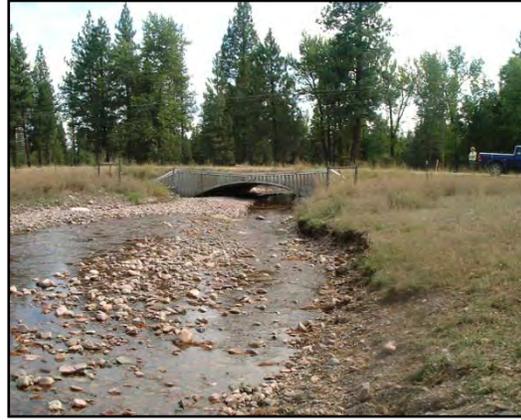
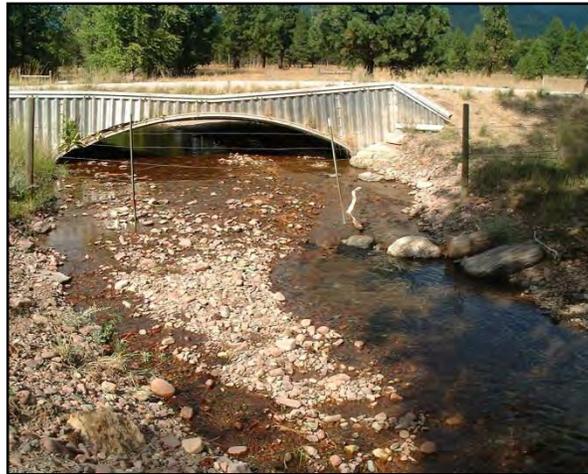
COMMENTS: 9/17/09 –The bridge remains functional and continues to allow for fish passage. The channel in the vicinity of the bridge appeared to be substantially dished-out following construction. This shallow and over-widened portion of channel has resulted in a fair amount of alluvial deposition on the left bank. The downstream side of the bridge is showing some slight failure; where a panel that holds road fill has bulged out from the bridge arch (see last photo).

Cottonwood Creek after (1999)

Cottonwood Creek after (9/2009)

MONITORING CONCLUSIONS: The bridge has maintained functional passage for aquatic organisms in spite of the over-widened and shallow nature of the channel. Improved fish passage, in combination with other restoration efforts in the drainage, likely has benefited the fishery in the drainage.

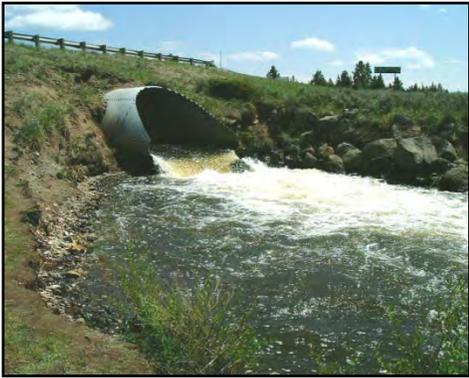
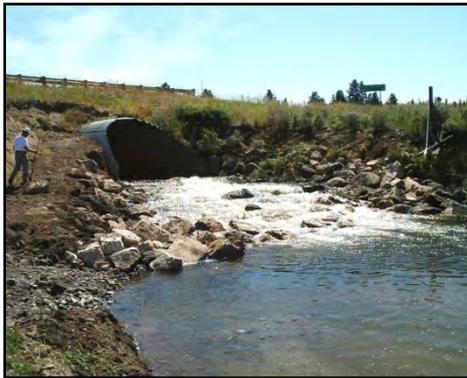
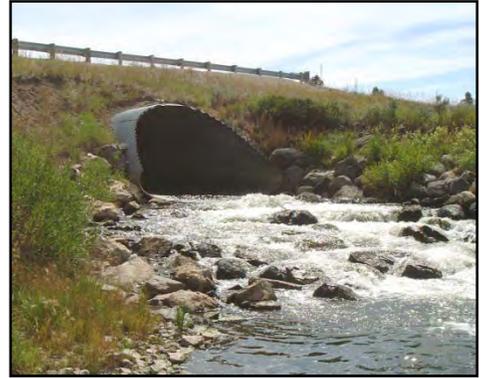
COMMENTS: 8/24/09 – The rock ramp has remained in place and re-vegetation efforts by the USFS (willow sprigging) have been relatively successful. Water velocities at the mouth of the culvert continue to appear to be relative swift. Some fish were able to pass through the pipe prior to the installation of the ramp. The USFS has documented greater numbers of fall spawning fish (mountain whitefish and brown trout) now are passing through the pipe.

Duck Creek before (6/2003)

Duck Creek after (11/2005)

Duck Creek after (8/20/2009)

MONITORING CONCLUSIONS: The project has improved upstream fish passage at this highway crossing. However, the velocities through the culvert likely continue to create a partial passage barrier, especially to smaller fish and spring migrants. Monitoring has shown the brown trout and mountain whitefish are the primary benefactors from this project.

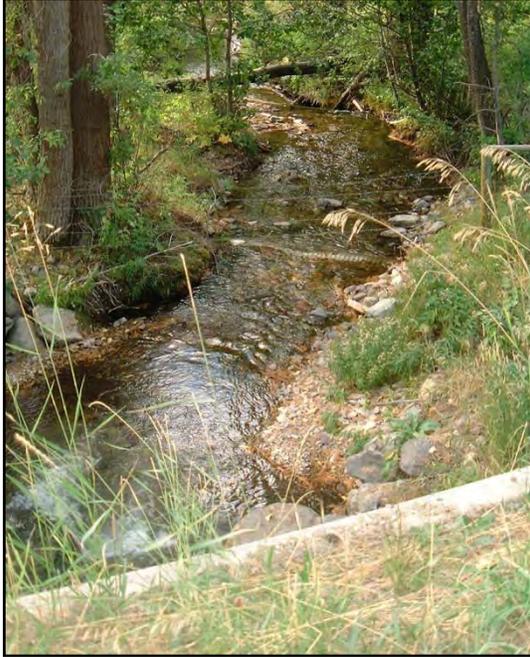
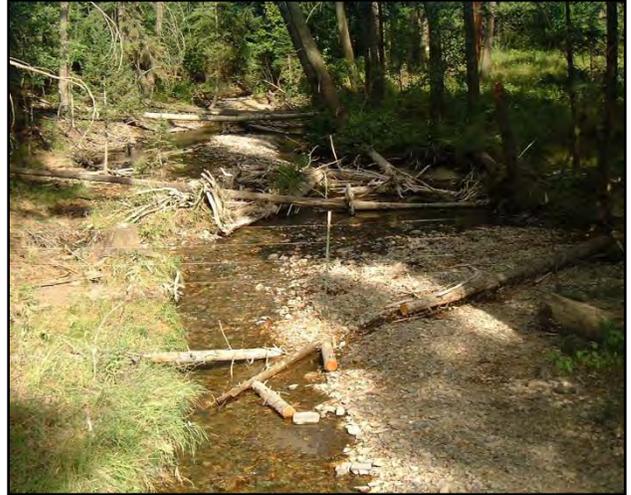
COMMENTS: 9/17/09 – According to the regional biologist, the ranch manager of the Two Creeks Ranch claimed that, historically, it was not unusual for McCabe Creek to become totally dewatered during the peak of irrigation. We have no other documentation, including photos, of past flow conditions on McCabe Creek. This project, among other restoration efforts, consolidated five diversions into a single diversion and converted the irrigation system from flood to sprinkler. The stream exhibited a good flow level at the time of the visit. However, all irrigation systems appeared to be turned off at the time of the visit. It would be of value to observe stream flows at the project site during the peak of irrigation to ensure in-stream flow is being adequately maintained. The size of the intake pipe essentially controls the amount of water that can be diverted.

McCabe Creek After (9/2009) Down

McCabe Creek #2 (9/2009) Up

MONITORING CONCLUSIONS: The quantity of water being salvaged for in-stream flow purposes is approximately 5 cubic feet per second. Region 2 personnel annually monitor stream flow. Greater flow in the stream likely provides substantial benefits to the fisheries.

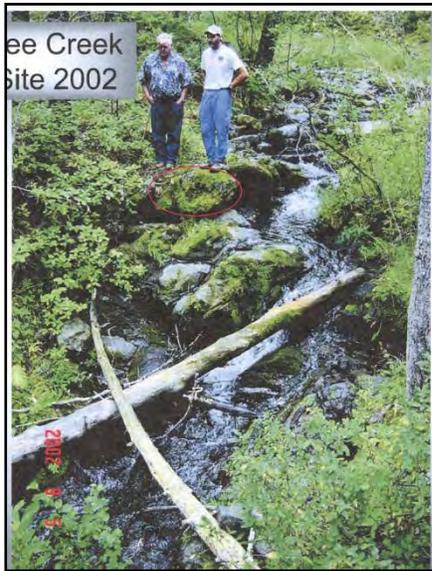
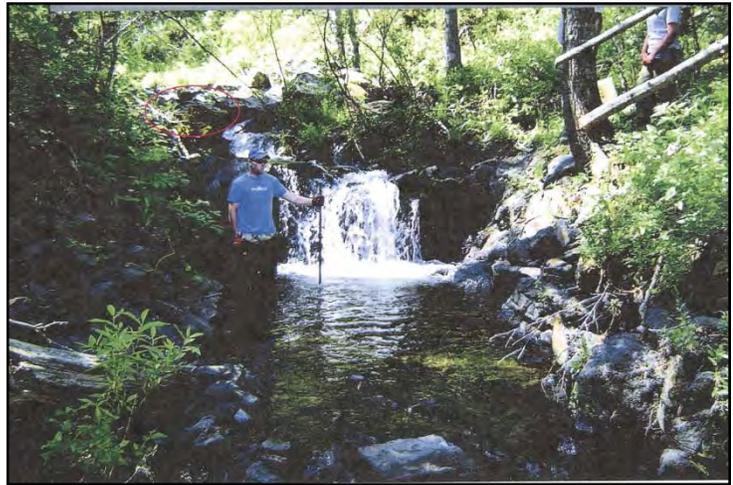
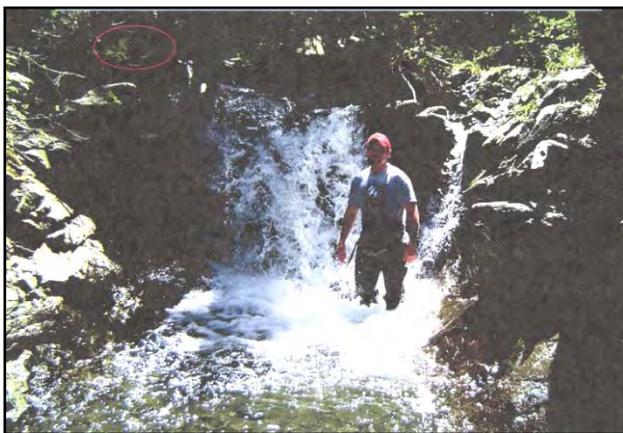
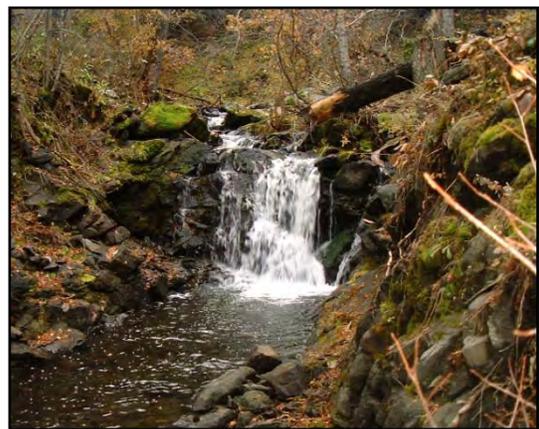
COMMENTS: 10-21-09 – The barrier has been modified by additional blasting at least once over the years. Currently, the barrier appears stable and continues to function. According to the USFS, westslope cutthroat trout are thriving upstream of the barrier. All photos are from the same vantage point.

Big Coulee before (summer 2000)

Big Coulee after (summer 2003)

Big Coulee after (summer 2004)

Big Coulee Photo after (10/2009)

MONITORING CONCLUSIONS: The barrier has remained functional and, as a result, has allowed USFS personnel to develop a thriving pure westslope cutthroat trout population in the stream. This project has been beneficial at securing and enhancing a remnant population of westslope cutthroat trout located in the Highwood Mountains.
