FUTURE FISHERIES IMPROVEMENT PROGRAM LONG-TERM PHOTO POINT MONITORING REPORT DECEMBER 2012

Mark Lere Fisheries Bureau Montana Fish, Wildlife and Parks

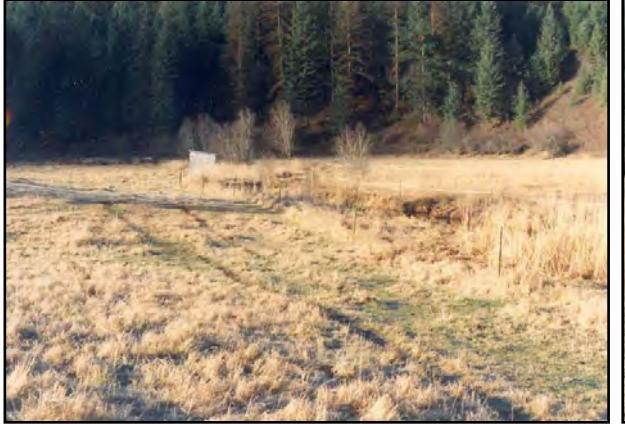
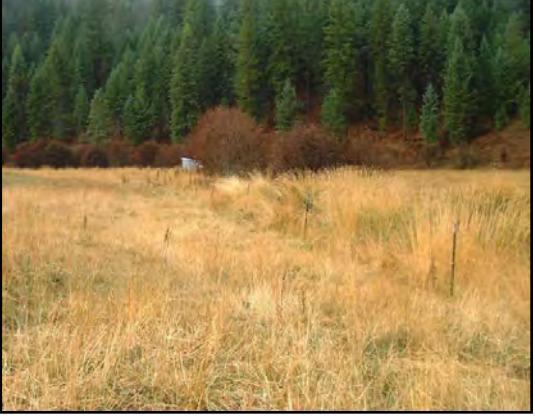
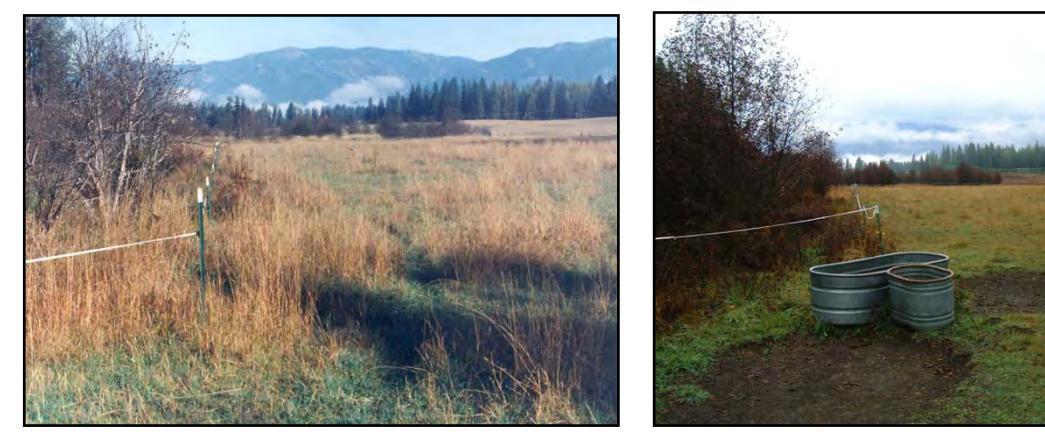
COMMENTS: 10/15/09 – The riparian fencing remains intact in most places. However, broken wires and laid down fence were observed in several locations. Low stocking rates and/or pasture management appears to be adequate to protect the riparian corridor even with the breaks in the fencing. Vegetation within the riparian corridor appears to be thriving. Reed canary grass dominates the stream banks. The physical characteristics of the stream channel do not appear to have changed since project completion. Fine sediment accumulations continue to dominate the channel substrate. The landowner claims sediment accumulations are due to upstream beaver activity. Weeds do not appear to be an issue.

MONITORING CONCLUSIONS: Fencing the stream-side corridor, in association with livestock grazing compliance, improved the riparian vegetative community. However, the channel morphology does not appear to have changed; with the channel remaining somewhat

over-wide and shallow and laden with fine sediment. Overall, fisheries benefits appear to be minimal, at best.

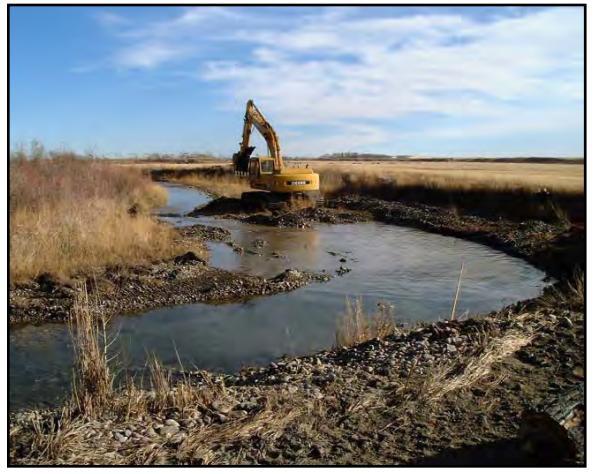
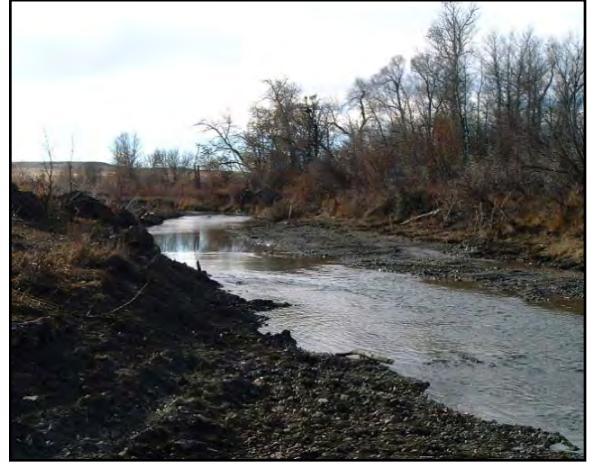
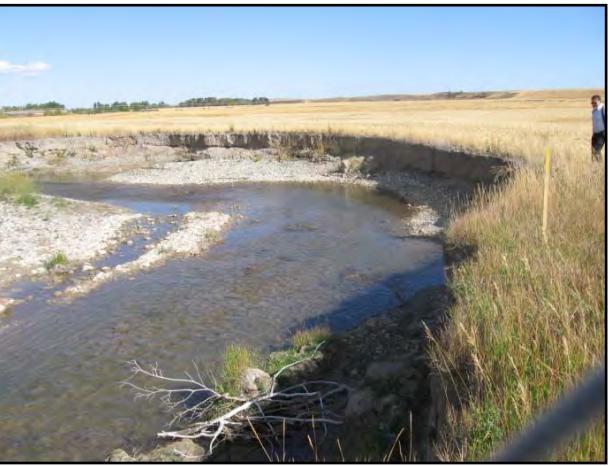
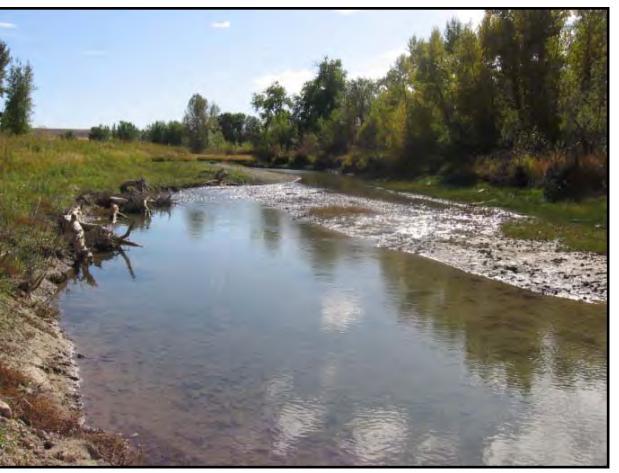
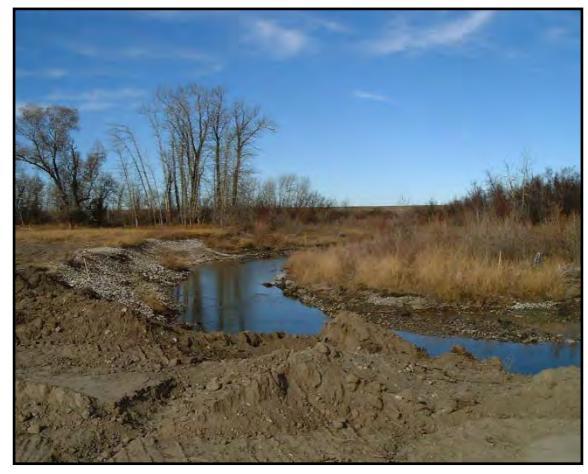
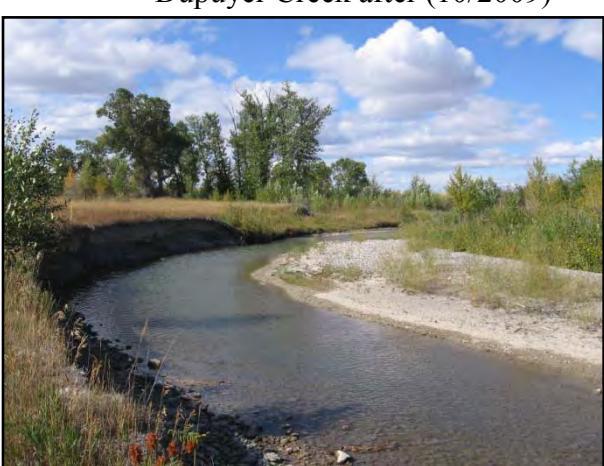
COMMENTS: 10/2/09 – The project fencing is in disrepair in a number of places. However, there was no recent evidence of livestock grazing within the project area. Farming activities were being undertaken to the edge of the active channel on one reach of the project area. Riparian shrubs and sedges have not re-colonized the denuded areas along the riparian corridor. Invasive weeds do not appear to be a problem in the project area. A large beaver dam has caused the channel to avulse to the left, resulting in some actively eroding stream banks. There also was a high eroding bank at the lower end of the project area where the old channel had been plugged.

MONITORING CONCLUSIONS: The purpose of this project was to repair a meander cutoff and stabilize the channel. The meander cutoff has remained repaired (stable). Other portions of adjacent channel exhibit bank erosion and the streamside fencing has done little to improve the riparian vegetative community. Overall, fisheries benefits appear minimal.

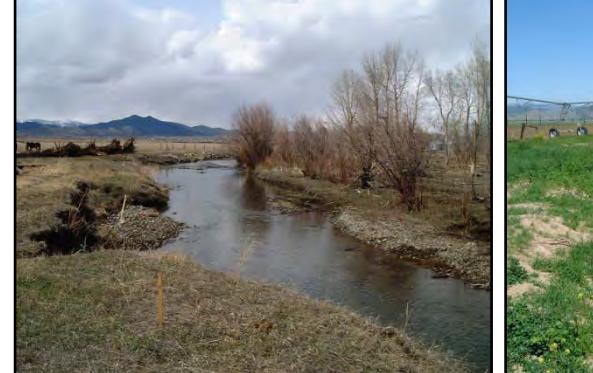
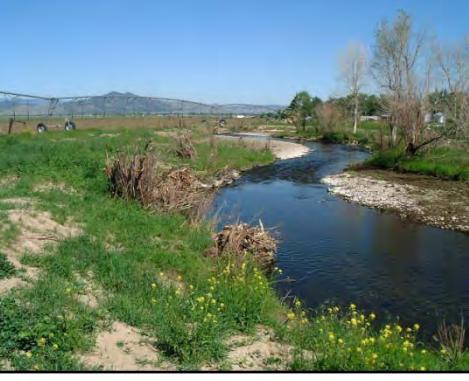
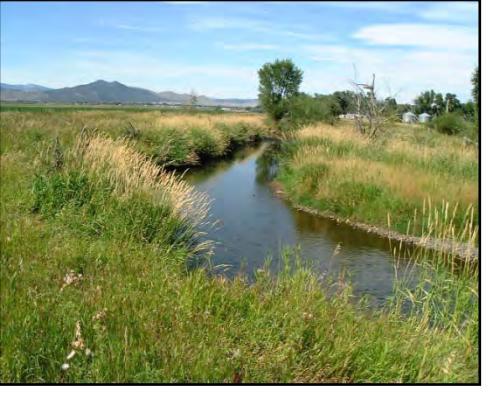
appears that all livestock grazing has been excluded since inception of project. Grasses were chest high. Some thistle patches were observed but weeds are not overwhelming. Willow transplants all appear to be dead, with the likely cause due to past severe stream dewatering, not to transplant methodologies. Native shrubs are showing some re-establishment. Browsing by wildlife was observed on the riparian shrubs (probably from the abundant deer population). Some channel changes have occurred over time, but overall channel function appears to be stable.

MONITORING CONCLUSIONS: This project involved both riparian fencing and channel restoration. The riparian vegetation has recovered significantly since completion of the project and the channel morphology has remained relatively stable. A major limiting factor on this reach of the stream has been severe dewatering. However, additional in-stream flow has been made available over the past 3 years, resulting in further recovery of the riparian vegetation. With the additional in-stream flow and with the associated channel restoration, this project has contributed toward benefiting the resident fishery (primarily brown trout).

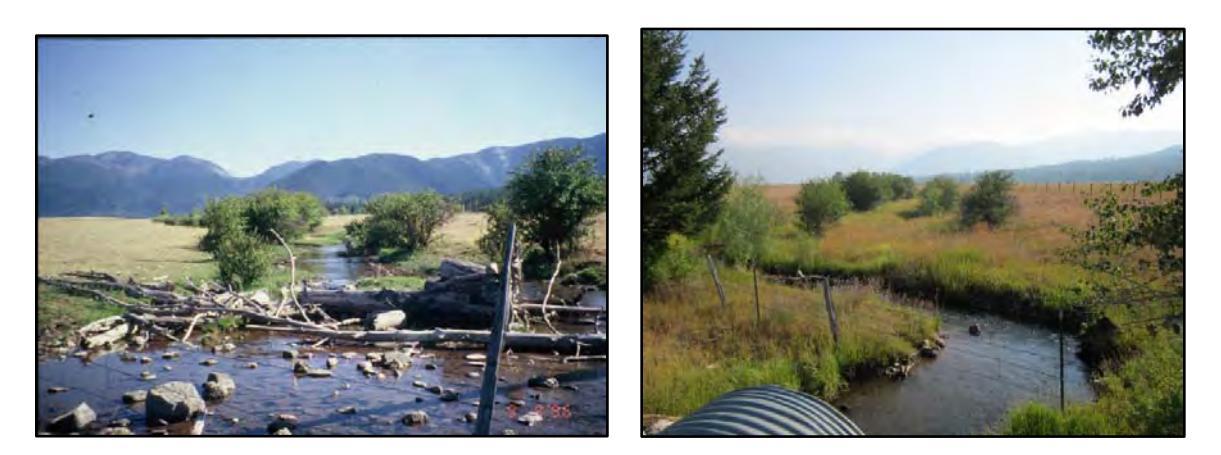
COMMENTS: 8/22/2012 – This project involved both channel and riparian restoration and was part of a drainage-wide restoration effort, involving improvements to in-stream flow, channel function and riparian condition. The fencing associated with this project created a

larger riparian pasture. It did not appear the pasture had been grazed in the recent past. No sign of livestock use was observed. Riparian condition has substantially improved and the restored channel has remained stable. No weeds were observed on the project site.

MONITORING CONCLUSIONS: This project has substantially restored the health and function of the stream, especially in context with the many other past restoration projects completed in the drainage. Adequate flow remained in-stream even in the face of the 2012 drought conditions. Riparian condition looks good and will continue to improve if land use activities continue to be managed as they have been in the recent past. Monitoring of fish populations in a lower reach of Rock Creek has shown increases in the number of trout in the stream. The project provides benefits to the resident fishery, and likely benefits fluvial westslope cutthroat trout as well.

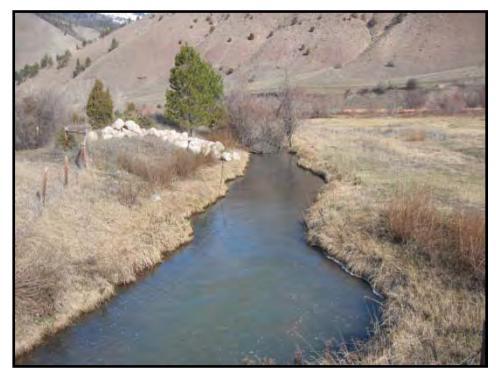
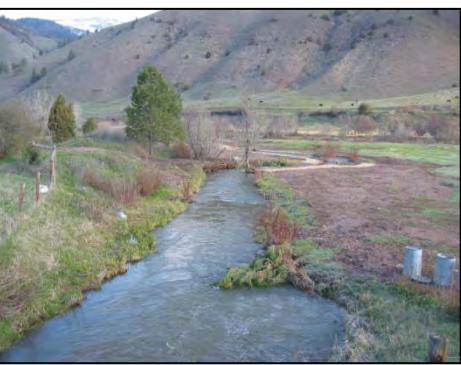
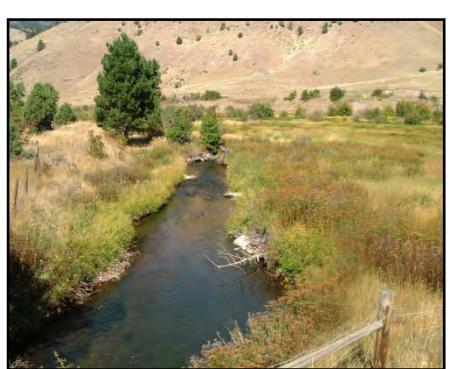
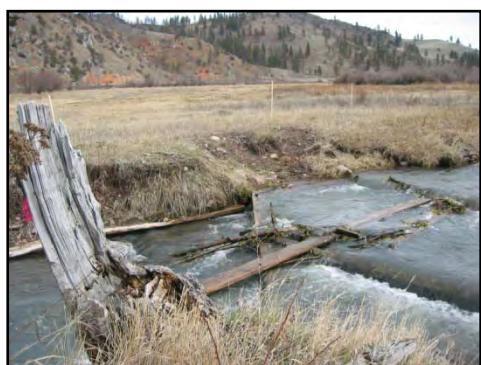
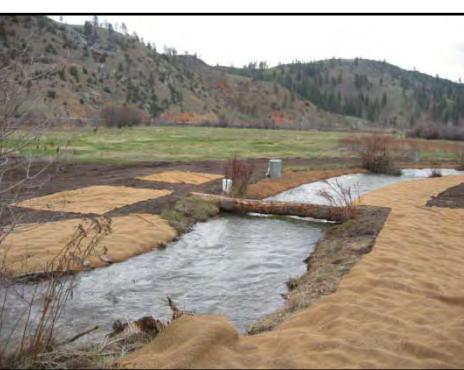
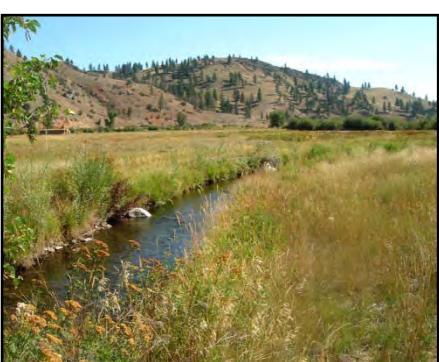
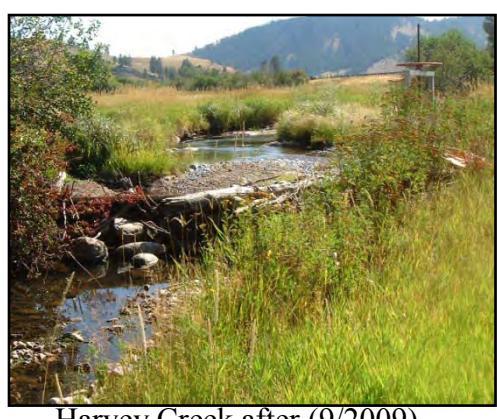
COMMENTS: 9/17/09 –The riparian corridor appears relatively healthy and the fencing remains in place. There are some signs of past cattle use (cow pies, tracking). Riparian shrub establishment appears to be slowly taking place. Weed infestations are extensive on the drier upland sites (knapweed and leafy spurge). The channel work appears to be successful, with the restored channel remaining stable. Unfortunately, the overall project is likely unsuccessful due to a diversion dam located at the bottom of the restored reach and near the confluence with the Clark Fork River (approximately 20 yards upstream from the mouth). This diversion appears to be a nearly complete barrier to upstream fish migration in low flow conditions and was taking ALL of the stream flow at the date of observation (see last photo).

MONITORING CONCLUSIONS: This project involved both riparian fencing and channel restoration. The intent of the project was to enhance recruitment of fish to the Clark Fork River. Although contrary to reports received in previous years, where observers claimed the site was extensively overgrazed (state lands section), the riparian vegetation has shown substantial recovery and the channel morphology has remained stable. However, the project likely has not provided recruitment benefits to the Clark Fork River due to the irrigation diversion located near the mouth of the stream. This diversion acts as a partial fish migration barrier and severely dewaters the channel during the irrigation season.

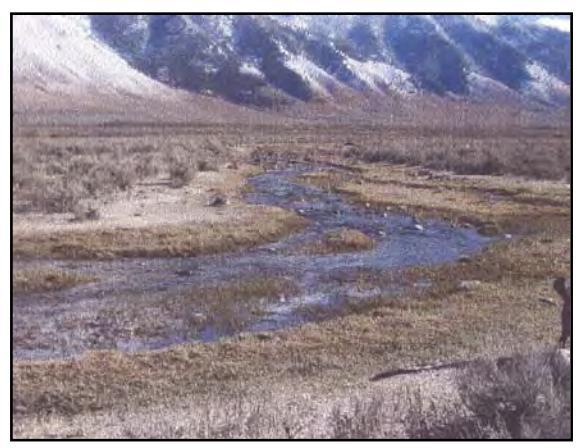
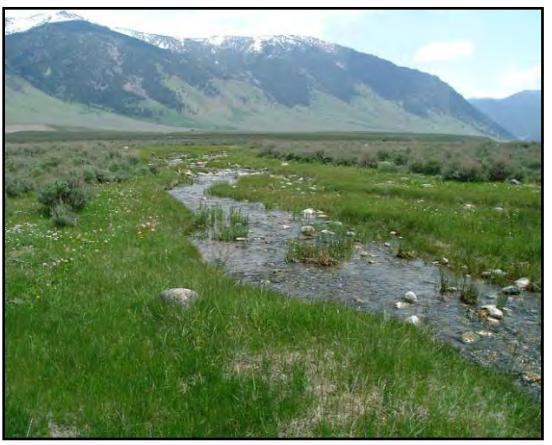
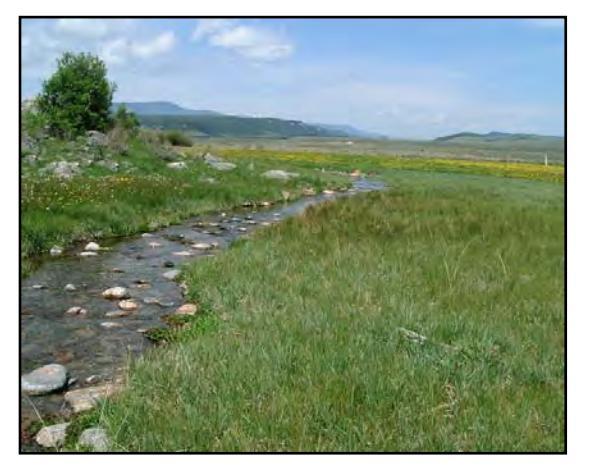
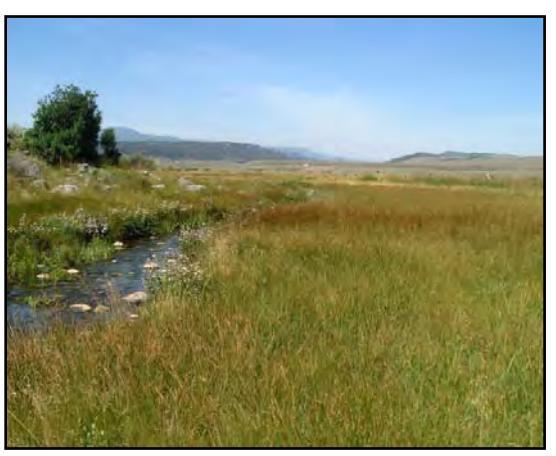
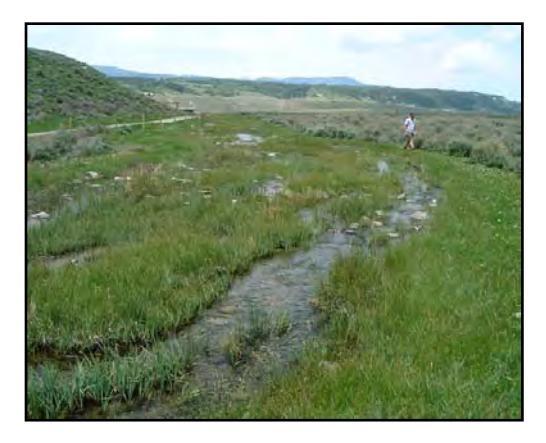
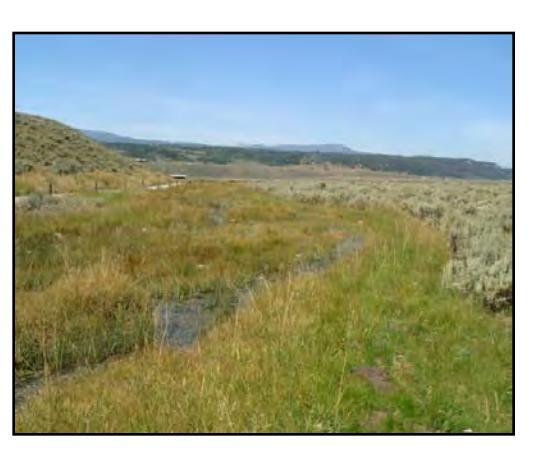
COMMENTS: 8/20/09 – The riparian fencing remains intact and fully functional. There were no signs of livestock grazing within the riparian corridor. Weeds do not appear to be an issue. Riparian grasses and sedges are thriving. It does not appear that riparian shrubs are recruiting to the corridor. The low energy of this small stream, in association with the large alluvial cobble that it runs through, appears incapable of adjusting channel width and depth in response to encroaching vegetation. It is unlikely that this upper portion of Madison Spring Creek has much potential to recruit juvenile fish to the Madison River due to shallow stream depths and the large cobble substrate that comprises most of the stream channel bottom.

MONITORING CONCLUSIONS: The installed riparian fencing and associated livestock grazing compliance has improved the riparian sedge and grass community. Riparian shrubs have not shown re-colonization. Based on the channel substrate being composed of large cobble, it is unlikely that this project has improved recruitment of fish to the Madison River. The project may have benefited the resident fishery (likely smaller brown trout and rainbow trout). Public benefits appear to be very marginal.

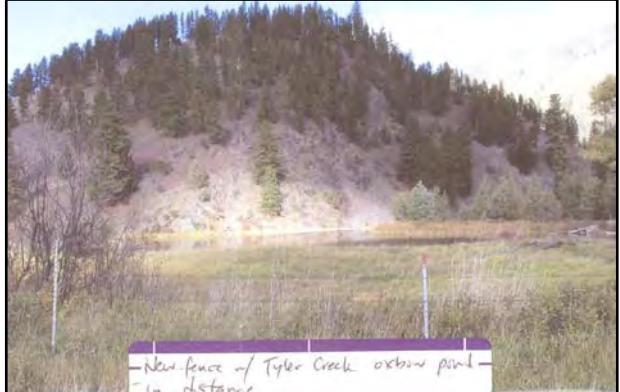
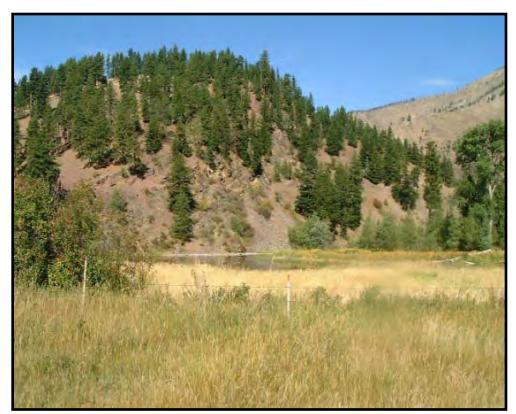
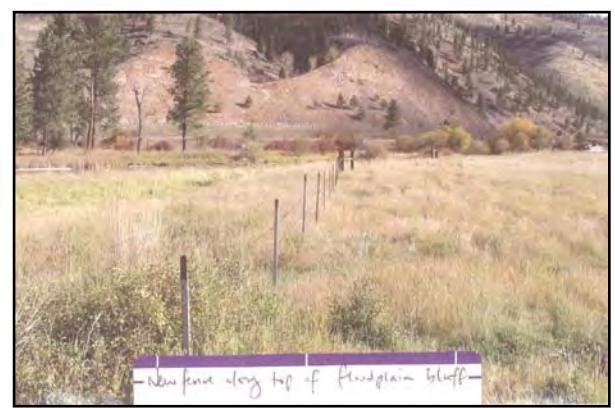
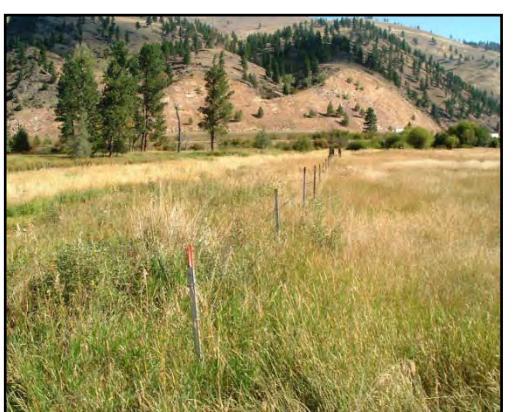
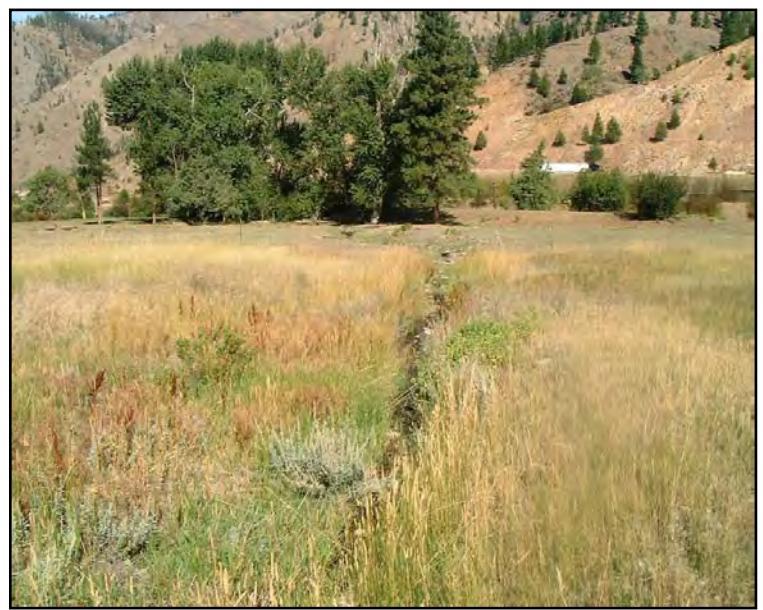
COMMENTS: 9/17/09 – This project appears to have been primarily directed at protecting some existing wetlands (existing river oxbow). The riparian vegetation at the site of the fencing appears healthy and there are no signs of livestock use. However, when looking down Tyler Creek from the private drive, a good portion of the stream (from fence line to confluence with the Clark Fork River) appears to be extensively overgrazed, with little or no remaining vegetation in the pasture (see fence line contrast shown in last photo). This project

did not benefit the fishery in Tyler Creek.

MONITORING CONCLUSIONS: This was a very small riparian fencing project, monetarily, for Future Fisheries. The project appeared to be solely associated with protecting a wetland complex (old river oxbow). The lower portion of Tyler Creek continues to be heavily over-grazed by horses. The project appeared to provide no benefits to the Tyler Creek fishery and the riparian corridor remains degraded.

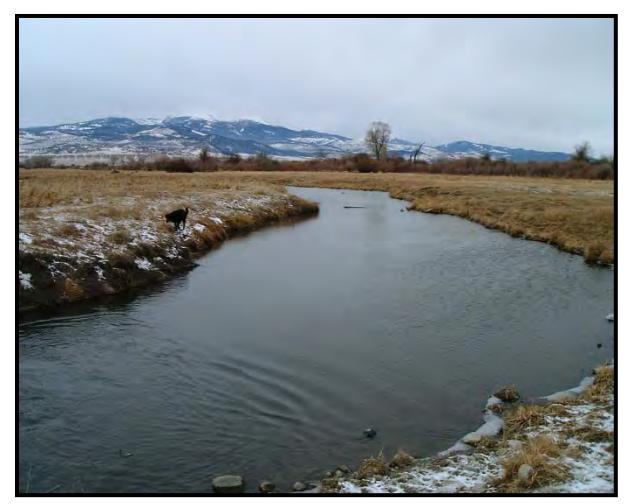
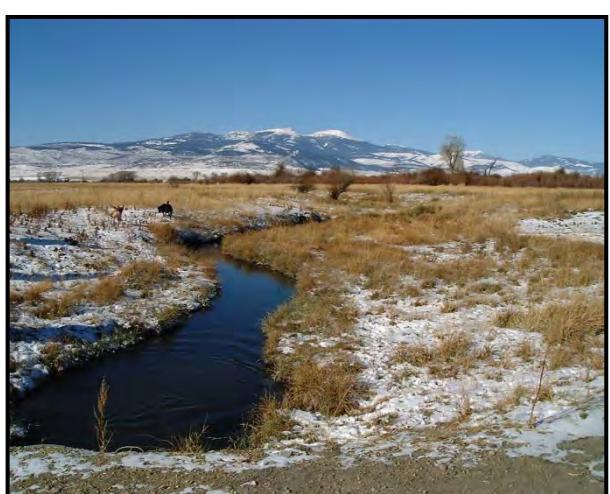
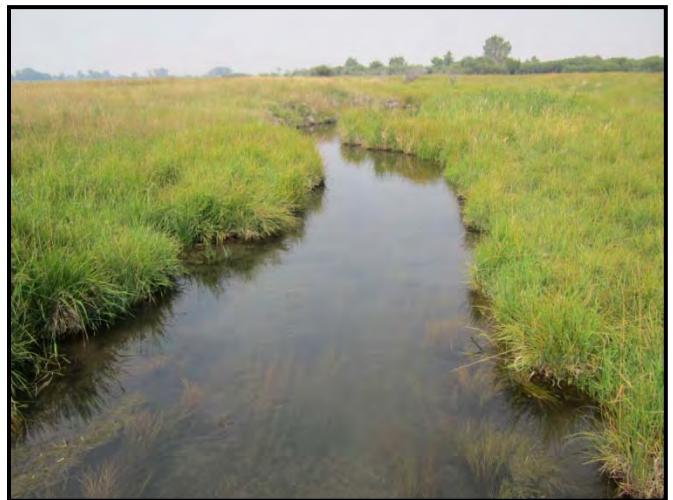
of the stream was narrowed and deepened, some spawning gravel was imported for riffle construction and fencing was installed to exclude livestock from the riparian corridor. The constructed channel has remained stable, but the low gradient and slow flow velocities have not maintained clean spawning gravel. The stream channel substrate is primarily composed of mud. The riparian fencing has remained functional and no livestock have been allowed into the fenced corridor. Pasture and wetland grasses are thriving in the riparian corridor. However, riparian shrubs have not recruited and remain virtually absent. All three photos were taken from the same vantage point.

MONITORING CONCLUSIONS: Monitoring by FWP has not documented any fluvial trout utilizing this spring creek to date. The new stream channel has not been able to maintain gravel substrate and, as a result, spawning habitat appears to be nearly non-existent. It is doubtful that fish from the Madison River will utilize this spring creek due to lack of spawning habitat.

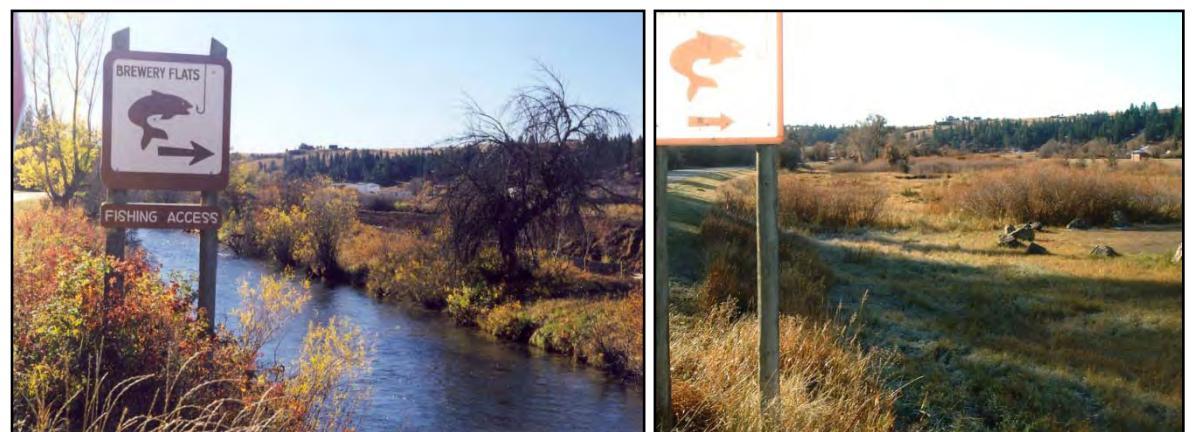
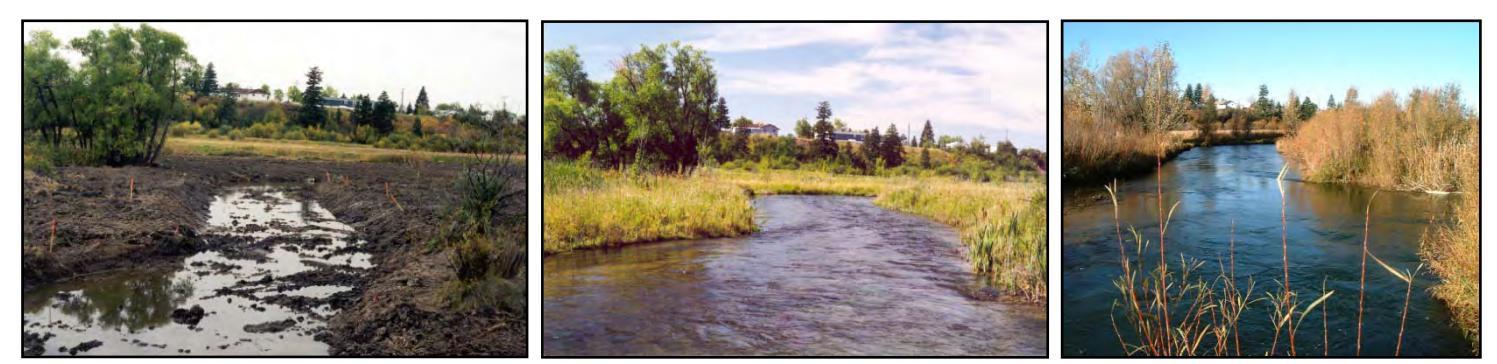
COMMENTS: 10/21/09 –The channel pattern has remained stable since project completion, however, the channel has widened over time. The newly constructed channel appeared to be undersized. A couple of outside meander bends are exhibiting some bank erosion. The riparian

area is lush, with significant wetland areas developing throughout the corridor. Vegetation is so lush that some of the viewing benches installed along the trail following project completion are now nearly surrounded by willow (and not providing much of a view). Few weeds were observed. The Parks division is mowing the access site close to water edge. Numerous willow sprigs from the original project were observed to be dead and under water. Much of the sprigging appeared to be installed at the wrong elevation along the bank line (either too high or too low). Sprigging was completed before water was turned down the new channel, making it difficult to determine the appropriate elevation for installation. Natural regeneration of willow certainly has outpaced the significant sprigging effort.

MONITORING CONCLUSIONS: This project is located on a FWP fishing access site. The site has become extremely popular with the community of Lewistown following the restoration. The channel morphology has remained relatively stable and the riparian and wetland communities have dramatically recovered. MDT received substantial wetland credits for this project. This project substantially benefited the resident fishery in this reach of the stream (rainbow trout and brown trout).

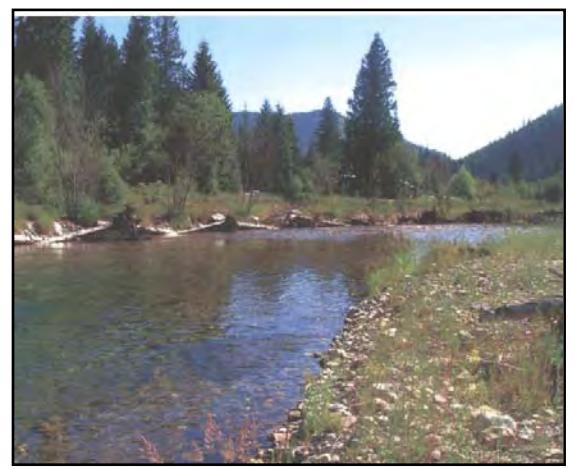
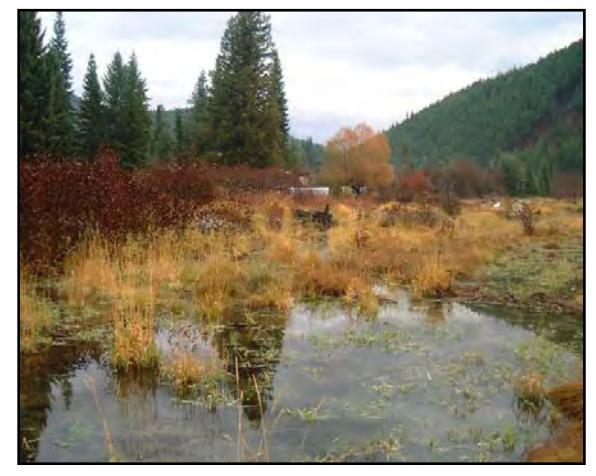
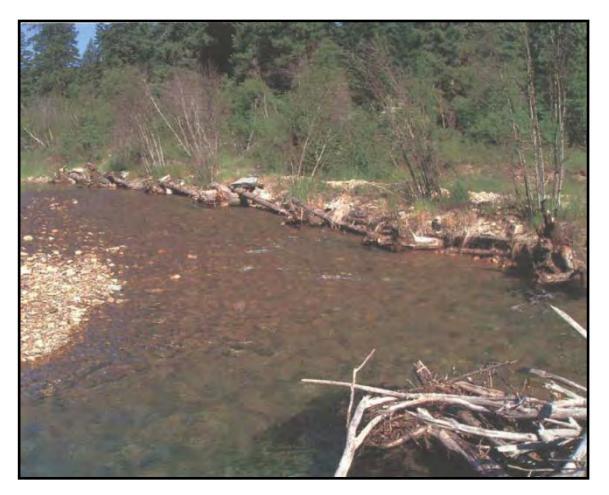
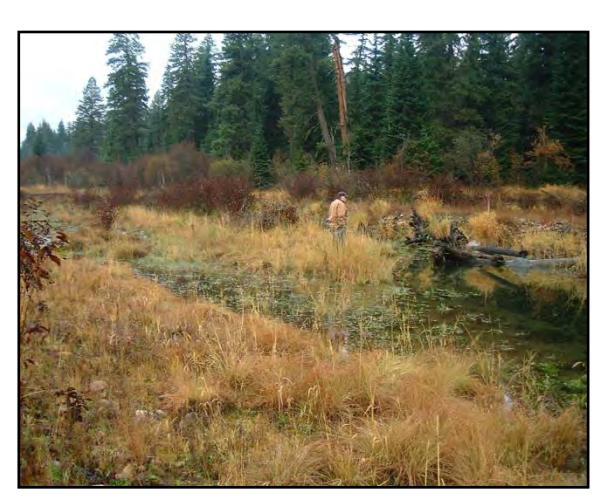
COMMENTS: 10/15/09 – This project involved channel stabilization over a significant reach of stream. Most of the stabilization structures have been lost or the stream has moved away from treated reaches. GPS'd photos are of a stabilization site where the stream has moved approximately 100 yards to the north of (away from) the treated bank. All transplanted alder at project completion appear to have died, but natural recruitment has been significant - significant enough to block viewpoints for matching photos. Root wads appear to have remained fully intact but are non-functional since the stream course is now about 100 yards away. Weeds do not appear to be an issue and livestock are not found in the area. Brush bundles installed on the floodplain bench appear to be intact but do not appear to have contributed to fine sediment accumulation or re-vegetation. Bank stabilization work appeared to be more directed at property protection than restoring channel function.

MONITORING CONCLUSIONS: The project appeared to be more associated with property protection than with channel restoration, at least on the stream reach that was observed for this monitoring effort. Some of the bank stabilization efforts have remained in place over time, but the active channel has migrated away from the protected banks at a

number of the treated reaches. The project appears to provide minimal benefit, at most, to the fisheries.

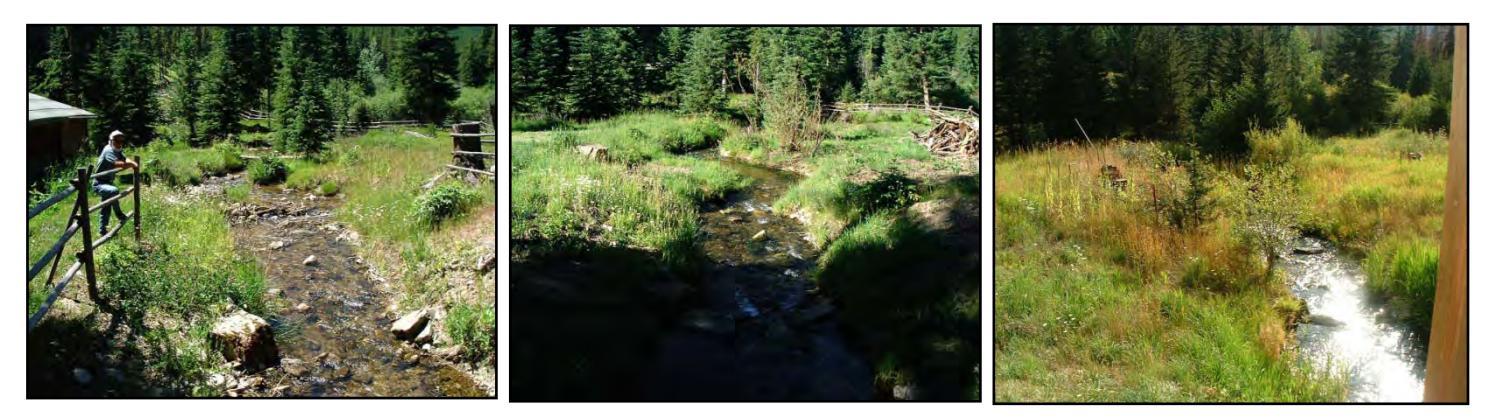
COMMENTS: 9/17/09 – The restored channel has remained stable and the riparian vegetation appears to be thriving. Weeds do not appear to be an issue. Riparian woody shrubs are re-establishing along the stream banks (appears to be through a combination of clump transplants, sprig or rootstock planting and natural recruitment). The old buildings located on the site have been torn down. The landowner has located his summer cabin and outbuildings in a similar location, between the South Fork of Poorman Creek and the main stem. Some of this development has encroached upon the riparian corridor, including a garage/bridge constructed over the active channel.

MONITORING CONCLUSIONS: This channel restoration project is located on a site that has been developed as a seasonal home site. The restoration work has remained stable and it appears to have created improved habitat for the resident fishery. Public benefits likely are minimal since the restoration work is located adjacent to a private cabin and associated outbuildings.

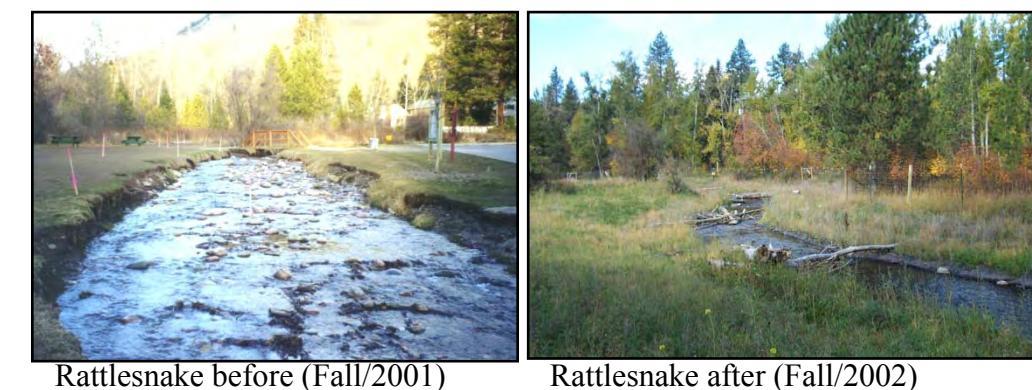
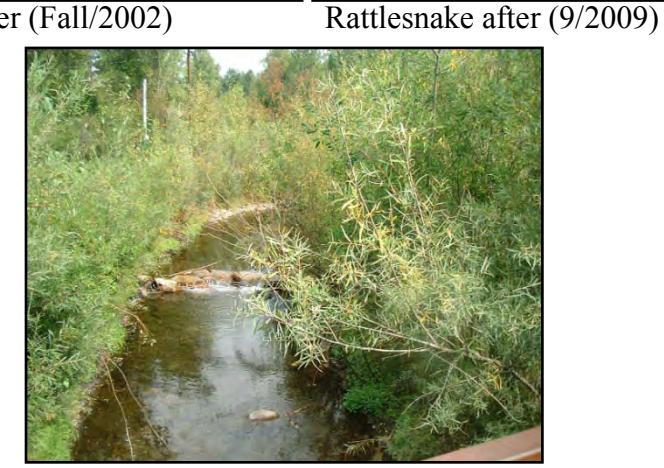
COMMENTS: 9/17/09 – This project is located in Missoula's Greenough Park. The original protective fencing (used to protect from wildlife browsing and from trampling by people) has been removed. The riparian vegetation at this project site has flourished, with riparian shrubs now heavily lining both banks. Weeds do not appear to be a significant issue. The channel restoration work has remained stable and the rock weir grade controls remain intact. Most of the relatively small woody debris initially placed in the channel has washed away. The plastic erosion control meshed used to line a good portion of the restored channel has remained intact and shows no sign of degrading after 8 years (see last photo). This plastic mesh is now an eyesore and likely ensnares wildlife and fish.

MONITORING CONCLUSIONS: This restoration project occurred on a side channel of Rattlesnake Creek located in Geenough Park. The project has remained stable over time and the riparian vegetative community has dramatically recovered. The vegetation recovery is probably the most dramatic response that I've ever seen. The project appears to have benefitted the resident fishery and may be providing improved recruitment of fish to the Clark Fork River

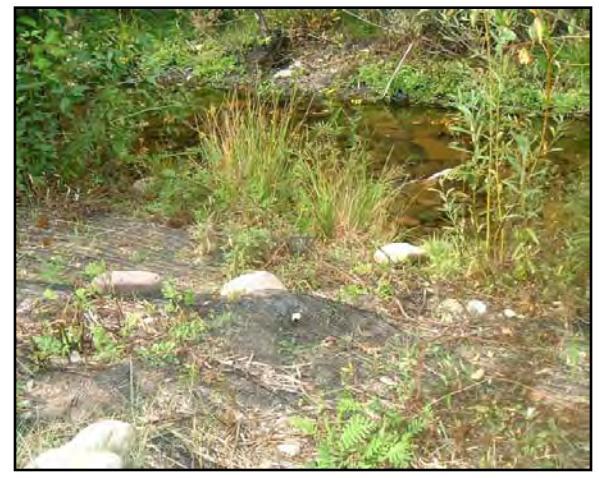
Rattlesnake Cr. Photo showing plastic mesh

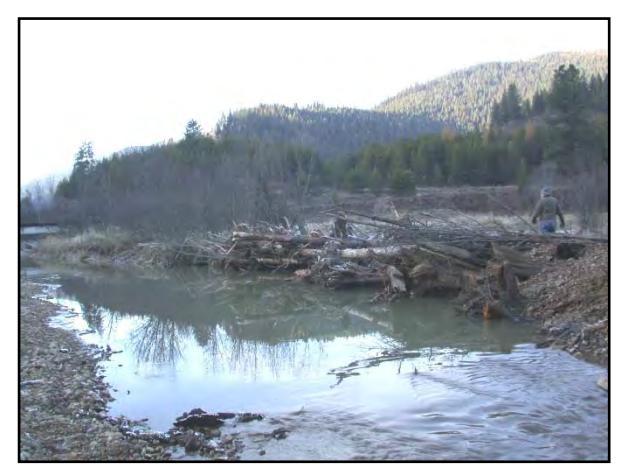
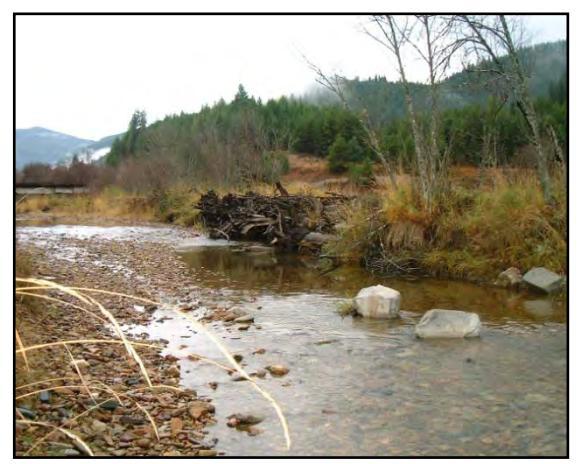
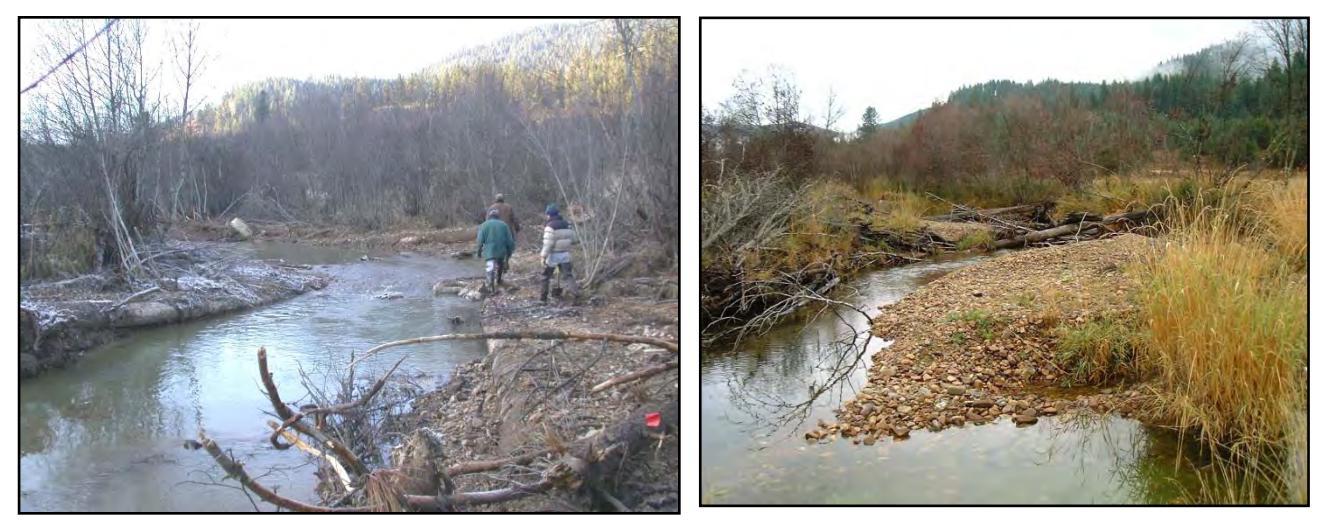
COMMENTS: 10/15/09 – The project has not maintained a "stable" channel (as designed) since about 2004. Most of the in-channel structures originally installed have been washed away or buried under gravel. These structures included log cross vanes and log and rock j-hook vanes. Repair work, apparently to no avail, was conducted in 2004 and in several additional efforts thereafter. Two engineered log jams have remained in place, although portions of each have been lost. The upper log jam had been installed to armor a site where an avulsion was starting to take place. This log jam has prevented further channel movement. The original designer pointed at shortcomings associated with the channel geometry during construction as the cause for the channel failures and has called for additional channel readjustments, bank wraps and more structures. The existing channel, however, appears to be relatively stable and appears to provide decent pools and overhead cover for fish habitat. A significant portion of the overhead cover appears to be from large woody debris produced from the installed in-channel structures that had been washed away. As a result of past channel adjustments, some j-hooks are now found on the inside of meander bends and appear to be non-functional.

MONITORING CONCLUSIONS: This project appeared to be more associated with protecting a landowner's private pond from a channel avulsion than restoring channel function. The blow-out of the installed channel structures may actually have created better fish habitat from the resultant jumble of logs than the original installations. This project appeared to provide minimal benefits, at most, to the fishery.

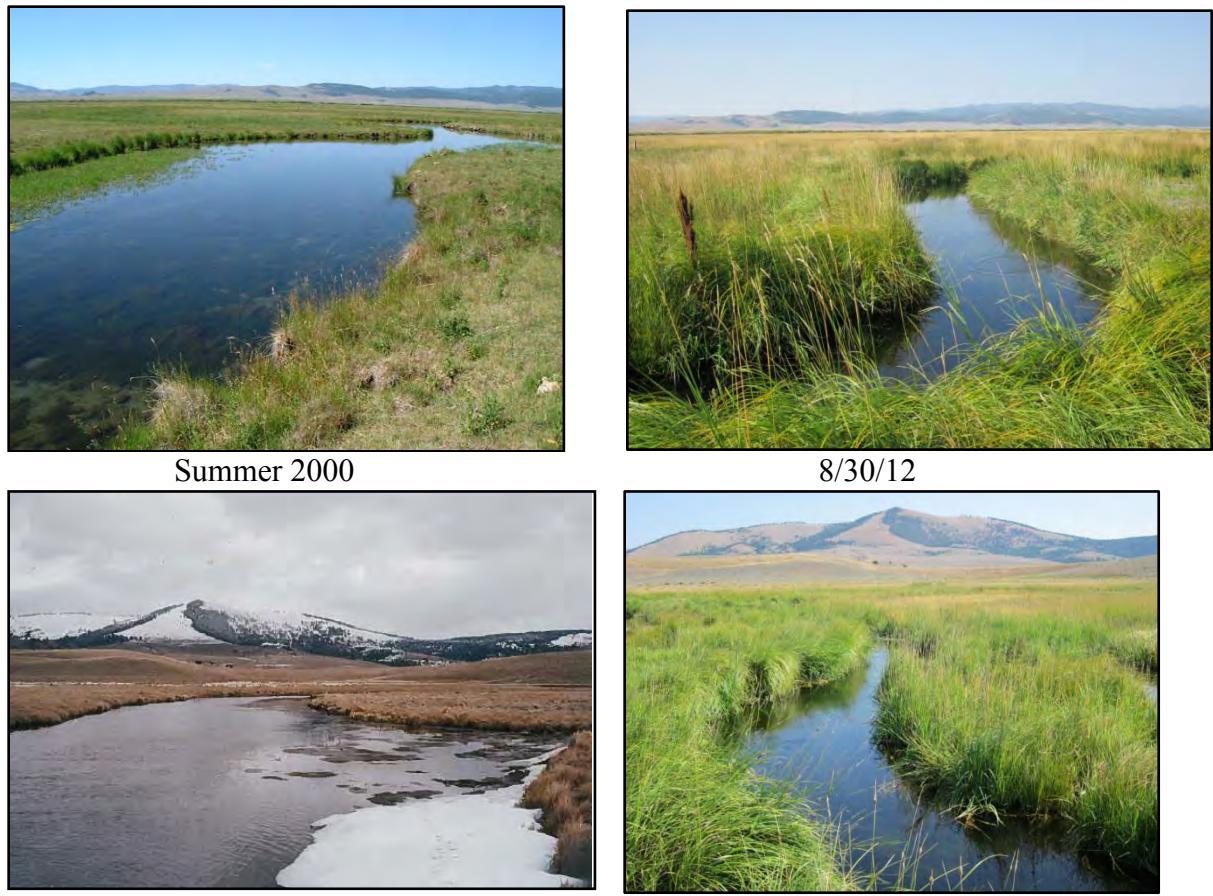
COMMENTS: This project restored approximately the upper one third of the stream. Due to the very flat gradient of the valley and to the presence of a substantial number of acres of wetland ponds created by the abandonment of the over-widened historic channel, the restored channel has had to be substantially modified at least twice following initial completion to prevent the new channel from capturing created ponds. The latest work was completed in the spring of 2012 when a low earthen berm was constructed along a portion of the north side of the new channel. Livestock have been fully excluded from the riparian corridor and weed infestations appear to be minimal. No woody shrub colonization was observed.

MONITORING CONCLUSIONS: The restored channel is relatively stable, with classic narrow and deep dimensions exhibited by "E" type channels. However, at least one meander bend was observed flowing into a wetland pond. Likely, there will need to be additional work done to prevent portions of the new channel from further capturing wetland ponds. Westslope cuthroat trout were observed in the stream, but no viable spawning habitat was observed. Channel substrate lacked gravel and was composed of silt/mud. Monitoring has documented westslope cuthroat trout migrating through Nevada Spring Creek (now nearly fully restored) to spawn in Wassan Creek, a headwater tributary. The restored spring creek is providing a migratory corridor and resident habitat for adult fish.
