FUTURE FISHERIES IMPROVEMENT PROGRAM

BIENNIAL REPORT

Summary of program activities for the period November 1, 2016 to October 31, 2018

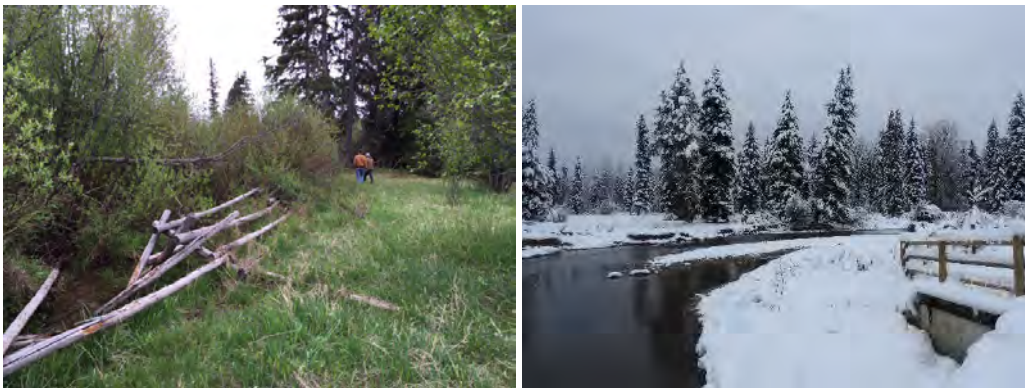
FIGURE 31. FAILING JACKLEG FENCE (L) AND NEW FENCE (R) ON MONTURE AND DUNHAM CREEKS.

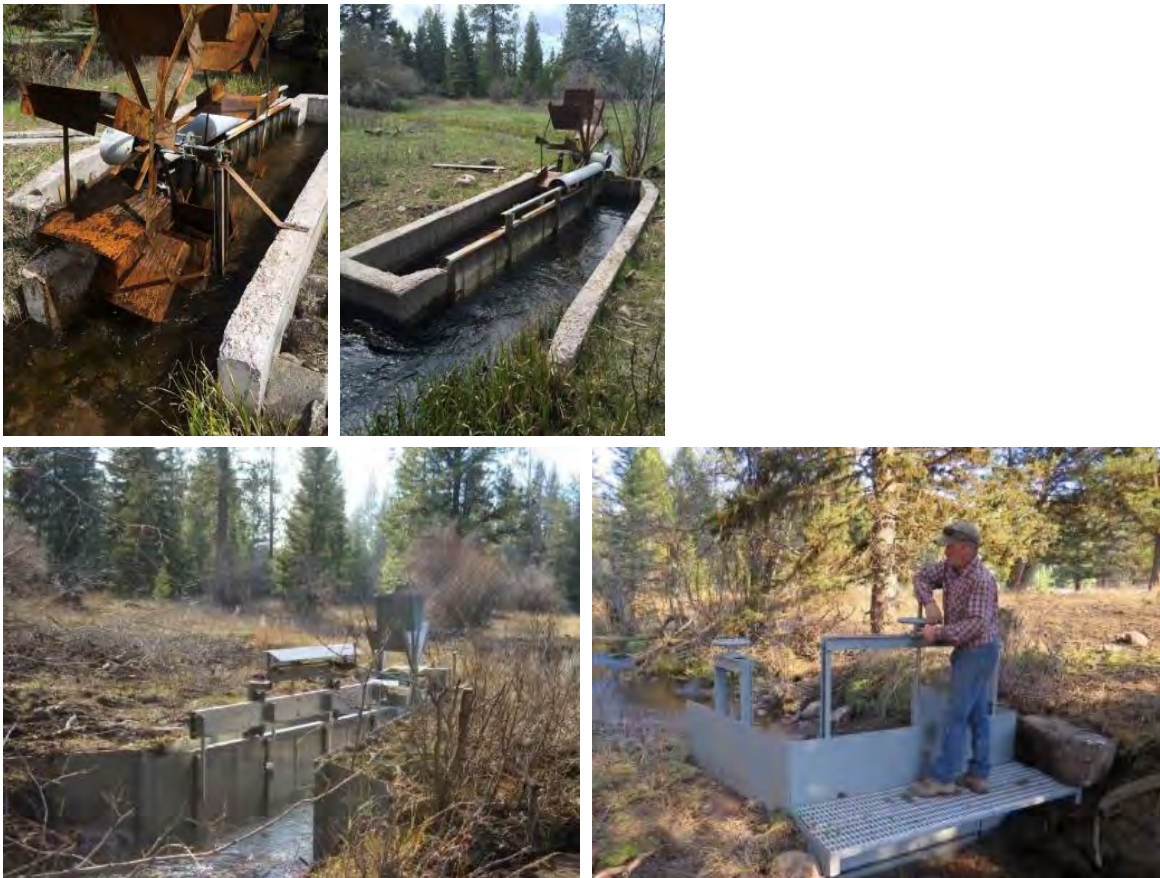
FIGURE 35. OLD, NON-FUNCTIONAL FISH SCREEN (TOP) AND NEWLY INSTALLED SCREEN AND HEADGATE (BOTTOM).

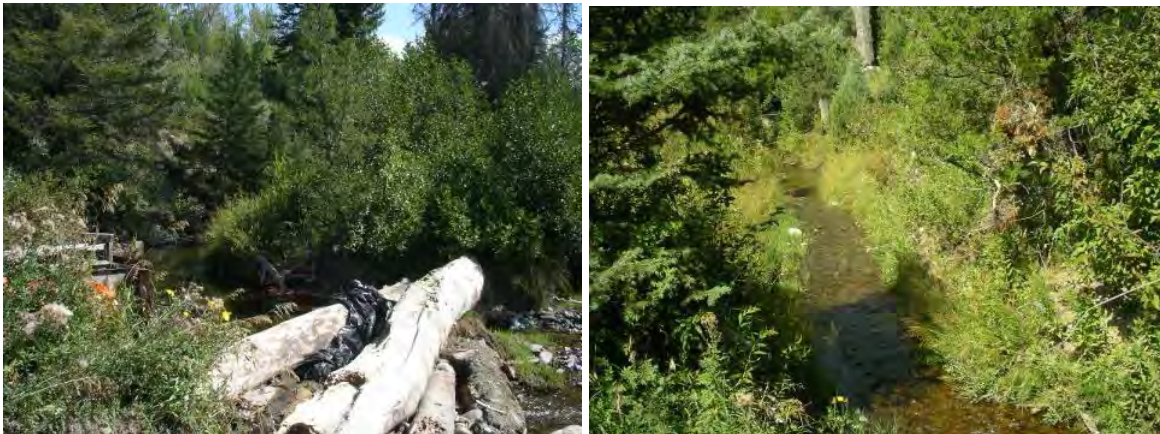
Pre-project photos document large logs with tarps backwatered the stream to deliver to the diversion (Figure 42). Considerable water leaked through the check boards at the head gate. The water savings with replacement of the leaking check boards with a Waterman gate would be beneficial and an appropriate use of FFIP funds.

FIGURE 42. LOGS CHECKING COTTONWOOD CREEK'S FLOWS TO DELIVER WATER TO THE PIN-AND-PLANK HEAD GATE (L). WATER LEAKING INTO DITCH WHEN CHECK BOARDS WERE BLOCKING FLOW (R).

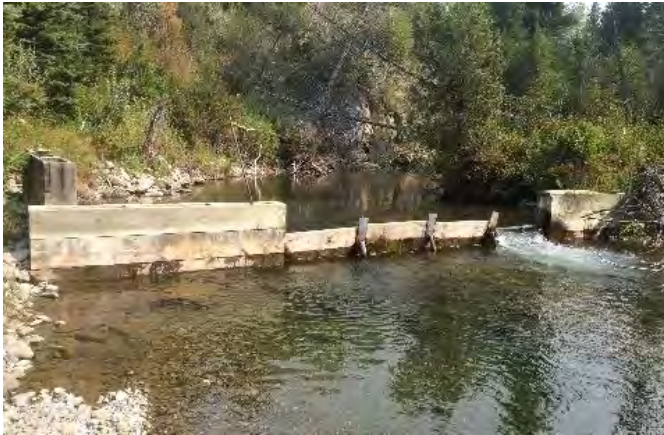
agreement. Neither feature was present (Figure 43). The diversion dam was a wooden pin and plank structure spanning the stream. A notch where a check board was not present could provide passage to some species and age classes of fish at certain flows but placing a board in this location would block upstream movement of fish. Water leaking through the check boards at the diversion resulted in considerable flow within the canal.

FIGURE 43. IRRIGATION DIVERSION ON COTTONWOOD CREEK.

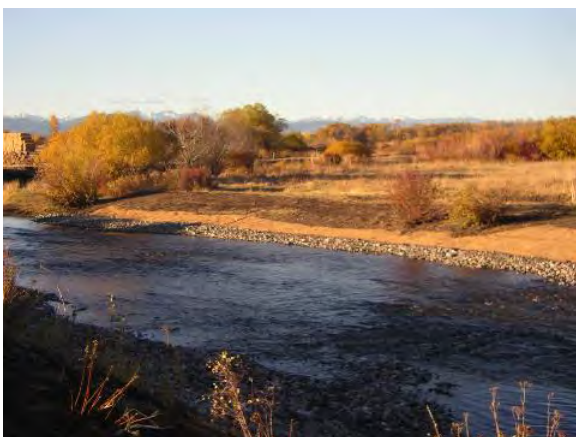
The first eroding bank had the potential to redirect flows against the footing of the bridge. The bank above the bank full margin was re-sloped to a 3:1 slope or less and covered with biodegradable erosion control blanket. Willows and dogwoods were planted at bank full edge, and the upper bank was planted with native grasses and sedges. The toe of the bank, below the bank full margin, was armored with natural cobble materials sized to resist the estimated 20-year flood modeled for that part of the river.

FIGURE 48. POST-CONSTRUCTION PHOTO OF BANK 1.

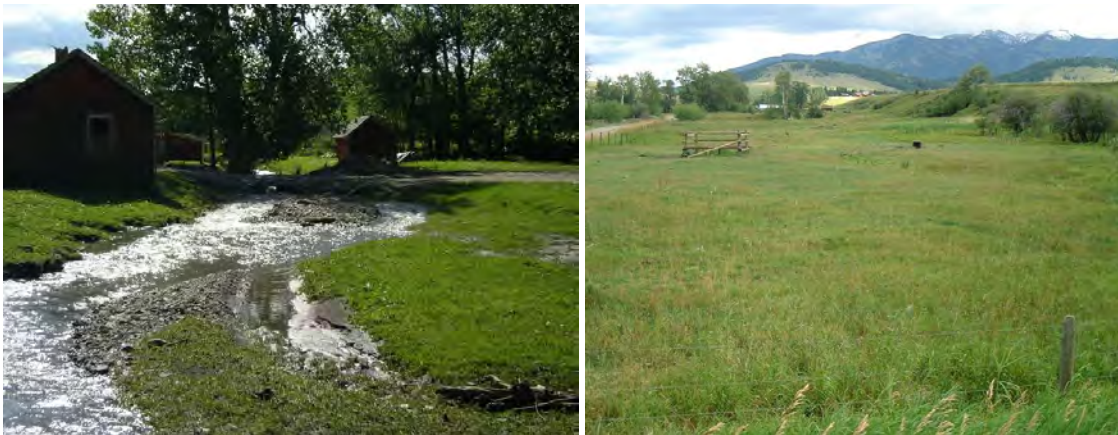
FIGURE 67. DEGRADED STREAM HABITAT (L) AND DOWNSTREAM END OF PROPERTY SLATED FOR RIPARIAN FENCING (R).

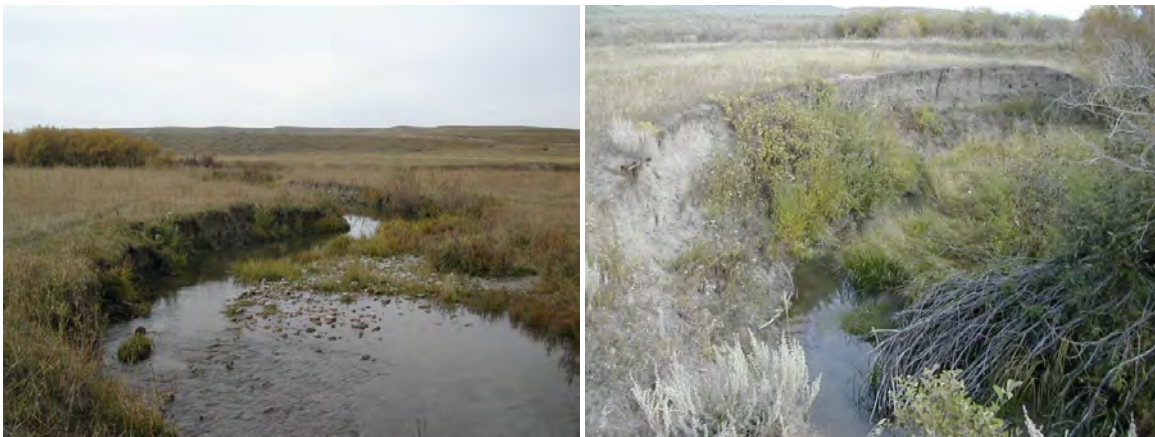
FIGURE 90. OVERLY WIDE CHANNEL, BANK EROSION, AND RIPARIAN DEGRADATION (L) AND CHANNEL DOWNCUTTING (R) ON ELK CREEK IN 2002.

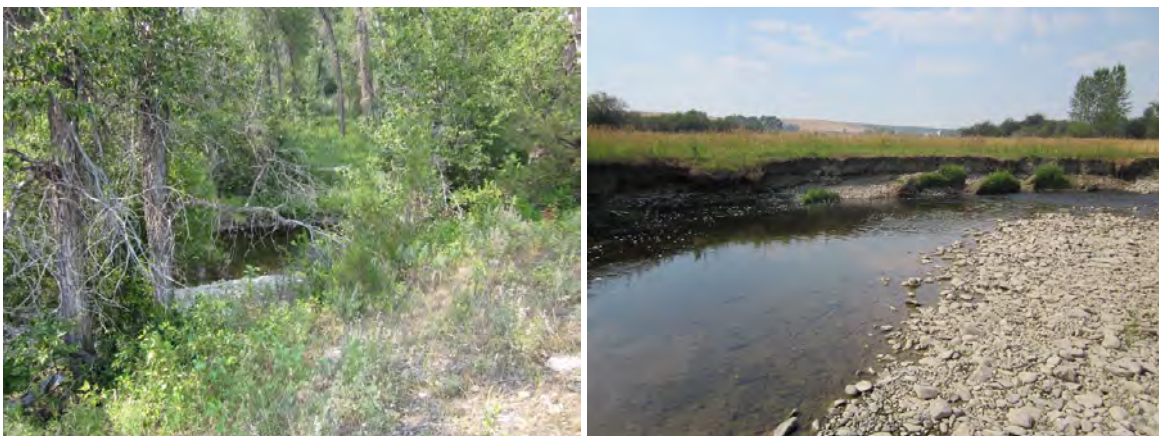
FIGURE 94. RIPARIAN AREA WITH DENSE UNDERSTORY (L) AND HAY PASTURE ON WEST BANK OF RIVER AND BANK EROSION (R).

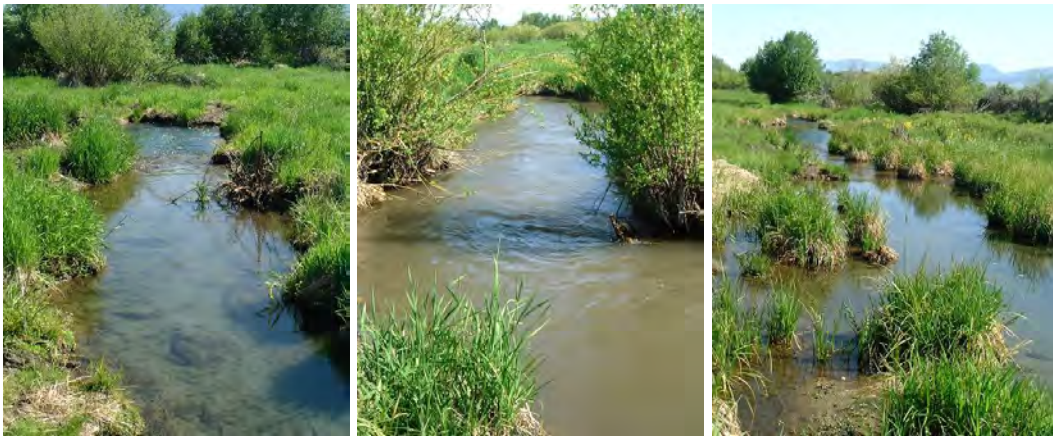
FIGURE 103. SOUTH FORK ROSS CREEK PRE-PROJECT VIEW (L), TURBIDITY (C), AND HUMMOCKY, POORLY DEFINED CHANNEL.

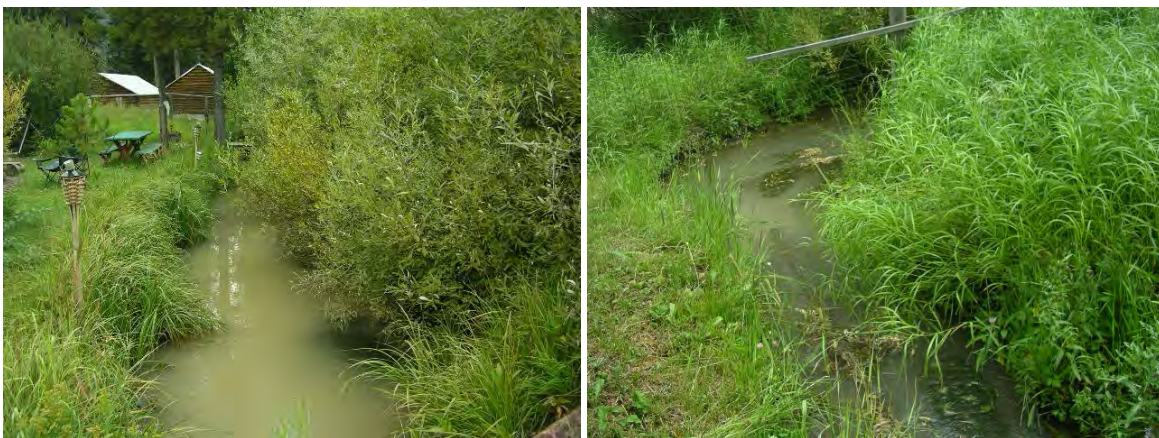
FIGURE 113. VIEW OF WILLOW CREEK SHOWING THE OVERLY WIDE CONFIGURATION TYPICAL OF MUCH OF THE CHANNEL (L) AND POOR SPAWNING HABITAT.
