PROJECT NAME: German Gulch channel restoration demonstration

PROJECT NAME: Upper Willow Creek channel restoration

BANK STABILIZATION PROJECTS:

FISH PASSAGE AT ROAD CROSSINGS PROJECTS

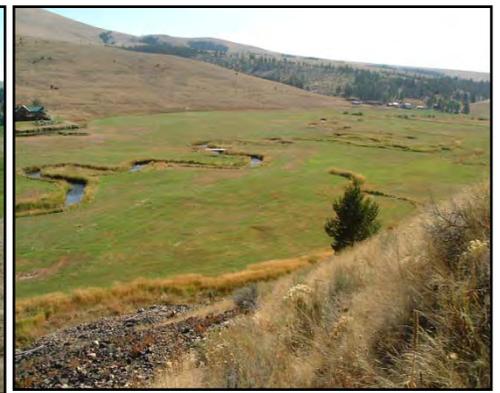
COMMENTS: 9/24/09 –The riparian corridor has been, and continues to be, dominated by Garrison foxtail. Nearly all of the willow clumps transplanted at the time of channel construction (August) display complete stem die-off but new willow stems continue to sprout from root crowns on almost all plants. The extensive willow sprigging efforts associated with the project are difficult to monitor because of the dominant grasses. Some willow sprigs have survived but percent survival is unknown. Haying operations by the lessee continue to encroach ever closer to the active stream channel. It’s likely this behavior is motivated by a combination of the lessee wanting to maximize hay production and the landowner wanting unfettered fishing access to the stream. No signs of livestock grazing were observed in the riparian corridor. Weeds do not appear to be a great concern, although there are small patches of thistle scattered along the entire reach. The reconstructed channel has remained relatively stable. The outsides of several meander bends have continued to expand and the inside bends are showing some increased deposition of cobble. An extensive photo point series revealed a stable plan and profile, with one exception, where a series of two adjacent meander bends located within the middle of the restored reach have shown fairly significant deposition of cobble on the point bars with lateral migration of the outside bends.

MONITORING CONCLUSIONS: This restoration project has remained relatively stable and the riparian vegetative community is showing recovery. Compliance with the grazing enclosure has been good, but farming practices (by the lessee) have encroached into the riparian corridor on portions of the stream. The resident fisheries have benefitted from the project, but the goal of improving recruitment to Rock Creek is unlikely. Public benefits appear to be marginal since the site is located on private land that is not readily accessible, although the landowner does allow some public fishing with prior permission.

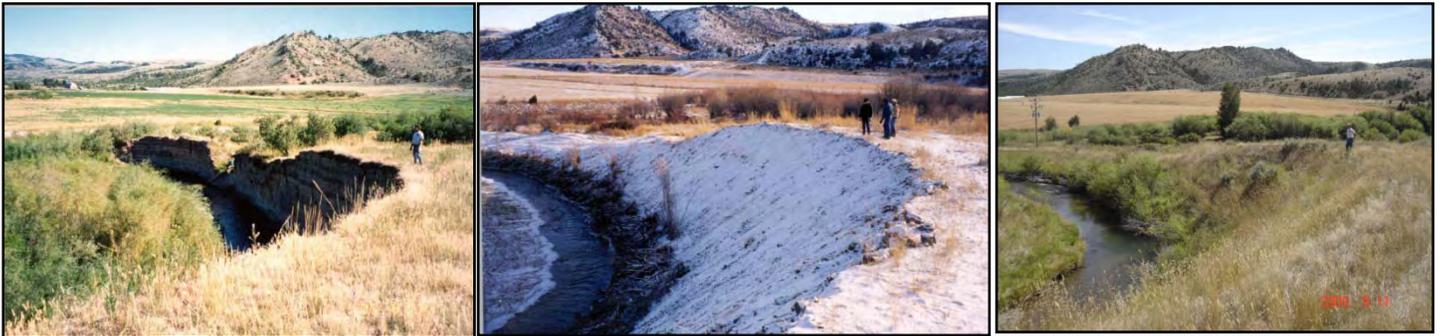
COMMENTS: 9/9/09 – The photos are just a representative of a much larger TMDL project completed on Deep Creek. Condition of the riparian corridor appears to be good, with no observed livestock use. Weeds also do not appear to be a problem. For the most part, stabilized banks appear to have remained so and willow recovery appears to be very good. Quite a few willow clump transplants appear to be thriving. One slump was observed on the steepest part of the highest stabilized terrace. This slump may allow the stream to start eroding around the cabled juniper and vegetated bank located just downstream. Several sites were treated with rock riprap. Landowners have tolerated beaver entering into the drainage and it appears this beaver activity (numerous dams) has acted to further stabilize the stream.

MONITORING CONCLUSIONS: This project has proven successful in stabilizing significant portions of Deep Creek. Compliance with livestock grazing in the riparian corridor has remained good and the riparian vegetative community is showing substantial recovery. The project likely benefitted the resident fishery, but the project goal of enhancing recruitment of fish to the Missouri River and Canyon Ferry Reservoir has not come to fruition.

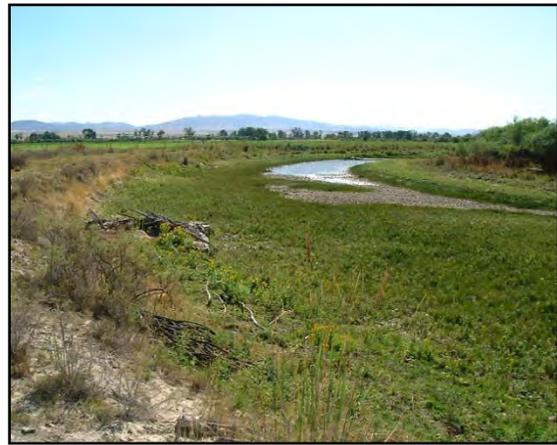
COMMENTS: 9/9/09 – The river has essentially abandoned this side channel, except during high water events. 2009 photos do not adequately show the severe grazing impacts on top of the existing bank and the cattle trampling down to water edge. Severe weed infestations (knapweed) were observed and there appears to be absolutely no survival of the large number

of willow cuttings placed on the stabilized bank in 1997. The rock vanes that were installed remain fully intact, but essentially abandoned. Although the value of future follow-up is questionable, the potential for the river returning to this side channel remains a real possibility. If and when this side channel becomes activated, it would be interesting to see how well the “restored” streambank would resist erosion in the face of little or no riparian vegetation.

MONITORING CONCLUSIONS: This project appears to have been undertaken more for the purposes of property protection than channel restoration. Grazing management within the riparian corridor appears to have remained poor. The bank stabilization work has remained stable, but the entire side channel has become inactive under most flow conditions. This project appears to provide no benefits to the fishery.

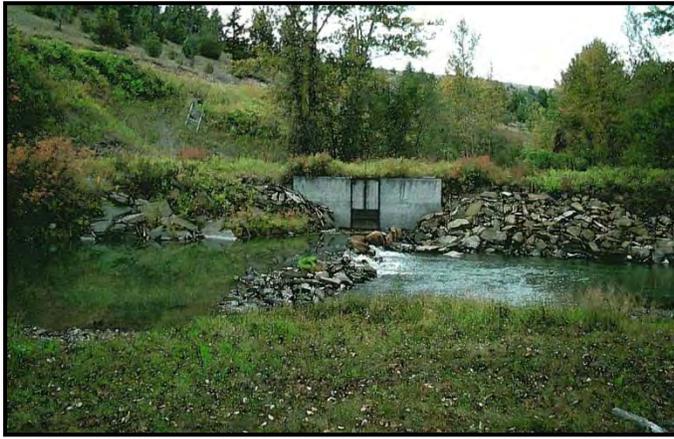
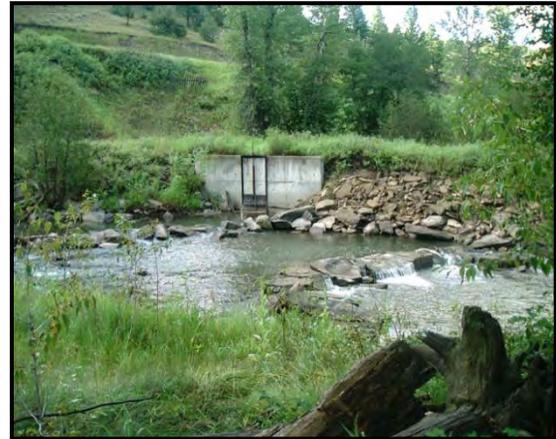
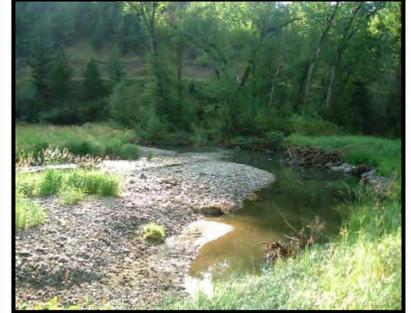
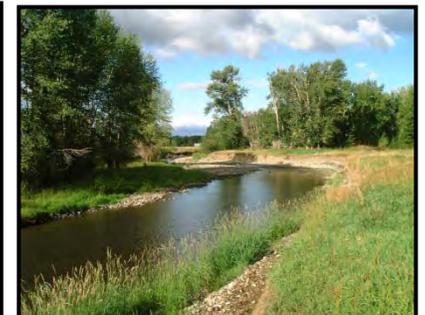
COMMENTS: This project involved the stabilization of several banks and an irrigation diversion. Grazing management appears to have been limited in the riparian corridor and riparian condition appears to be relatively good, although there didn't appear to be much recruitment of woody shrubs. Weed infestations do not appear to be a problem. According to the landowner, the irrigation weirs have self maintained since installation. The bank revetment (primarily rootwads) has not been effective for the most part and has been lost in a number of areas. Willow sprigging efforts, as were proposed in the application, did not appear successful; although it is unknown if sprigs were actually installed in the first place.

MONITORING CONCLUSIONS: The purpose of this project was three-fold. First, the project involved stabilizing a short reach of the river to prevent capture of the lower end of the Cole Creek channel; thereby potentially by-passing an irrigation diversion structure. Although not observed on the ground due to time constraints, the ranch manager indicated that the effort at avulsion protection has prevented the capture of the channel and maintained the irrigation diversion over the years. Second, the project stabilized an existing irrigation diversion structure. This diversion structure has self-maintained since completion in 2000. Third, the project stabilized a series of actively eroding stream banks using primarily rootwads in combination with some rock v-weirs and fabric wraps. For the most part, the

rootwads have proven ineffective, with many being lost over time. Overall, this project appeared to provide little to no benefits to the Shields River fishery.

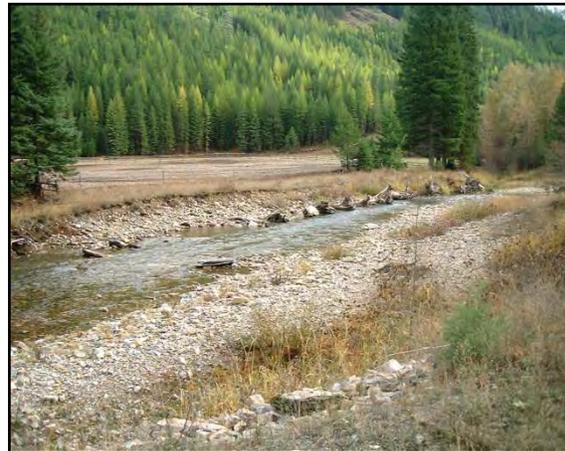
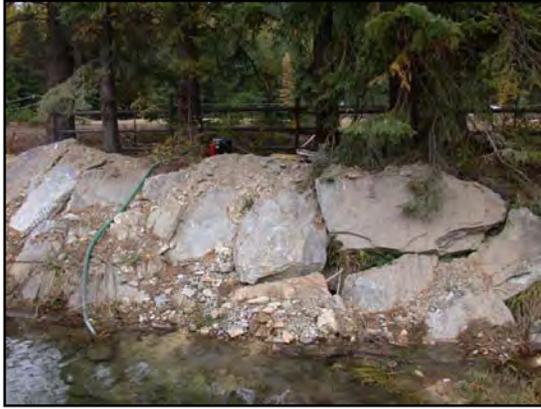
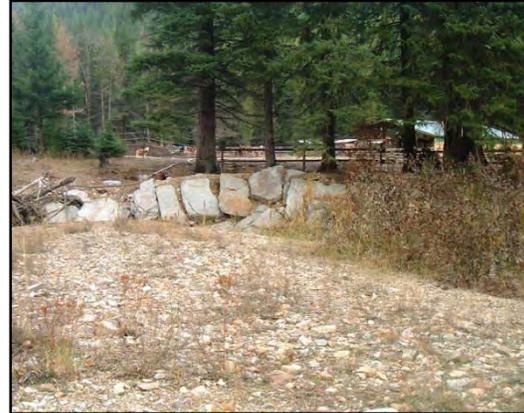
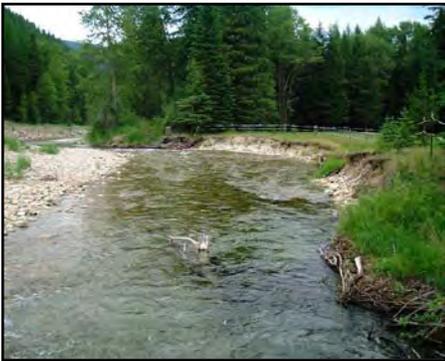
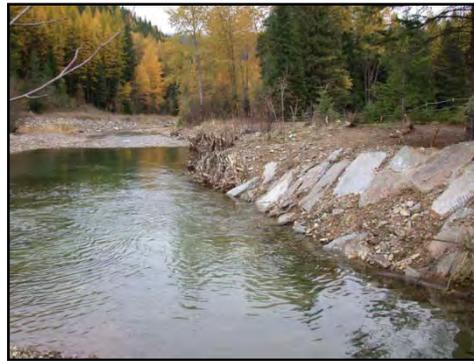
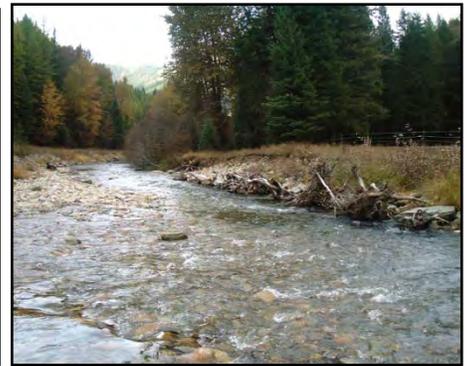
COMMENTS: 10/15/09 – This project, designed by NRCS, was originally touted as a demonstration project for alternative bank stabilization. The blanket rip-rap observed was not initially included in the project but was done by the landowner as part of the project. The stream has moved away from the head of the project but continues to flow along the lower 2/3's of the treated reach. The installed root-wads appear to have remained in place. Some of the large flat rock used for rip-rap located on the lower half of the project has floated downstream. All of the woody shrub transplants appear to have died. Woody riparian shrubs have not shown any natural recovery on the downstream 2/3's of the project, with some recovery visible on the upper 1/3. The landowner has a significantly over-grazed horse pasture adjacent to the project and the setback for the riparian fencing is very minimal. The riparian fencing has remained in place. This project appeared to be more for property protection than fisheries benefits. It is unlikely that this project is providing a benefit to the fishery, and it does not appear to be a viable demonstration project.

MONITORING CONCLUSIONS: The purpose of this project was to provide a demonstration of alternative bank stabilization. However, actions by the landowner and by the NRCS turned this into a poor demonstration project by armoring a portion of the bank with large rock and by creating a very minimal riparian setback. This project appeared to provide no benefits to the fishery.

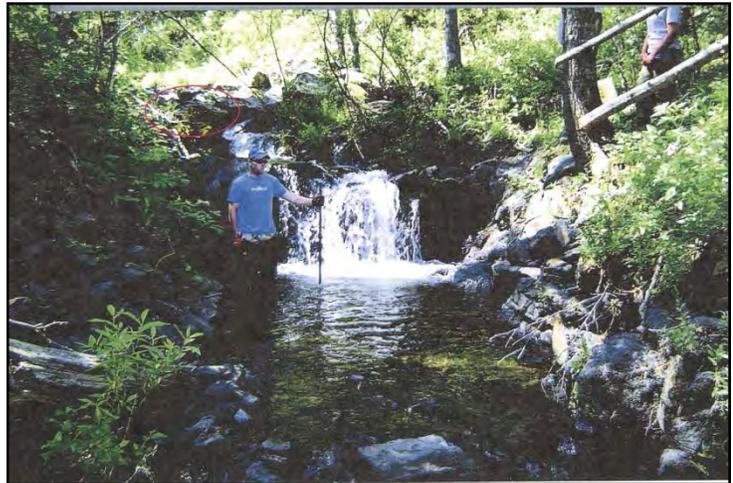
COMMENTS: 10-21-09 – The barrier has been modified by additional blasting at least once over the years. Currently, the barrier appears stable and continues to function. According to the USFS, westslope cutthroat trout are thriving upstream of the barrier. All photos are from the same vantage point.

MONITORING CONCLUSIONS: The barrier has remained functional and, as a result, has allowed USFS personnel to develop a thriving pure westslope cutthroat trout population in the stream. This project has been beneficial at securing and enhancing a remnant population of westslope cutthroat trout located in the Highwood Mountains.
