FUTURE FISHERIES IMPROVEMENT PROGRAM

REPORT PREPARED FOR THE 2017 MONTANA STATE
LEGISLATURE AND THE FISH & WILDLIFE COMMISSION

Summary of program years 2015–2016 and anticipated future expenses

Montana Fish, Wildlife & Parks, Fisheries Division, Habitat Bureau
<http://fwp.mt.gov/fishAndWildlife/habitat/fish/futureFisheries/legislative/>

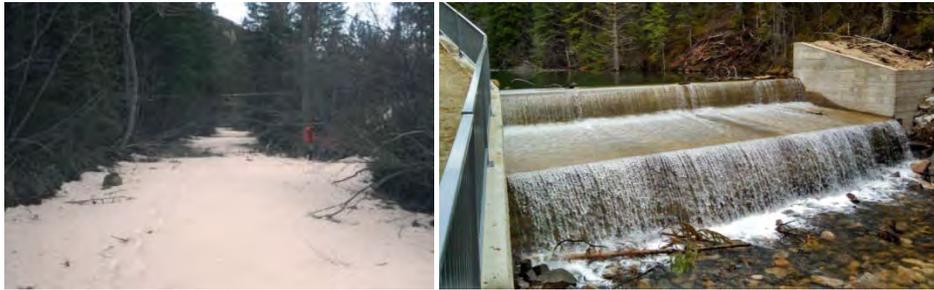
002-2013 & 001-2015 BARKER HUGHESVILLE / DRY FORK BELT CREEK BARRIER

This project greatly expanded habitat available for a very important population of cutthroat trout. FFIP granted \$40,000 to the project but only \$10,000 was used as the project was completed under budget. The total cost was approximately \$212,200.

Before

After

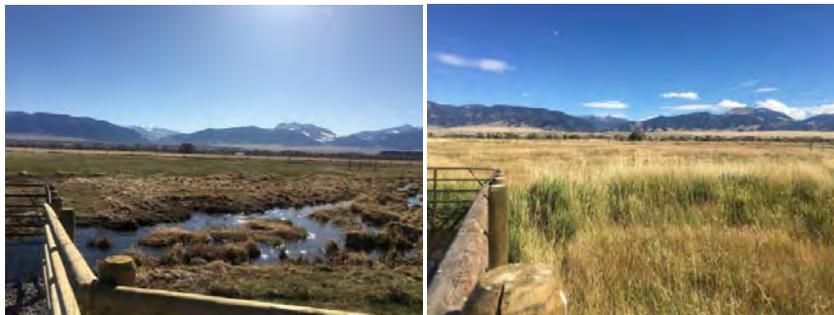
010-2015 MOORE'S CREEK GRAZING AND WATER QUALITY ENHANCEMENT

The project applicant has photo monitoring stations in place. FFIP contributed \$10,478 and the total cost was \$51,237.36. *Photos by the Madison Conservation District.*

Before

After

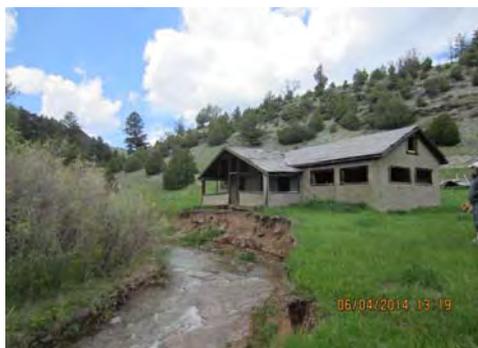
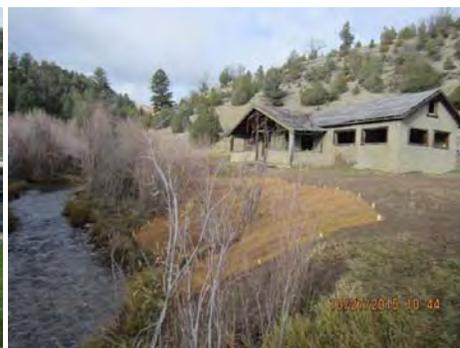
013-2015 RUBY CREEK CHANNEL RELOCATION

FFIP contributed \$2,475 to this project, and the total cost was \$15,075. *Photos by FWP.*

Before

After

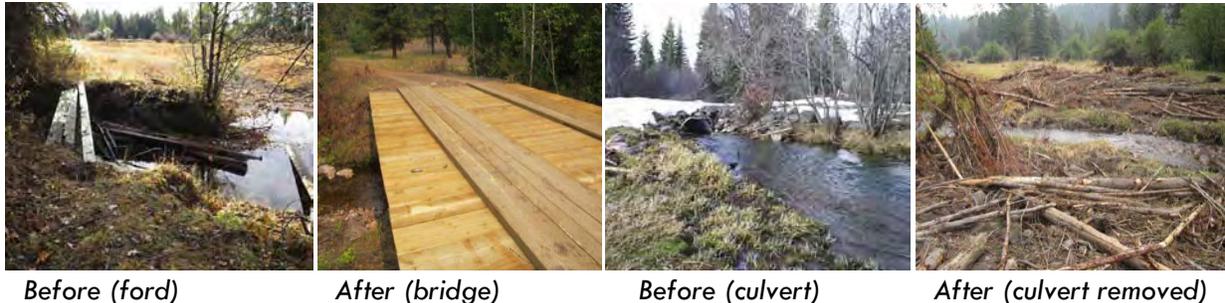
014-2015 SHANLEY CREEK RESTORATION

- **SHANLEY CREEK RESTORATION (014-2015).** Shanley Creek (Powell County) is a second-order tributary to Cottonwood Creek, is a bull trout core area stream, and supports pure populations of westslope cutthroat trout. Poor road locations and undersized stream crossings negatively affected the stream. This project involved relocating nearly one mile of road out of the Shanley Creek floodplain and

replaced two undersized culverts with a single crossing capable of passing a 100-year flood event. The bed and banks of the stream at each crossing were restored. An unimproved ford was upgraded with a short-span bridge to accommodate the new road system location. The goal of this project was to correct the road damage problems, eliminate sources of excessive sediment, provide for fish passage, and restore natural channel morphology at the impaired crossings. **COMPLETED, SEE PHOTOS BELOW.**

FFIP contributed \$13,300 to the project (10% overrun), which had a total cost of \$52,072.81 (adjusted balance). *Photos by Big Blackfoot Chapter of Trout Unlimited and FWP.*

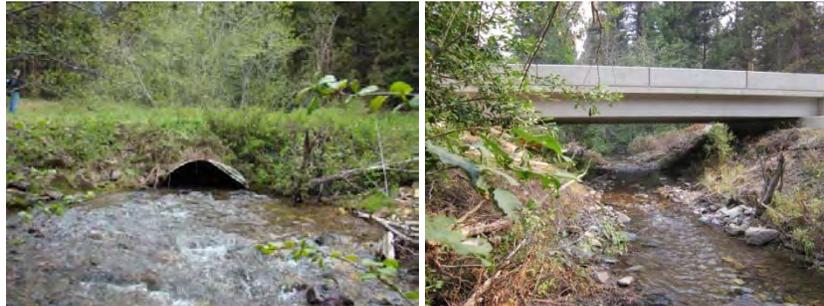
018-2015 THEODORE CREEK FISH PASSAGE IMPROVEMENT

- **THEODORE CREEK FISH PASSAGE IMPROVEMENT (018-2015).** Theodore Creek (Lewis and Clark County) is a tributary to Beaver Creek and supports fluvial, genetically pure westslope cutthroat trout. Bull trout were also historically found in the system. This project replaced an undersized culvert that impeded fish passage during high flows with a pre-stressed concrete bridge structure that creates year-round connectivity and natural stream conditions. **COMPLETED, SEE PHOTOS BELOW.**

FFIP contributed \$20,000 to the project, which had a total cost of \$160,738.19. Photos by Big Blackfoot Chapter of Trout Unlimited and FWP.

Before

After

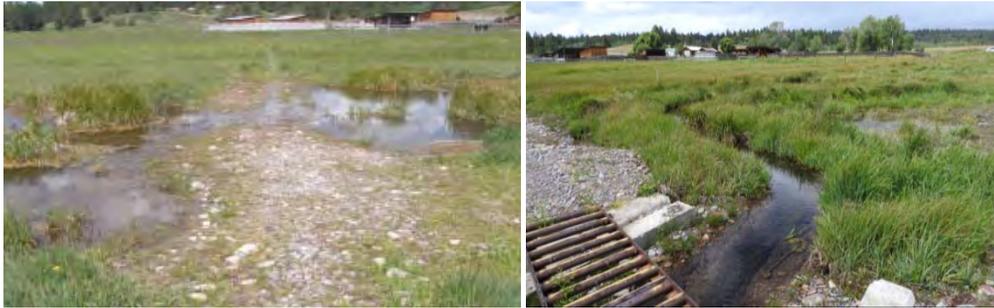
021-2015 WEST FORK JACOBSEN SPRING CREEK RESTORATION

- **WEST FORK JACOBSEN SPRING CREEK RESTORATION (021-2015).** West Fork Jacobsen Spring Creek (Powell County) is a tributary to Jacobsen Spring Creek, which contains bull trout and westslope cutthroat trout, and feeds the North Fork of the Blackfoot River. West Fork Jacobsen Spring Creek was over-wide and shallow, impacted by livestock hoof shear. Three undersized culverts caused backwater ponding issues, further affecting water temperature and stream flow. This project restored the stream channel to a more natural channel width, depth, and dimension, and riparian vegetation was installed to stabilize the streambanks. The three undersized stream crossings were be upgraded, and a grazing management plan was incorporated. **COMPLETED, SEE PHOTOS BELOW.**

FFIP contributed \$7,500 to this project, and the total project cost was \$38,200. Photos by Big Blackfoot Chapter of Trout Unlimited and FWP.

Before

After

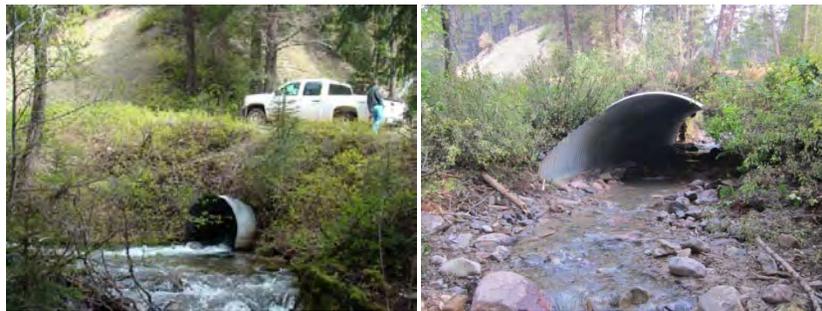
022-2015 YUKON CREEK FISH PASSAGE IMPROVEMENT

- **YUKON CREEK FISH PASSAGE IMPROVEMENT (022-2015).** Yukon Creek (Lewis and Clark County) is a tributary to Beaver Creek and supports fluvial, genetically pure westslope cutthroat trout. This project addressed an existing stream crossing that was undersized, impeded fish passage during high flows, and impaired the channel. The 60-inch culvert was replaced with a bottomless arch structure large enough to pass 100-year flood events. The goals of this project were to develop a stable stream crossing that would correct road drainage problems, eliminate delivery of excessive sediment, provide fish passage, and restore natural channel morphology to the site. **COMPLETED, SEE PHOTOS BELOW.**

FFIP contributed \$23,400 to the project, which had a total cost of \$169,004.69. Photos by Big Blackfoot Chapter of Trout Unlimited and FWP.

Before

After

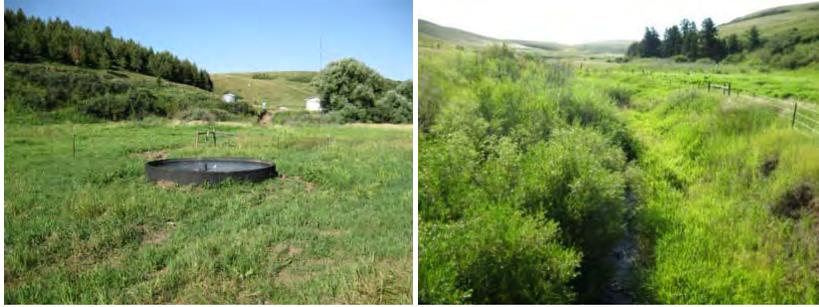
023-2015 BIG OTTER CREEK FENCING AND STOCK TANK

- **BIG OTTER CREEK FENCING AND STOCK TANK (023-2015).** Big Otter Creek (Judith Basin County) is a tributary to Belt Creek that supports populations of brook trout, brown trout, and rainbow trout. The project involved the rehabilitation of a highway underpass for livestock use, the building of a bridge, installation of fencing, and addition of a stock tank. The landowner can now use a new route to move cattle and protect the stream from livestock impacts. The goal of this project was to prevent stream degradation and represents a proactive approach to protect the stream from imminent negative impacts. **COMPLETED, SEE PHOTOS BELOW.**

FFIP contributed \$7,028.55 and the total project cost was \$11,378.55. Photos by landowner.

After (both photos)

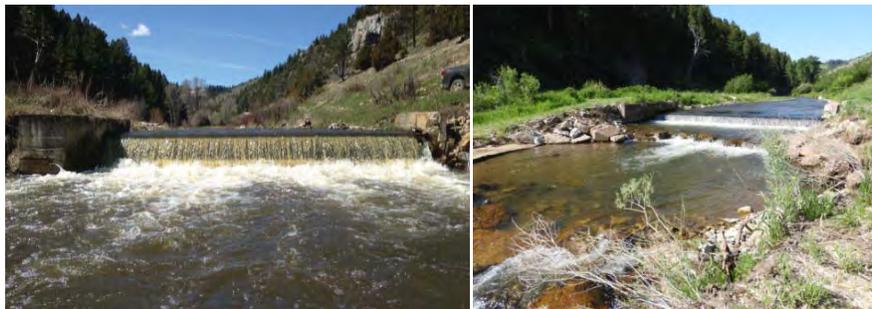
025-2015 CHERRY CREEK FISH PASSAGE

FFIP contributed \$7,080 to the project; total cost was \$15,884. Photos by Turner Enterprises Inc. and FWP.

Before

After

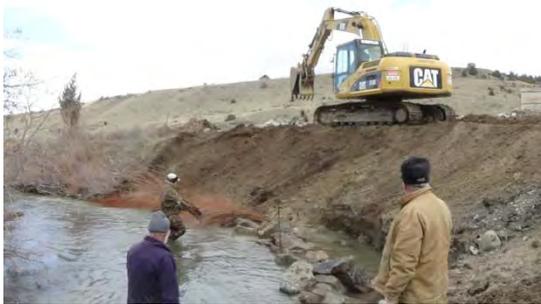
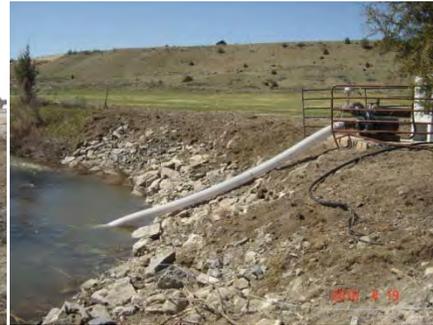
026-2015 DEEP CREEK STREAMFLOW IMPROVEMENT

FFIP contributed \$8,950 to this project, and the total project cost was \$137,950. *Photos by NRCS and FWP.*

During construction

After

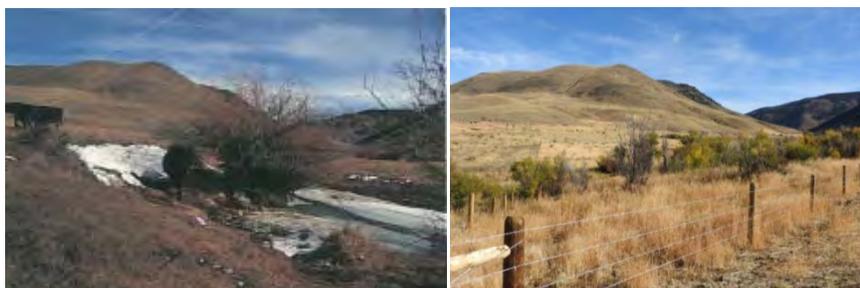
031-2015 MOOSE CREEK RIPARIAN FENCING

FFIP contributed \$3,000; the total project cost was \$16,500. *Photos by Big Hole River Foundation and FWP.*

Before

After

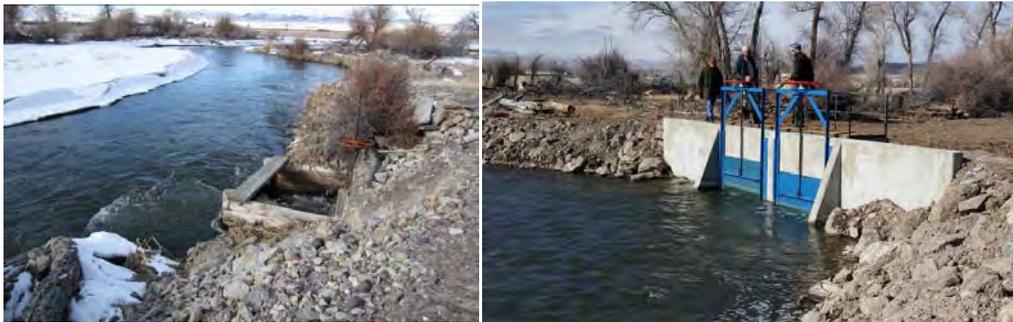
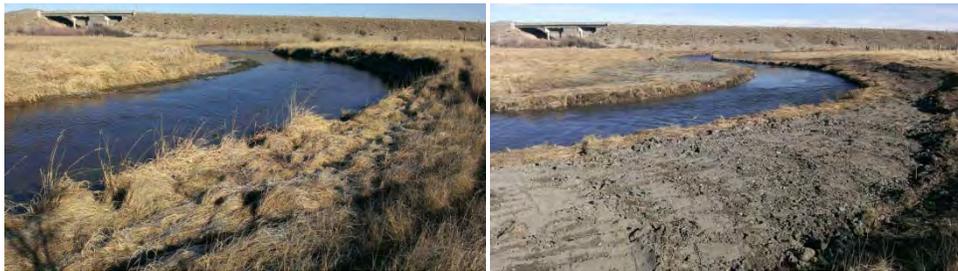
- **POINDEXTER SLOUGH CHANNEL RESTORATION (033-2015).** Poindexter Slough (Beaverhead County) is 4.7-mile-long channel of the Beaverhead River, located near Dillon, fed by a combination of groundwater and water diverted from the river. The project area supports a very popular fishery for rainbow trout and brown trout. FWP surveys on this slough have documented a steady decline in trout numbers over the last 12 years. This decline was attributed to impaired riparian conditions and the loss of instream habitat, primarily as a result of stream flow management that has restricted high spring flushing flows. The slough was traditionally fed by groundwater returning from flood irrigation. As landowners converted from flood to sprinkler irrigation, groundwater inputs decreased and the slough was supplemented with more water from the Beaverhead River to meet water rights. The diverted water deposited sediment into the slough, which filled pools and inundated riffle habitat. To effectively mobilize and transport these fine sediment deposits, a larger head gate at the top of the slough was installed. Appropriately sized channel dimensions were achieved and backwatered reaches were eliminated in most of the project area. The lower 2.1 miles of the slough were narrowed, allowing maintenance of riffle and

This project was three-phase project. Future Fisheries provided \$163,626 to this project (total cost \$1,059,362). Fishing opportunities on this public reach of stream are expected to increase.

Before

After

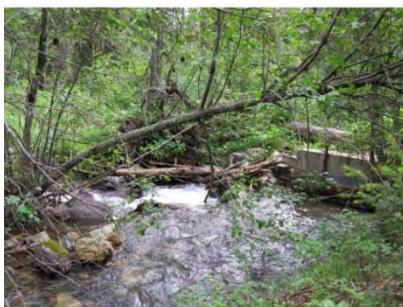
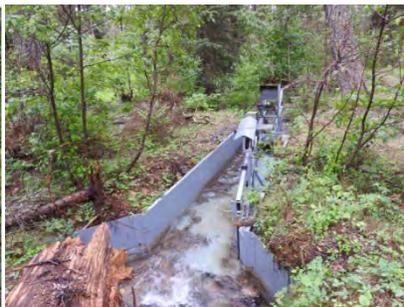
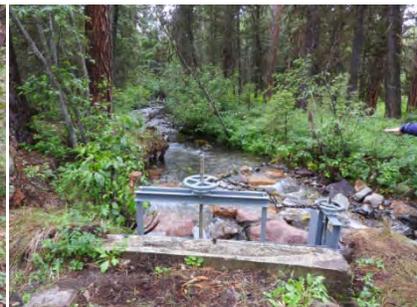
038-2015 STONEWALL CREEK FISH SCREEN

- **STONEWALL CREEK FISH SCREEN (038-2015).** Stonewall Creek (Lewis and Clark County) is a tributary to Keep Cool Creek located near Lincoln and contains westslope cutthroat trout. Near stream mile five, an unscreened irrigation diversion caused channel impairments and entrainment of cutthroat trout. This project upgraded the existing diversion with a fish screen and instream cross vane. These upgrades are expected to permit fish passage, bedload movement, and keep fish from entering the ditch. A flat-plate fish screen with a paddlewheel was installed. **COMPLETED, SEE PHOTOS BELOW.**

FFIP contributed \$13,300 to this project and the total cost was \$41,000. *Photos by Big Blackfoot Chapter of Trout Unlimited and FWP.*

Before

After (screen)

After (headgate)

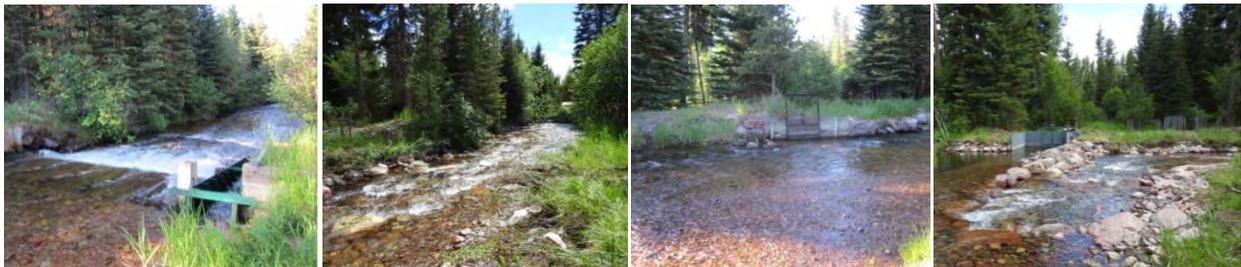
039-2015 TRAIL CREEK FISH SCREEN

- TRAIL CREEK FISH SCREENING AND PASSAGE (039-2015).** Trail Creek (Missoula County) is a tributary to Morell Creek near Seeley Lake. Trail Creek supports westslope cutthroat trout, bull trout, and brook trout populations. This project screened the last of three unscreened diversions within the Trail/Morrell Creek watershed. This diversion entrained trout and acted as an obstruction to upstream fish passage. The pin-and-plank check dam and a denil ladder were removed and replaced with a rock cross vane and armored riffle that will allow fish passage, stream channel function, and bedload movement. A McKay-style, flat-plate fish screen with a paddlewheel was installed with flow measuring devices in each ditch and downstream of the diversion. **COMPLETED, SEE PHOTOS BELOW.**

FFIP contributed \$21,175, and the total project cost was \$75,000. Photos by FWP.

Before (fish ladder)

After (fish ladder)

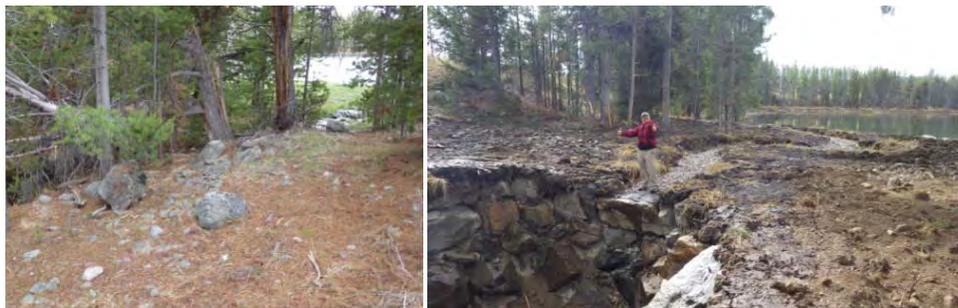
041-2015 VAN HOUTEN LAKE

FFIP contributed \$10,000, and the total project cost was \$30,000. *Photos by FWP.*

Before (barrier location)

After (barrier)

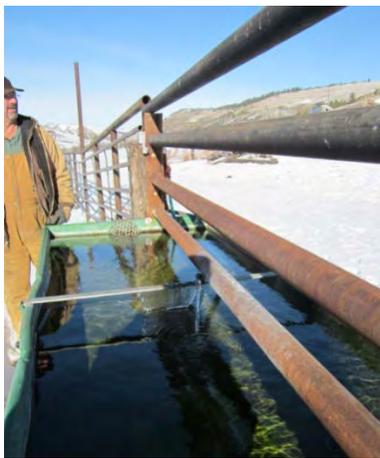
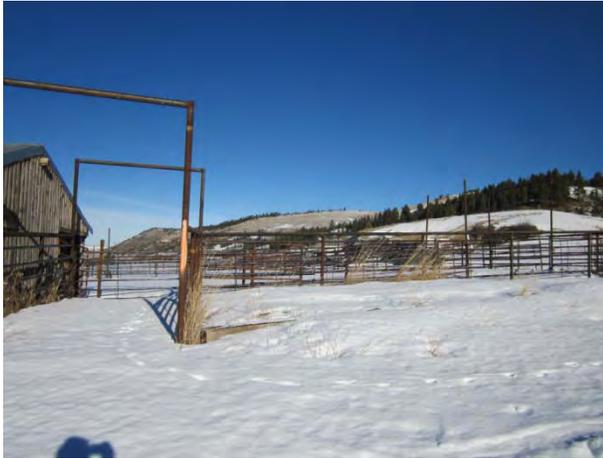
LITTLE OTTER CREEK CORRAL RELOCATION (006-2012)

After (water tank)

(corral)

This project moved a corral system from the stream corridor to an upland area and revegetated and fenced the disturbed area. The intent was to reduce sedimentation and improve water quality. The project area included 100 to 300 yards of riparian corridor. Future Fisheries contributed \$6,622, including a 10% overrun (total cost \$37,236). *Photos by FWP.*

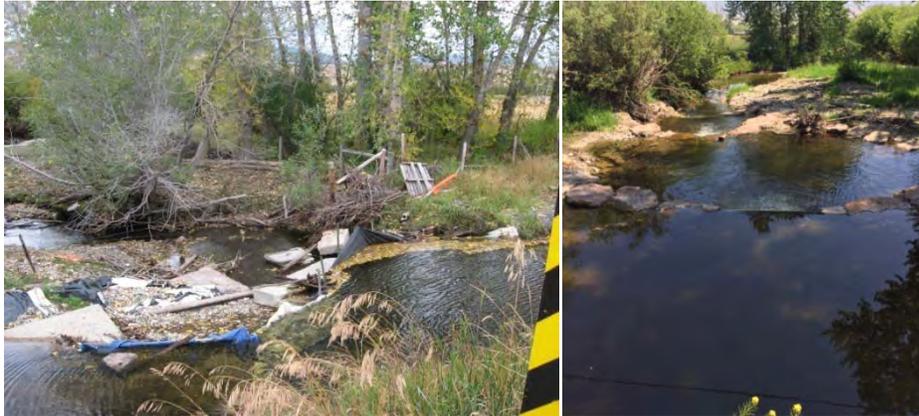
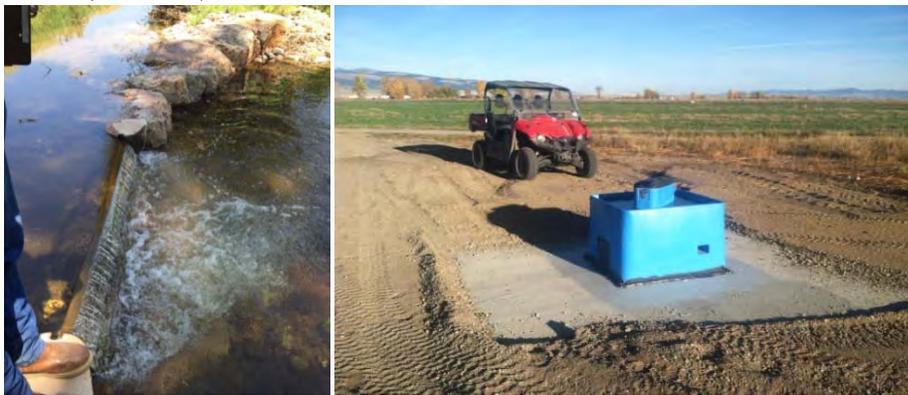
RACETRACK CREEK RIPARIAN FENCING AND FISH PASSAGE (007-2012)

Before (diversion)

After

After (diversion)

After (stock tank)

This project replaced and relocated a riparian fence that had been damaged by past flooding. Additional riparian fence was installed, an offsite well and two winterized stock tanks were built, and an irrigation diversion was upgraded to provide fish passage. The intent was to create fish passage and to keep livestock off the stream and riparian corridor. Future Fisheries contributed \$14,735.73 to the project, which came in under budget due to a change in the fish passage structure and a reduction in the scope of the riparian fencing (the furthest downstream landowner dropped out). The total cost was \$25,320. Photos by the Clark Fork Coalition and FWP.

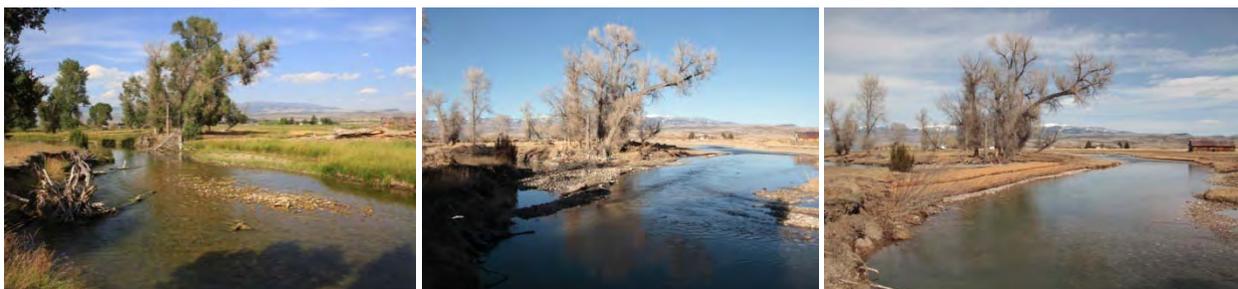
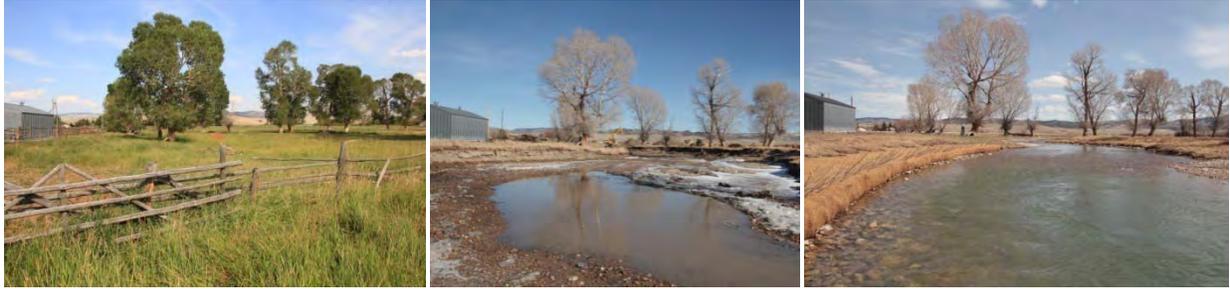
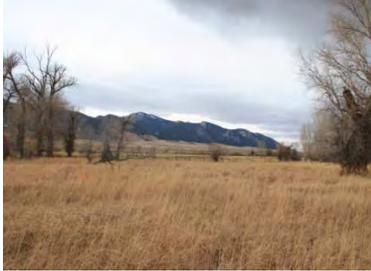
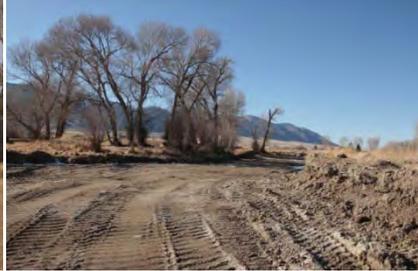
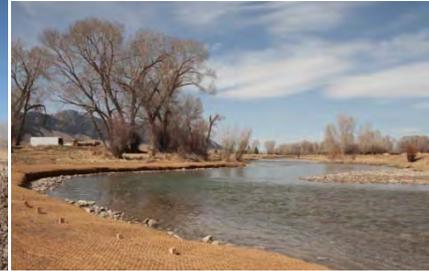
RUBY RIVER CHANNEL STABILIZATION (008-2012)

This project took a straightened channel and reconstructed it; sinuosity and stream length were increased, returning this portion of the Ruby River to its natural state. A feedlot was also moved away from the channel, 7,000 feet of riparian fencing were installed, and a bridge was constructed. FFIP contributed \$40,661 to the project, which had a total cost of \$698,411. Photos by the Ruby Valley Conservation District.

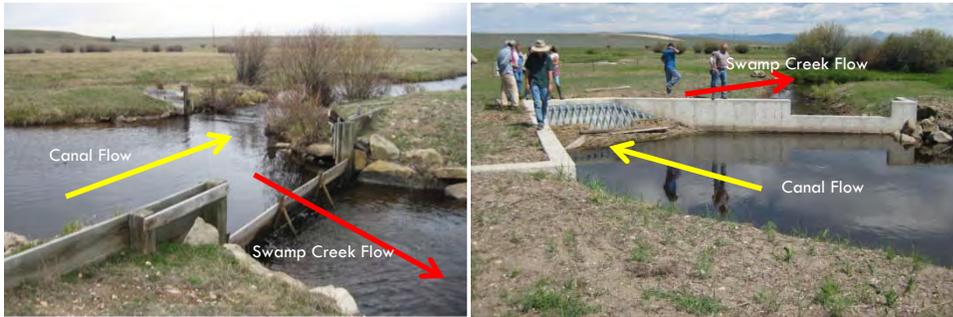
SWAMP CREEK SIPHON (021-2012)

Before

After

This project installed a siphon at the crossing of an irrigation canal and Swamp Creek. The intent was to separate canal water from Swamp Creek, increasing stream flow and creating fish passage for an additional 12 miles of stream. A new diversion, watering device, and fish ladder were installed into Swamp Creek at another location. FFIP contributed \$30,000 to the project and the total cost was \$385,556. Photos by the U.S. Fish and Wildlife Service and FWP.

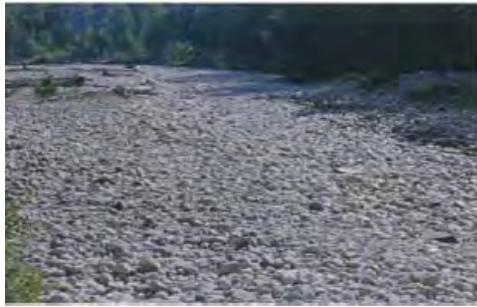
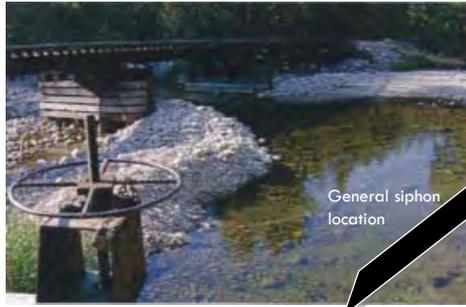
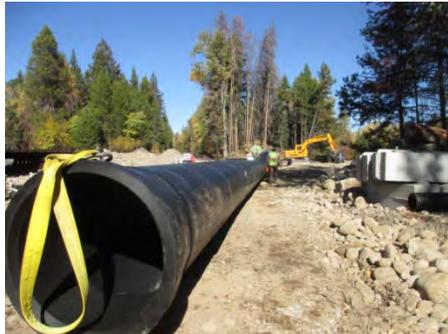
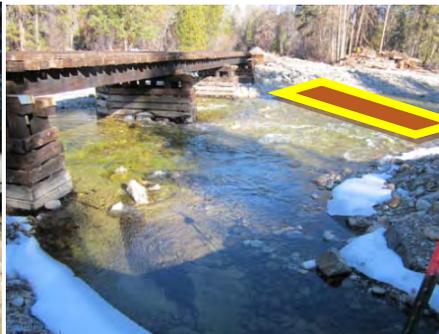
LOST HORSE CREEK SIPHON (007-2013)

Before (looking downstream)

Before (looking across stream)

During (siphon pipe)

After (looking across stream)

This project installed a siphon underneath Lost Horse Creek, to convey water diverted from the Bitterroot River down the Ward Canal. The siphon eliminates the need for constructing a seasonal in-channel dam on Lost Horse Creek, which removes a seasonal migration barrier, and reduces a source of fish entrainment. A minimum flow agreement was also made with the irrigation district. FFIP contributed \$98,350 (including 10% overrun) and the total cost was \$487,006, due to an increase in costs. Photos by the Clark Fork Coalition and FWP.

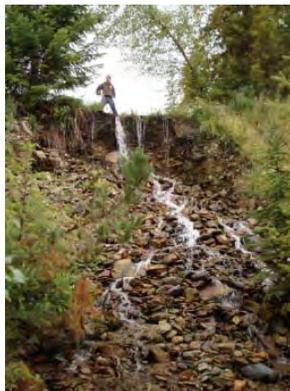
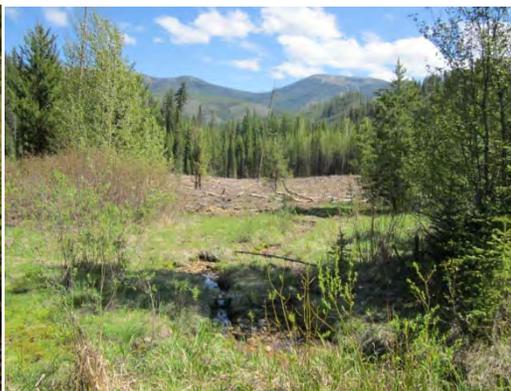
SAWPIT CREEK MINE RECLAMATION (012-2013)

Before

After

In the Sawpit Creek vicinity, past mining activity led mining deposits in the riparian area (with no vegetation), a dredge pond, and a gully. The project involved excavation of approximately 10,000 cubic yards of mine tailings, re-grading, and creation of a functional floodplain. Approximately 1,000 feet of disturbed channel was reconstructed with rock and log step-pool structures for habitat

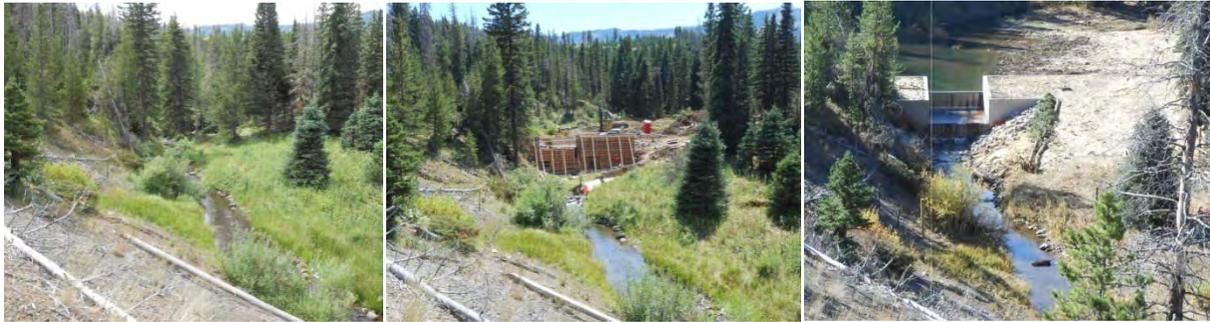
SOUTH FORK SIXTEENMILE CREEK FISH BARRIER (016-2013)

This project installed a fish migration barrier, intending to protect a native westslope cutthroat trout habitat. A second phase of the project involves removing non-native fishes using a piscicides, and a third phase will restock the stream with genetically pure westslope cutthroat trout. FFIP contributed \$61,681.36 to the project, coming in \$18,070.64 under budget. The total cost was \$174,991.36. *Photos by the U.S. Forest Service.*

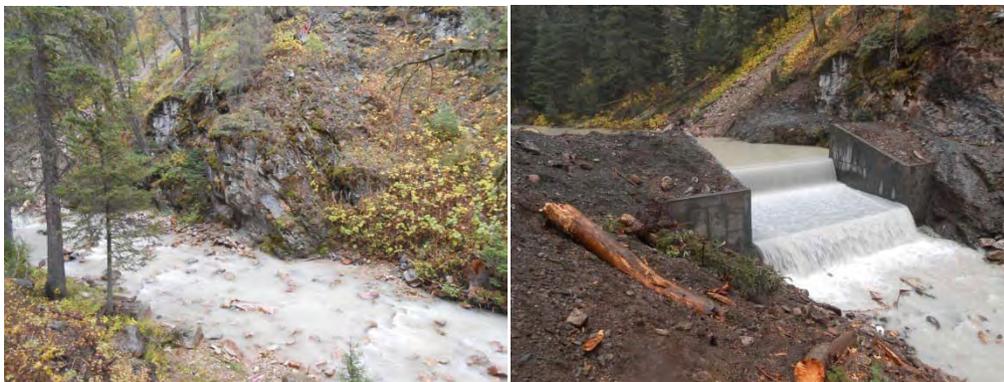
CABIN CREEK FISH BARRIER (002-2014)

This project installed a permanent fish migration barrier to preserve genetic purity in a relatively large population of westslope cutthroat trout. A scarp, created from the 1959 Quake Lake earthquake, has slowly eroded and allowed a few rainbow trout to enter the drainage. This barrier will keep rainbow trout separated from westslope cutthroat trout. FFIP contributed \$64,372.65, as the project was completed under budget. The total project cost was \$334,372.65, approximately \$100,000 less than estimated. *Photos by the U.S. Forest Service and FWP.*

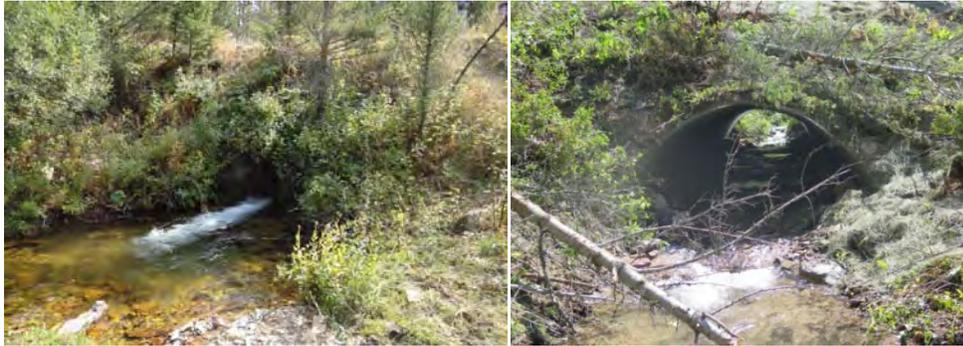
GLEASON CREEK CULVERT REPLACEMENT (004-2014)

This project replaced an undersized culvert, which acted as a partial fish barrier, with a larger steel pipe that accommodates larger flows and allows year-round fish passage. Rock weirs were added downstream for grade control. FFIP contributed \$10,000 to the project, which had a total cost of \$48,650. *Photos by Big Blackfoot Chapter of Trout Unlimited and FWP.*

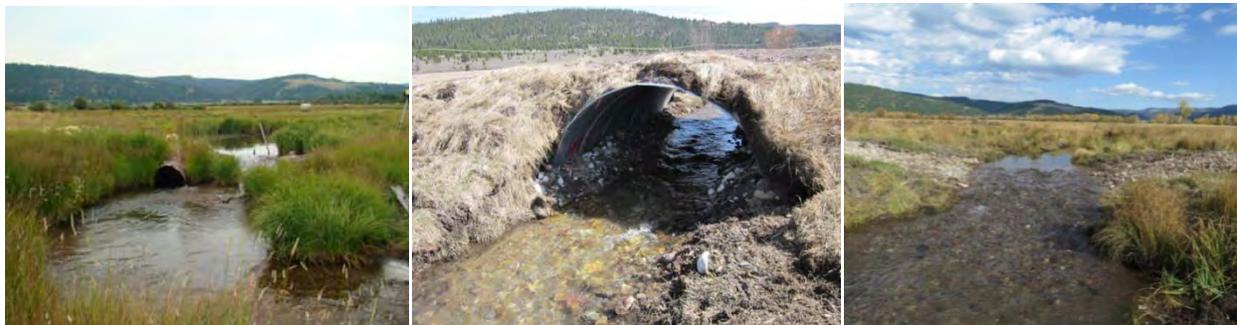
KEEP COOL CREEK CULVERT FISH PASSAGE (006-2014)

This project replaced two undersized culverts that acted as partial fish passage barriers, with a hardened ford and a steel arch pipe. The intent was to improve stream and floodplain function and to provide fish passage. FFIP contributed \$6,000 to this \$16,052 project. *Photos by Big Blackfoot Chapter of Trout Unlimited and FWP.*

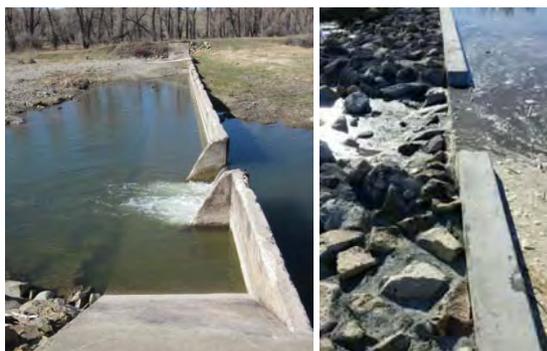
DEADMANS DIVERSION DAM FISHWAY (012-2014)

Deadmans diversion dam was deteriorating, and was not built to allow for fish passage. This project ensured fish passage was a component of the diversion repair. Rock was used to create step-pools and create fish passage, potentially connecting fish habitat 52 miles upstream and 39 miles downstream. FFIP contributed \$82,400 to this \$96,400 project. *Photos by FWP and Deadmans Basin Water Users Association.*

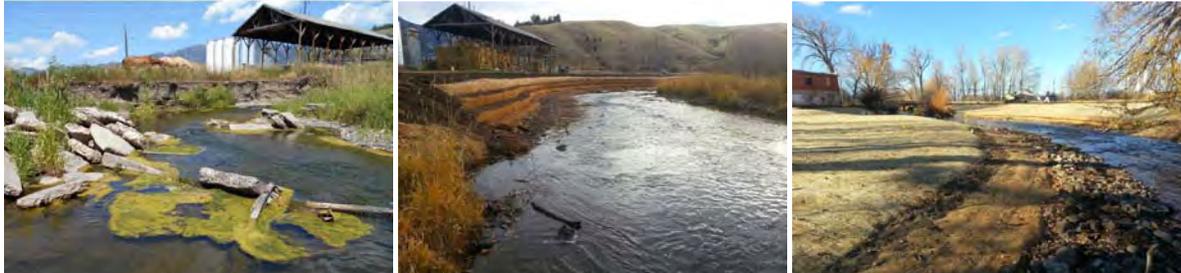
EAST GALLATIN RESTORATION AT STORY MILL (013-2014)

This project restored a riparian-wetland complex within Bozeman, intending to improve water quality and provide additional fishing opportunities to the East Gallatin River. Man-made materials were removed, streambanks were revegetated, backwater areas were restored, and floodplain connectivity was improved. This project encompassed 0.5 miles of river. FFIP contributed \$51,953 to the project, and the total cost was \$172,294. *Photos by Respec.*

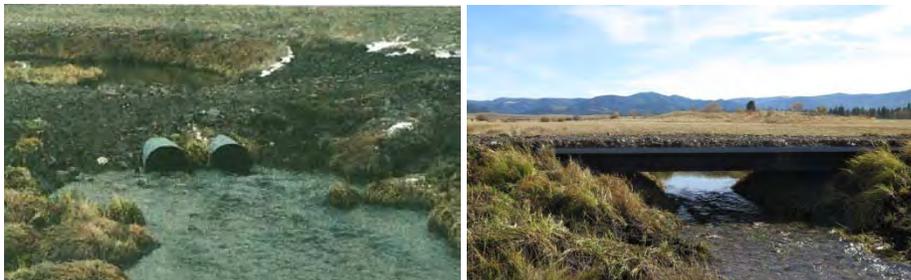
KEEP COOL CREEK FISH PASSAGE IMPROVEMENT (014-2014)

This project replaced an undersized stream crossing with a timber bridge. The intent was to improve natural channel condition, floodplain function, and fish passage. FFIP contributed \$8,500 to the project, which had a total cost of \$28,222. *Photos by Big Blackfoot Chapter of Trout Unlimited.*

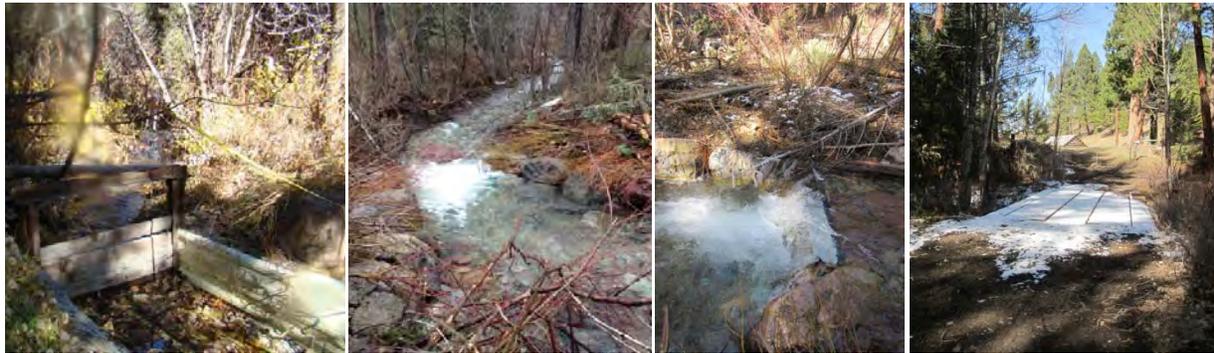
LIVERPOOL CREEK FISH PASSAGE/ENTRAINMENT/FLOW (016-2014)

This project replaced an undersized stream crossing with a bridge, eliminated an upper diversion, and replaced the lower diversion with a coanda fish screen. A long-term instream flow lease will be pursued in the future. FFIP contributed \$11,255 to the project, which had a total cost of \$44,442. Photos by Big Blackfoot Chapter of Trout Unlimited and FWP.

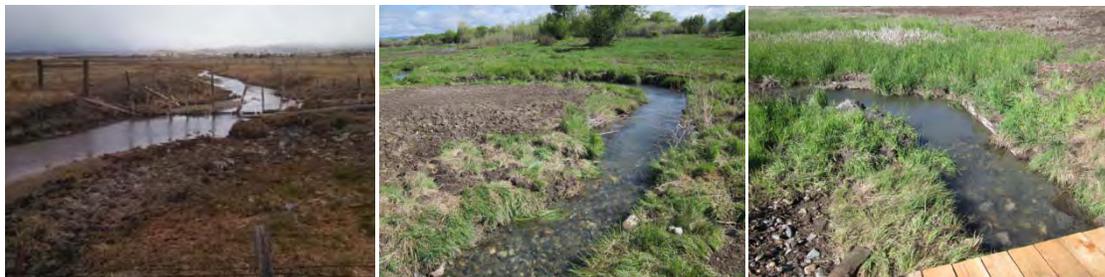
PRICKLY PEAR CREEK BANK STABILIZATION (020-2014)

This project improved pool and riffle habitat in selected meander bends of the spring creek that feeds into Prickly Pear Creek, replaced an undersized culvert with a bridge, and reconnected the spring creek with the original confluence with Prickly Pear Creek. Realignment, revetments, and debris cleanup were components of the adjacent project on Prickly Pear Creek. FFIP contributed \$6,323 to the project and the total cost was \$77,886.55 (including the Prickly Pear Creek component). Photos by FWP.

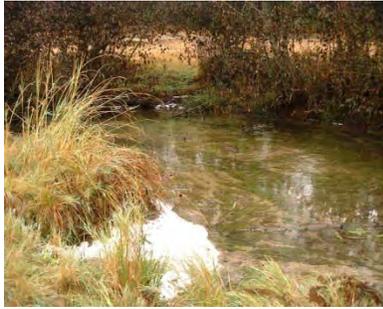
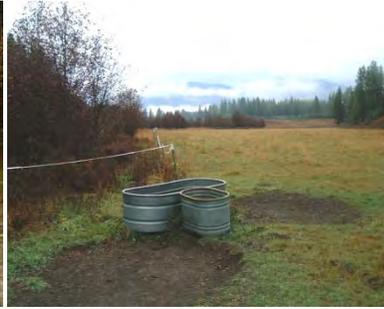
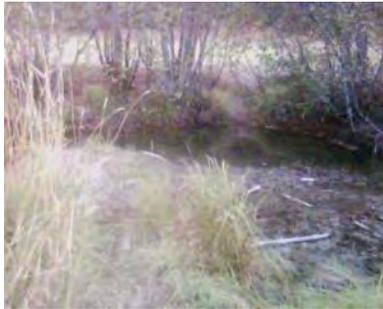
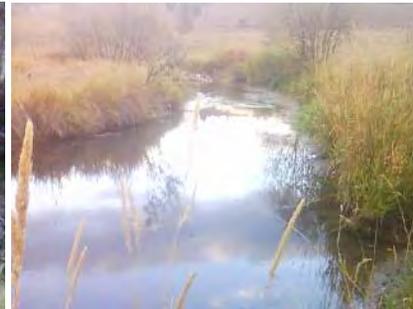
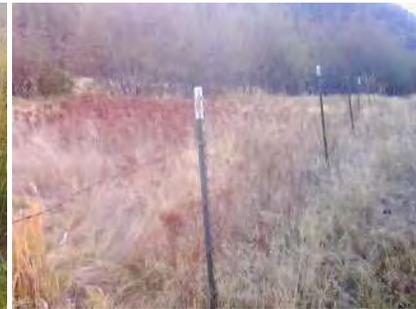
LITTLE BEAVER CREEK RIPARIAN FENCE (013-1996)

This project involved fencing the riparian area along one mile of stream. In 2009, fencing was listed as broken but project was still effective. In 2015, TEEI noted an enclosure and functional fence but also reported grazing. It is unclear what grazing has occurred and how (no notes). There were observed areas where wildlife was breaking/jumping fencing and accessing the creek. Ultimately, stream benefits were from removing beaver dams more so than fencing. Completed in 1996.

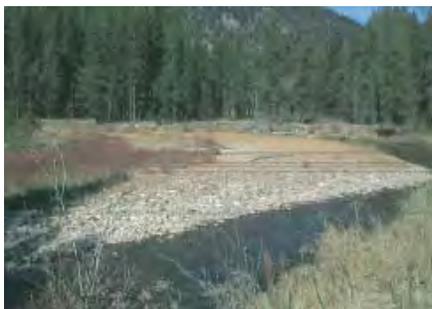
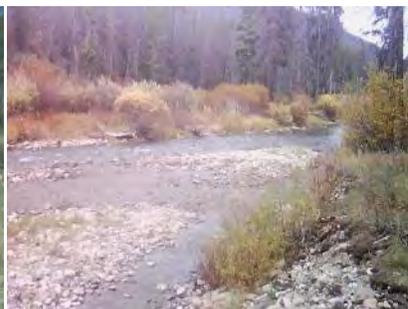
MIDDLE FORK ROCK CREEK RIPARIAN ENCLOSURE (004-1997)

This project involved riparian fencing to exclude livestock from streamside areas and off-stream water development to provide alternative watering. Three miles of stream were treated. The site was visited by TEEI in 2015. Fencing was no longer functional and grazing was occurring that has resulted in moderate browsing. Cattle guards had been removed. According to past monitoring information, the enclosure ended around 2003/2004. Long term compliance is questionable and requires follow up with the U.S. Forest Service. Completed in 1997.

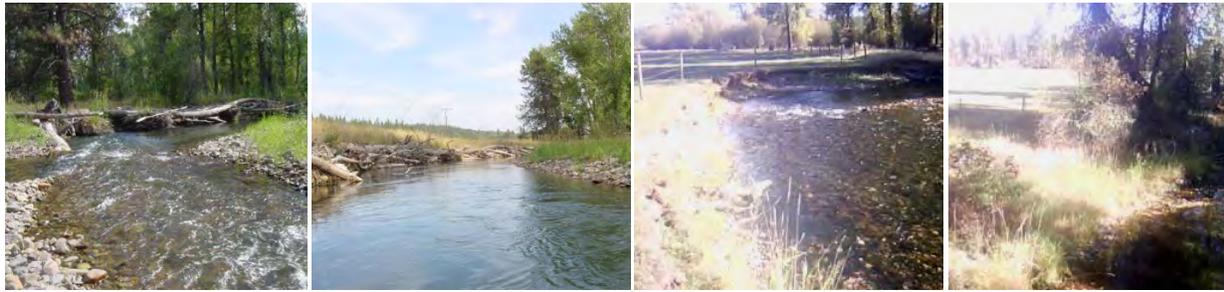
NINEMILE CREEK RESTORATION AND FENCING (050-1999)

This project involved riparian livestock to exclude livestock from 1.75 miles of stream and treated eroding banks using natural materials. The landowner reported that Missoula county floodplain administrator has prevented her from addressing bank stabilization issues since time of original work and reported that the plantings have washed away. The fencing was not evaluated and needs follow-up. The project was beneficial to the landowner and improved stream/riparian conditions. It is unclear if fencing/eroded structures are causing problems. Failure of wood structures was obvious. Completed in 1999.

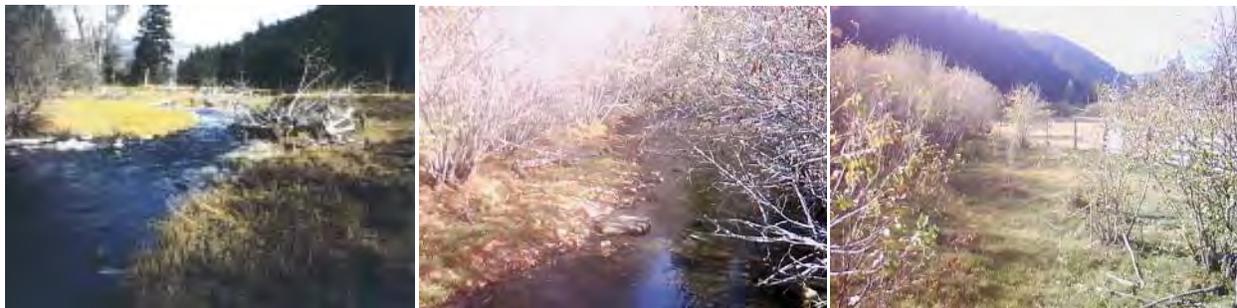
LOWER WILLOW CREEK (027-1999)

This project involved installation of 4.6 miles of fencing, development of a grazing management plan to protect the stream, and willow planting. In 2015, riparian growth was abundant and there were no signs of grazing. Riparian fencing was in great condition and despite wildlife browsing the riparian area appeared to be in good condition. TEEI listed the stream as aggrading/narrow and deep with no other information; photos do not illustrate this condition. Overall, the project was considered successful with beneficial impacts to stream function, fishery, and landowner. Completed in 1999.

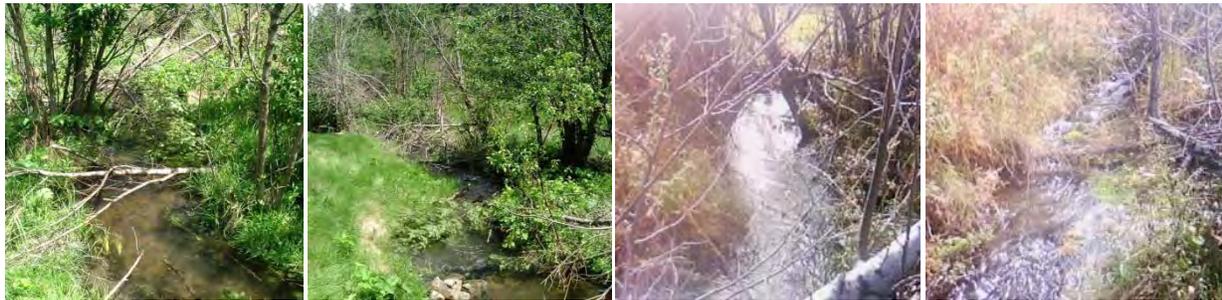
DUNKELBERG CREEK RESTORATION (005-2001)

Dunkelberg Creek had a healthy riparian area but poor instream habitat. The project added woody debris to the stream channel to improve habitat complexity. Approximately 1,500 feet of channel was treated. In 2015, there were no signs of cattle grazing or livestock use. Project reach is primarily within a recreational/residential property. Woody material was highly weathered, yet mostly intact and partially buried in sections of the stream channel. Completed in 2001.

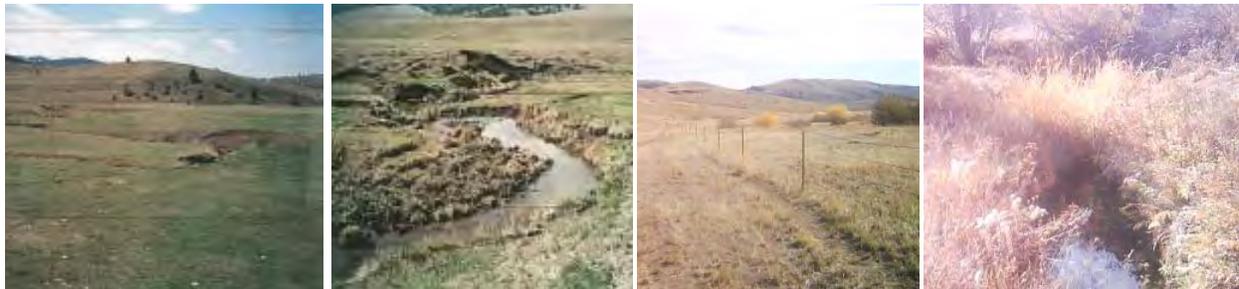
ANTELOPE CREEK (031-2001)

Antelope and Woods Creeks had been impacted by grazing. This project installed 4.8 miles of riparian fencing, water gaps, and livestock crossings. The site was also revegetated. In 2015, the streambank at the site was considered stable or degrading and the channel had very low or no water flowing. Weeds were abundant, and the riparian fencing was in good condition. Light grazing is allowed but TEEI monitoring reported no or unknown increase in riparian condition since last visit; the level of project improvement is unclear. The landowner reported a beneficial project with improved stream and riparian conditions. Completed in 2001.

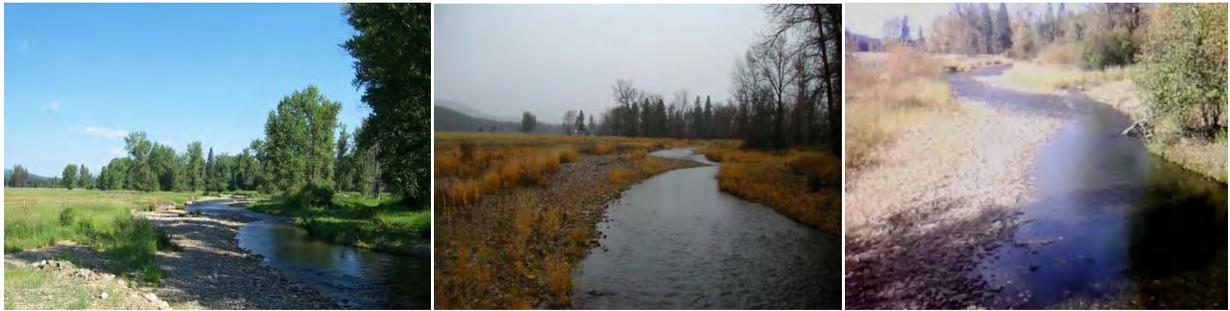
NINEMILE CREEK RIPARIAN FENCING (028-2002)

This project addressed portions of the stream degraded due to grazing. It involved installation of 1,150 feet of riparian fencing and management as a grazing exclosure. In 2015, exclusion fence appeared to be in good working order. The landowner had installed additional fencing to prevent further grazing along the creek through the property and reported an improvement in riparian condition and an overall benefit as a result of the project. Completed in 2002.

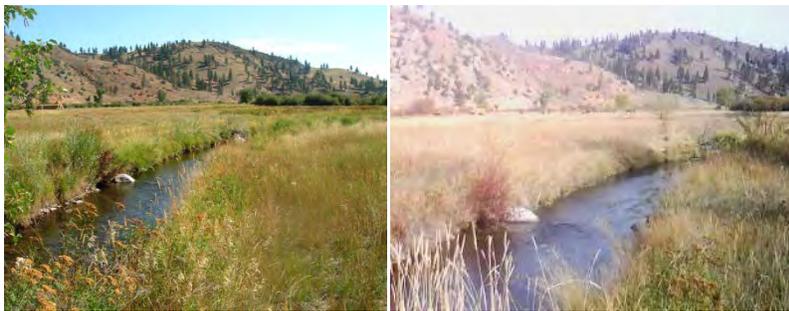
HARVEY CREEK (012-2002)

This project reconstructed the stream channel, revegetated riparian areas, installed riparian fencing on both sides of the stream, and installed a fish screen on the diversion. In 2015, TEEI observed a stable streambed with abundant gravel and no improvement in riparian condition since 2009. Beaver were observed in the area. The landowner reported no improvement in stream/riparian conditions and no overall impact. Previous monitoring noted a dam on lower end of project site that could be affecting the population. Completed in 2002.

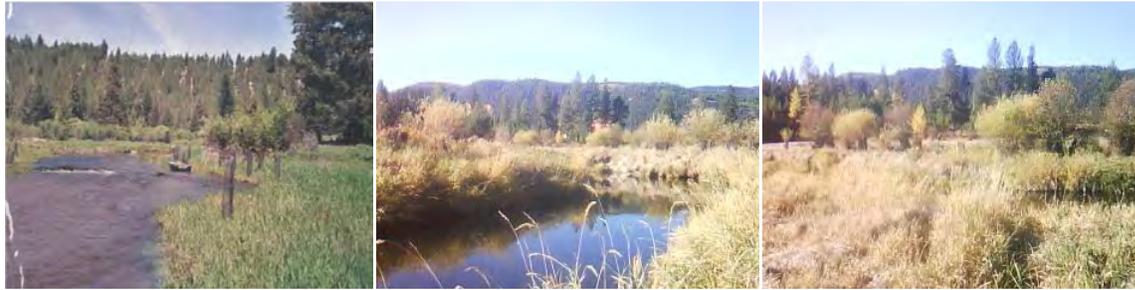
THOMPSON RIVER RIPARIAN ENHANCEMENT (018-2008)

In response to an invasion of reed canarygrass that negatively impacted the riparian areas and suppressed native vegetation, this project built upon a previous project that was successful in establishing native shrubs through the use of browse protectors. This project installed 500 browse protectors around shrubs to protect them. In 2015, the willows were thriving and the landowner reported riparian improvement. Of the three projects on the property, this was the most successful. Canarygrass was still present, but the relative amount was not recorded. Completed in 2008.

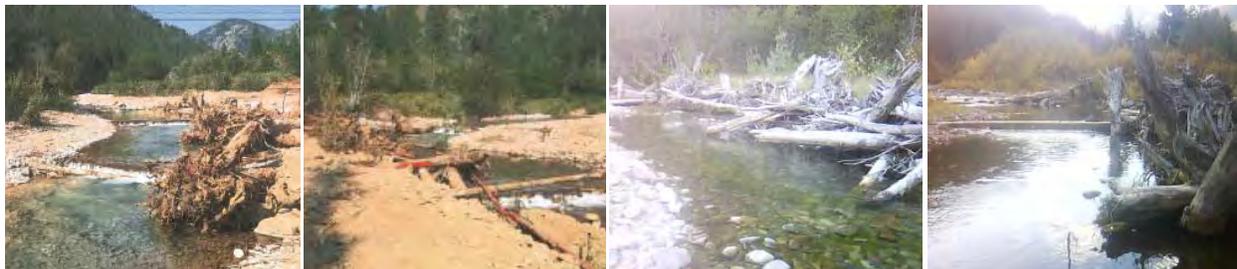
MARTEN CREEK BANK STABILIZATION (015-2009)

Before this project, high spring runoff resulted in channel degradation through accelerated bank erosion, downstream channel braiding, and loss of fish habitat complexity. The project restored 1,500 feet of stream channel by reconstructing the floodplain and installing grade control/energy reducing structures. In 2015, the consultant noted that riparian enclosures around willows were removed. The overall project appeared successful in stabilizing stream banks and reducing erosion/sedimentation. The structures were in place and the project appeared successful. Completed in 2009.

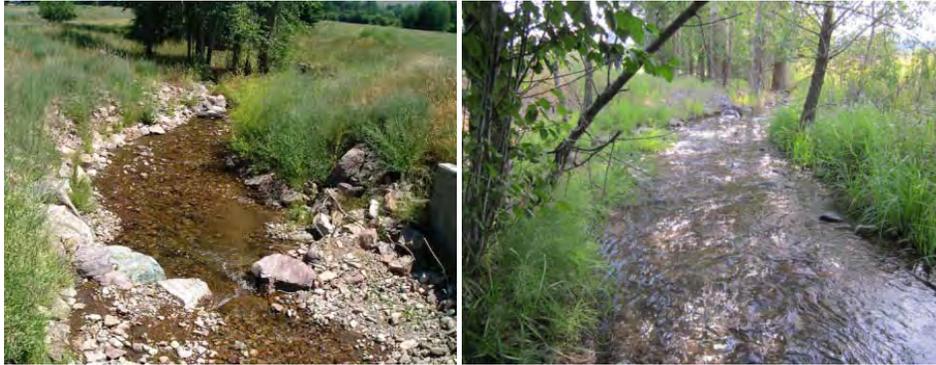
OBRIEN CREEK (010-1997 & 051-1999)

This project restored pools and riparian areas in O'Brien Creek, near Missoula. Habitat structures remain in place and functional and the riparian area has grown in since project. Some erosion is present, but the overall project is functional. Completed in 2000.

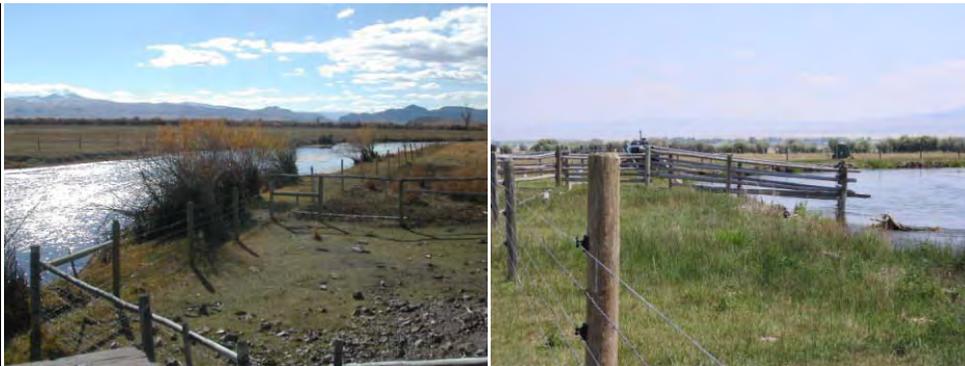
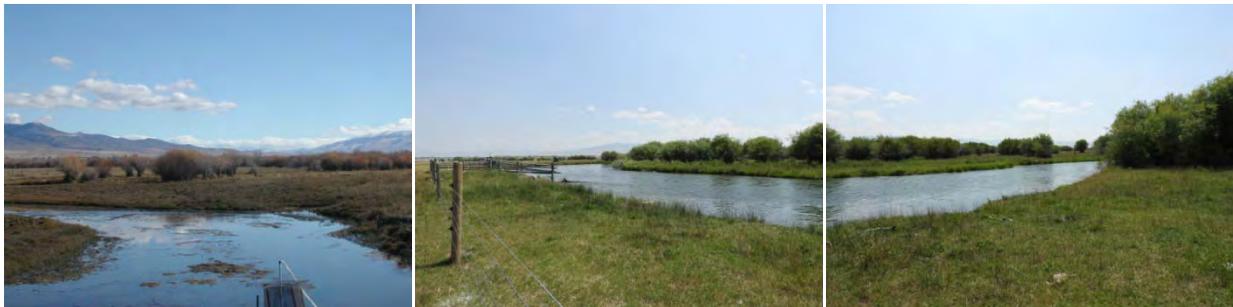
BEAVERHEAD RIVER FENCING (003-1998)

This project fenced three miles of the Beaverhead River on both sides and installed water gaps to protect the riparian area from cattle. Limited grazing was allowed, as long as it was consistent with riparian protection. Past monitoring identified a poor riparian condition. In 2016, the landowner reported short duration fall grazing, which helps with weeds. Conditions appear to be improved compared to pre-project conditions, but sections of eroding bank persist. Fencing was in place and most riparian areas were moderately vegetated. Sheep have been allowed to graze the entire property and probably affected the success of the project. Completed in 1998.
