FUTURE FISHERIES IMPROVEMENT PROGRAM

REPORT PREPARED FOR THE 2017 MONTANA STATE
LEGISLATURE AND THE FISH & WILDLIFE COMMISSION

Summary of program years 2015–2016 and anticipated future expenses

Montana Fish, Wildlife & Parks, Fisheries Division, Habitat Bureau
<http://fwp.mt.gov/fishAndWildlife/habitat/fish/futureFisheries/legislative/>

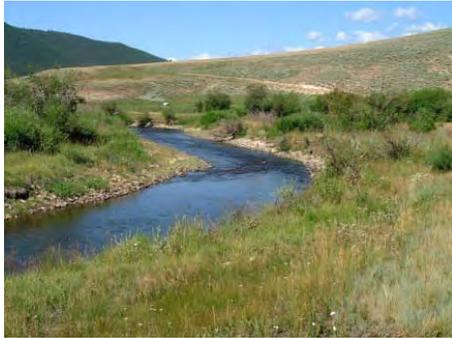
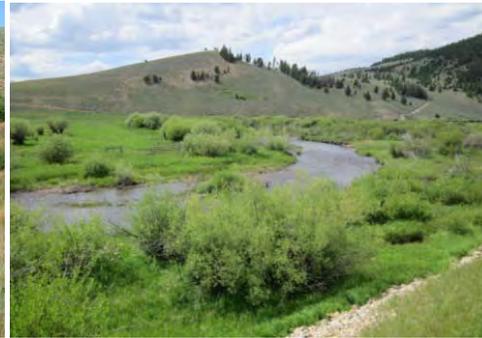
DEEP CREEK (010-1998 & 037-2003)

This project used bioengineering techniques, revegetation, and riparian fencing to stabilize banks, and insert a gravel plug to reestablish a stream meander (completed in 1998). Additional riparian fencing and off-channel water were added in 2006. Project now appears natural and fully functional.

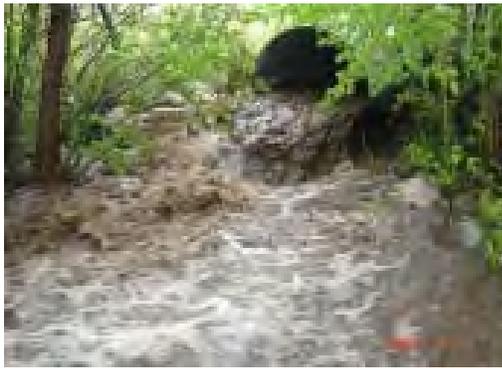
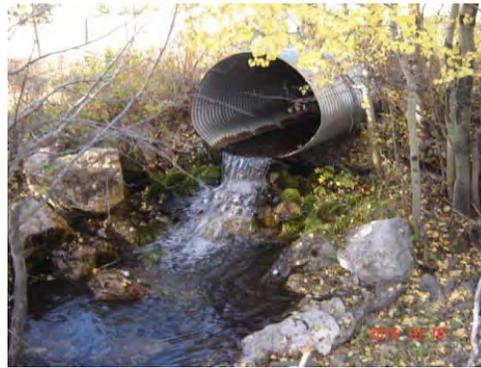
STAUBACH CREEK FISH BARRIER (056-1998)

This project installed fish barriers in the form of perched culverts at county road crossings. In 2016, the barrier continued to keep brook trout below the barrier and westslope cutthroat trout isolated above the barrier. Completed in 2000.

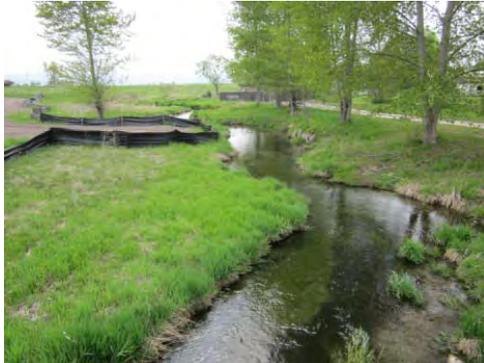
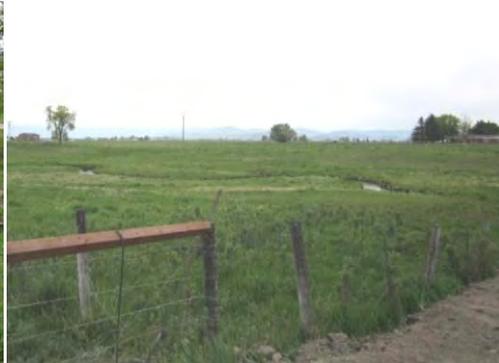
SPRING CREEK (057-1999)

This project restored an untreated reach of stream that was degraded by land use activities. The channel was narrowed, deepened, and returned to a single channel. In 2015, the channel appeared overwide and shallow with very little deeply rooted vegetation. Some erosion/slumping is occurring. The fish biologist believes project is performing decently well; there are no pre-project or other monitoring photos. Completed in 2000.

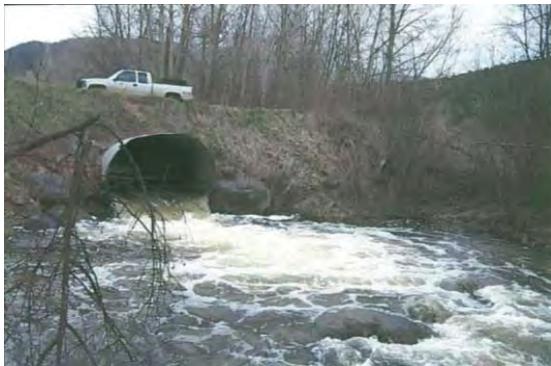
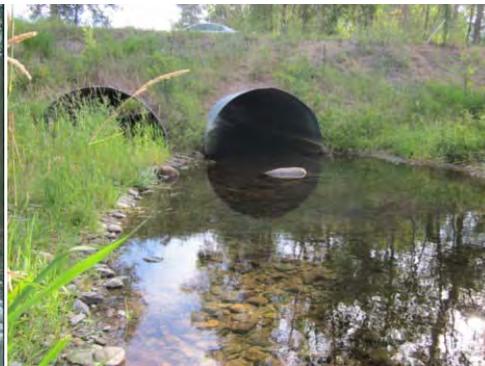
MILL CREEK CULVERT REPLACEMENT (009-2001 & 020-2004)

This project replaced an undersized culvert with two embedded arch culverts. It was scaled back, not installed well, and has experienced stream function problems. However, it continues to provide fish passage. Completed in 2004.

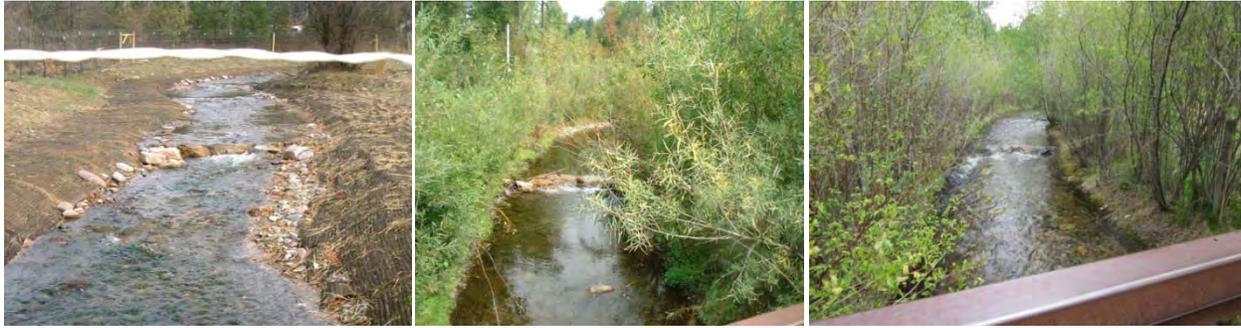
RATTLESNAKE CREEK (013-2001)

This project reconnected a side channel on Rattlesnake Creek and reconstructed the main channel, improving spawning habitat, fish habitat, and riparian condition. The project is in good condition. Banks and stream are stable and well vegetated. Rock vanes have been retained and show limited movement. Completed in 2002.

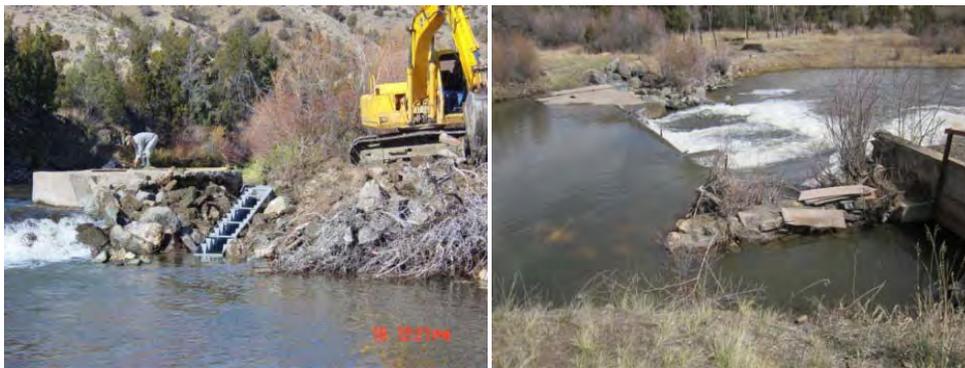
BOULDER RIVER FISH LADDER (037-2001)

This project installed a denil fish ladder to provide fish passage around a diversion dam on the Boulder River. The ladder has been effective at providing fish passage, but is difficult to maintain. In 2015, the biologist agreed to fix the structure, which was damaged with recent flooding. Completed in 2003.

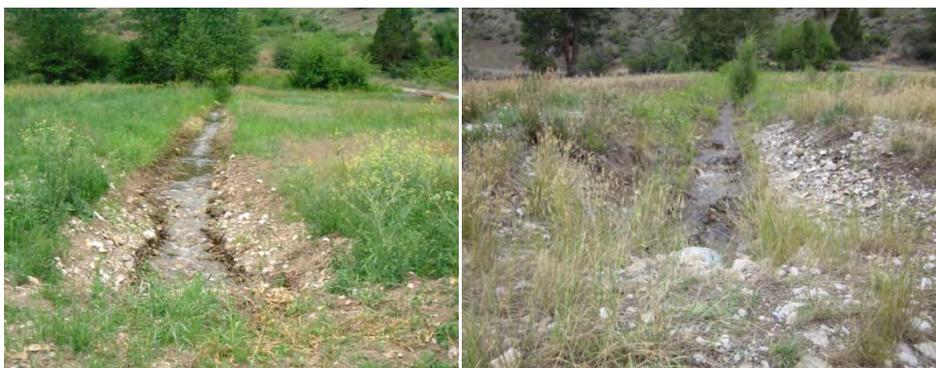
BEAVER CREEK DIVERSION REPAIR (002-2002)

This project reconnected the bottom end of an irrigation diversion with Beaver Creek, allowing return flows to re-water the stream and prevent fish loss. The diversion remains connected to the creek and the project is in good condition. Completed in 2003.

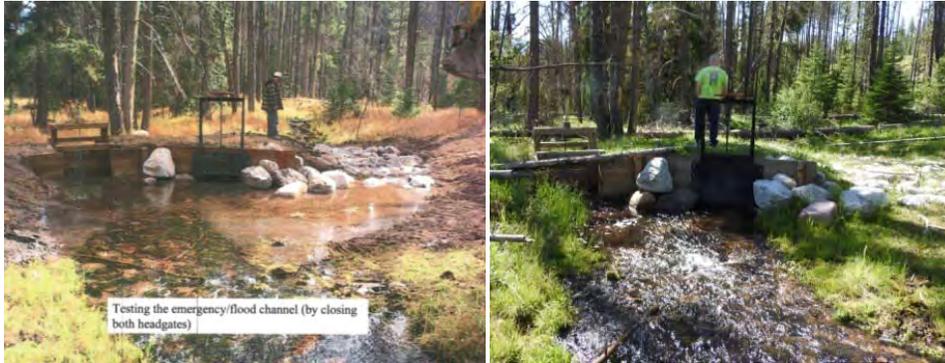
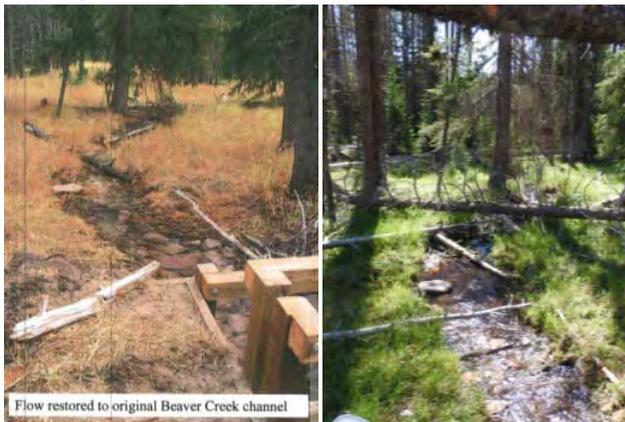
BEAVER CREEK (003-2002)

2003 (after construction)

2016

2003 (after construction) 2016

This project intended to restore an area that had been overgrazed. It was significantly reduced in scope and ultimately involved a headgate installation due to difficulties with landowner cooperation. Water was to be managed so that the user maintains their water right and the creek gets the remainder. The goal was to connect Beaver Creek with Upper Willow Creek. In 2016, the headgate appeared to be in excellent condition. Year round fish passage is unlikely, as the headgate was only cracked open. The majority of the streamflow was going down the ditch, which passes through two shallow ponds and Bear Creek before connecting with Upper Willow Creek. Completed in 2003.

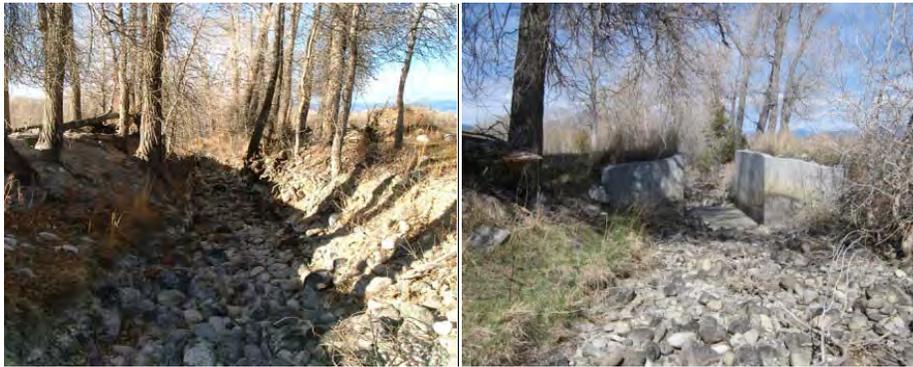
JEFFERSON RIVER FISH ENTRAINMENT (014-2002)

Pre-project

2015

This project installed a velocity barrier that would exclude fish from the Kurnow overflow and prevent fish from being lost down Parrot Ditch (when running). In 2015, the project was intact and assumed to be functional. It had not been monitored for fishery impacts. Completed in 2004.

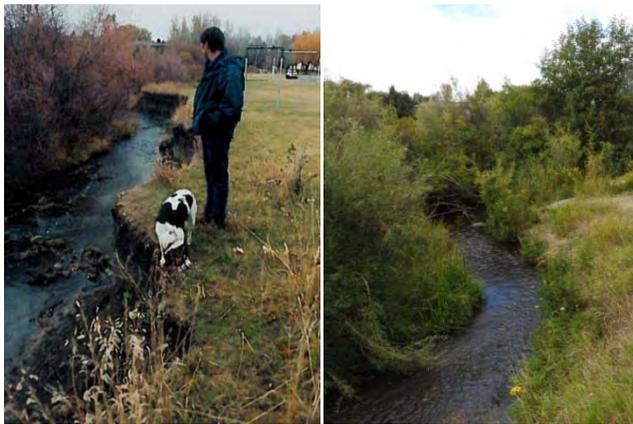
MATTHEW BIRD CREEK (016-2002)

Pre-project

2016

This project addressed vertically eroding banks, and restored approximately 300 feet of stream using back sloping, erosion control fabric, and revegetation. In 2016, vegetation was abundant and the stream was stable. The project looks natural and is considered a success. Completed in 2003.

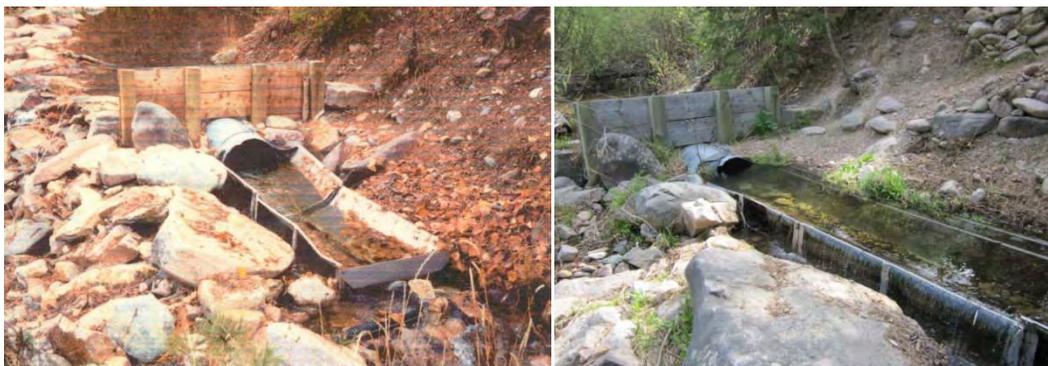
RATTLESNAKE CREEK FISH SCREEN (022-2002)

Pre-project

2015

This project constructed screens on two of the four unscreened diversions on Rattlesnake Creek and made improvements to an existing screened diversion (above). The screens were not functional 5/2015 (during runoff), but get cleaner post-runoff. The screens currently function as barriers and need to be updated in the future. Completed in 2002. One screen update was funded in 2016.

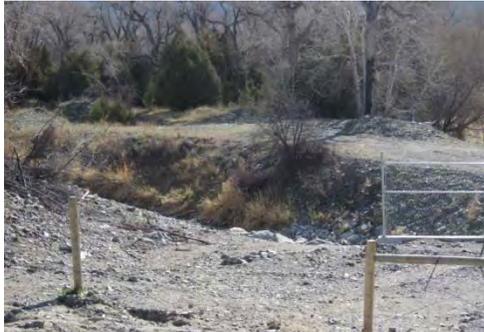
CREEKLYN DITCH AND JEFFERSON CANAL (030-2002)

2015

This project involved the sealing of two major diversion canals with polyacrylamide. Preliminary results indicated that water savings were realized. However, in 2015 the biologist noted that the sealant had a two year lifespan and would have worked better with sand substrate (gravel was present in the project area and sealant could not fill the interstitial spaces). No historical photos were available. Completed in 2002.

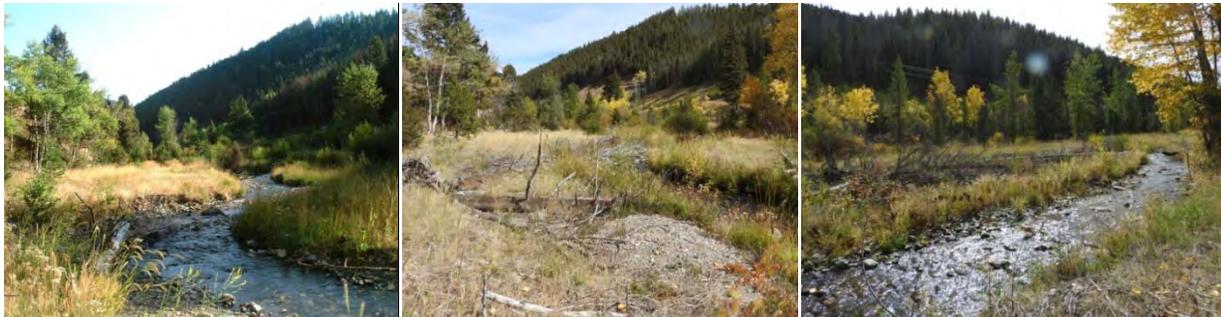
GERMAN GULCH (040-2002)

2009

2016 (meander abandoned)

This project intended to improve a stream impacted by logging, grazing, and historic placer mining. The stream was improved by adding woody debris and boulders, excavating pools, widening the floodplain, and adding vegetation to the riparian areas. It was reduced in scale and used as a demonstration project. Past monitoring indicated a relatively healthy riparian area with minimal riparian shrub establishment, stream channel widening, and loss of small woody debris. In 2016, the riparian area was inundated with weeds. Some of the wood was at the margins of the stream or abandoned and vegetation establishment was considered fair. The channel has adjusted to a less sinuous configuration. The actual demonstration value is unknown. Completed in 2007.

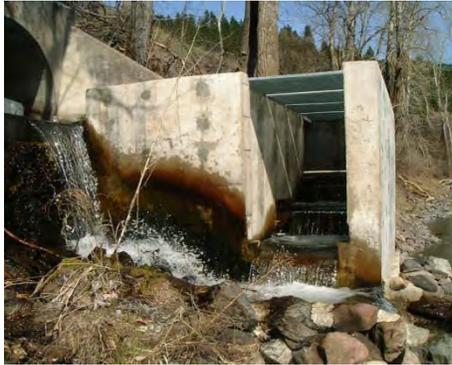
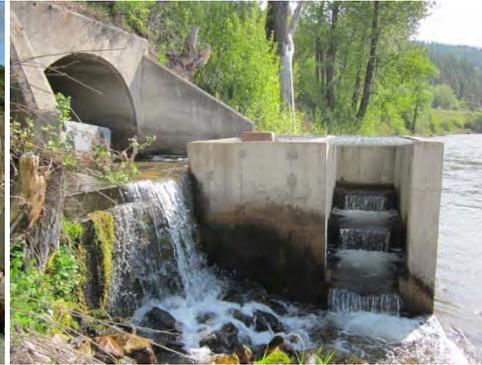
MARSHALL CREEK (013-2003)

2005

2015

This project upgraded a culvert, which was a barrier to fish passage. A pool-and-weir fish ladder was installed and baffles were added to the inside of the culvert to provide fish passage. It is functioning as intended. Completed in 2005.

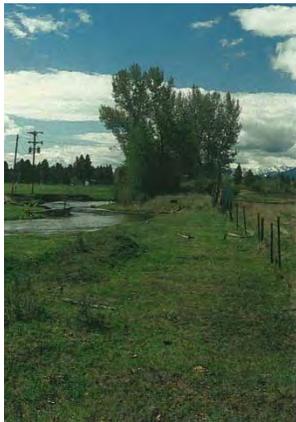
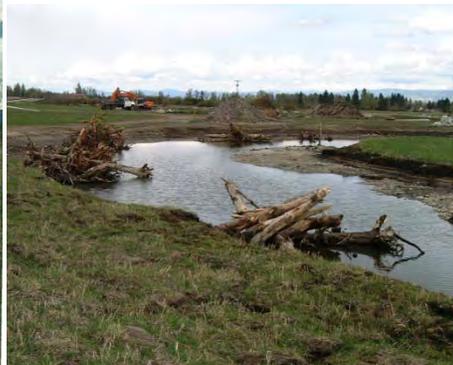
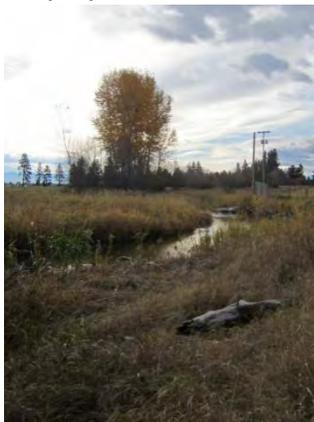
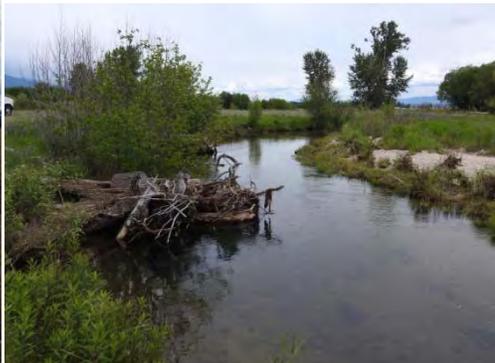
MILL CREEK (017-2003)

Pre-project

2004 (after construction)

2014

2016

This project reconstructed and restored approximately 7,500 feet of channel with channel shaping, riparian revegetation, and riparian fencing. Since project construction, erosion has been reduced and the riparian area was improved. The channel is stable and the wood has remained in place. The

limiting factor is water quantity and streamflow, particularly in the fall. Because of this, the impact to the fishery is probably negligible. Completed in 2004.

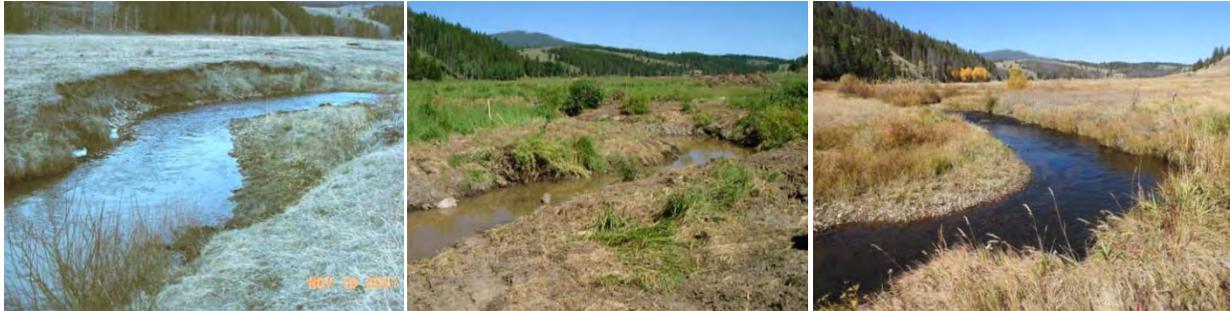
UPPER WILLOW CREEK (029-2003)

Pre-project

2005

This project restored about 6,500 feet of stream that had been degraded by agricultural practices. The channel was reconstructed, habitat features were installed, stream crossings and irrigation structures were rebuilt, and the riparian area was revegetated. Past monitoring indicated that riparian condition was fair but improved. Grazing compliance was high. In 2016, the condition of the project was improved relative to pre-project conditions, but the riparian area was dominated by reed canarygrass and willow establishment was minimally successful (project applicant noted installation of willow was not ideal). The channel has adjusted and has some erosion and incision. Completed in 2005.

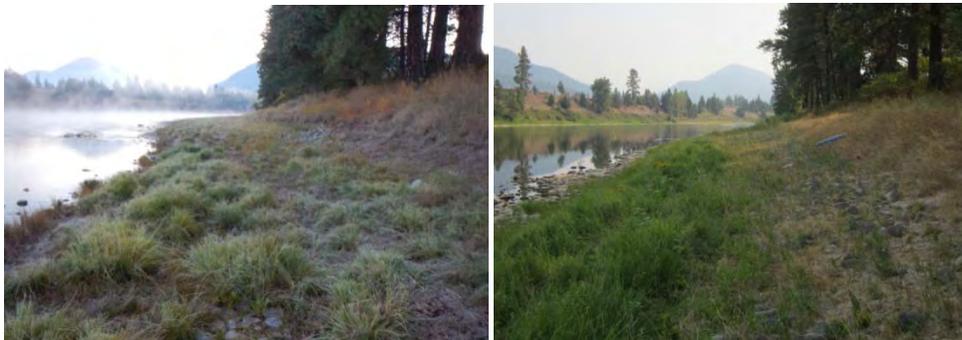
CLARK FORK RIVER (036-2003)

2013

2015

This project installed riparian fencing on the river and property boundary. Monitoring completed in 2013 indicated a violation, as horse grazing was seen on the riverbank. A follow-up site visit in 2015 found that the fences were mended and the issue was resolved. The riparian area was in good condition. No historical photos were available. Completed in 2004.

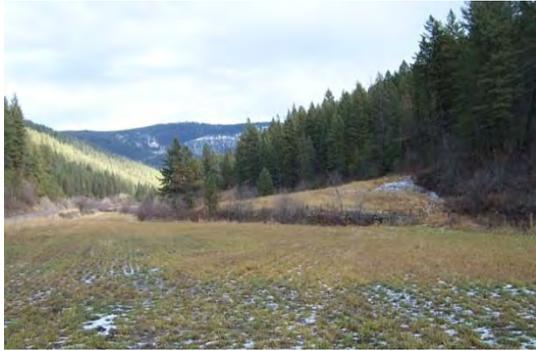
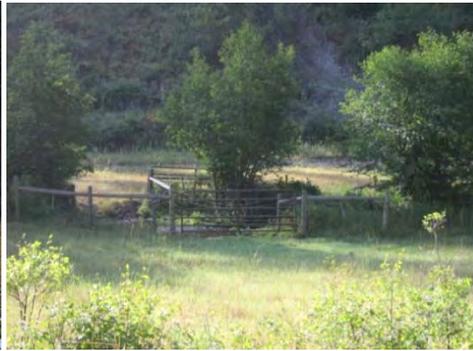
MARSHALL CREEK (043-2003)

Pre-project

2015

This project constructed approximately 2,500 feet of streamside fencing to improve riparian management and facilitate woody vegetation recovery. In 2015, the fencing was in good condition and the local biologist reported that the project was a success. The enclosure could have been bigger but the landowner wanted to maximize pasture area. The area is a stronghold for westslope cutthroat trout. Completed in 2003.

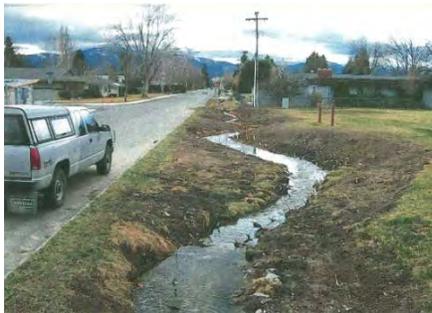
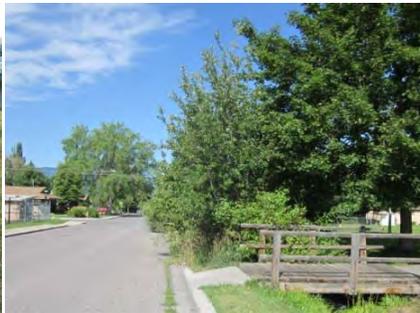
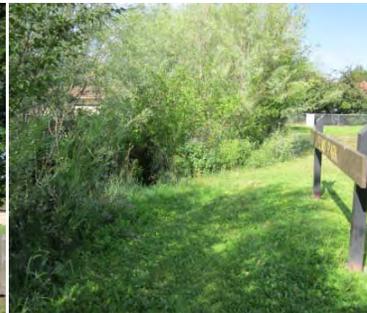
PATTEE CREEK (024-2004)

2005

2015

This project, within the town of Missoula, involved channel reconstruction in Elms and Lester Parks. The stream was originally channelized, and is now meandering and vegetated. However, the stream above and below the project remains channelized. The project appears to be in good condition, but presents a good opportunity to consider the role of FFIP in these types of projects—including the utility as fish habitat or demonstration project. Completed in 2005.

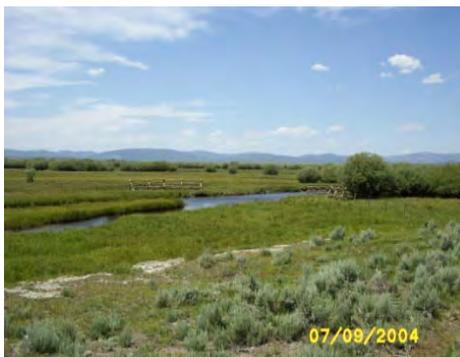
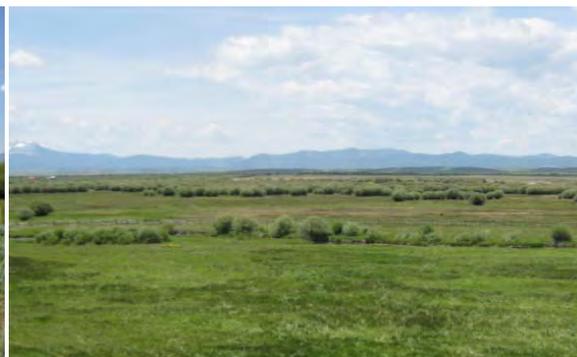
STEEL CREEK (026-2004)

2004 (after construction)

2015

This project installed riparian fence, willow transplants, and seedlings. The project was considered successful because modifications were made to the fence. The original application fenced the riparian corridor and excluded cattle for 5 years. The pasture wasn't working for the landowner and the fence was moved, with FFIP approval. A project partner indicated that jackleg fence is needed in wet, marshy areas. A lesson learned was to make sure the initial pasture configuration will work long-term. Stream and riparian condition appears to be in decent condition, but willow expansion could be greater. Completed in 2004.

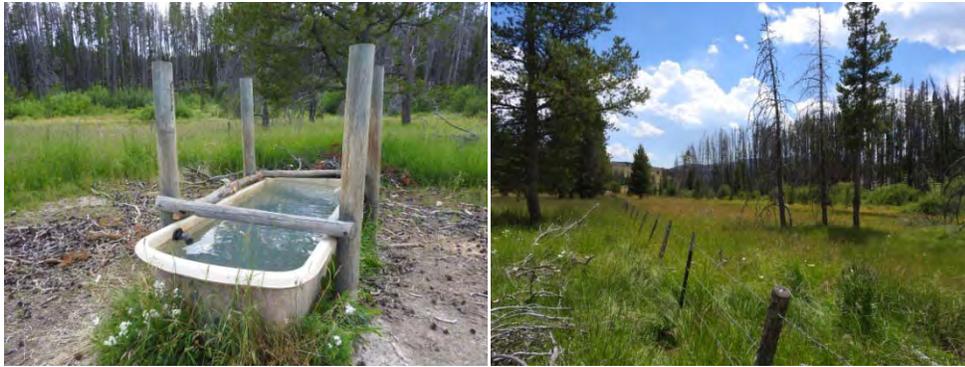
UNCLE GEORGE CREEK (031-2004)

2015

This project installed riparian fencing along ¼ mile of stream and developed off-site water on Uncle George Creek, a site that had been degraded by livestock. In 2016, the site was functioning well. Riparian fence was intact and the off-stream water was operational. The project location is the headwaters of Uncle George Creek and the fishery impact is unknown. Downstream of the project site, heavy grazing by cattle is apparent (no historical photos available). Completed in 2004.

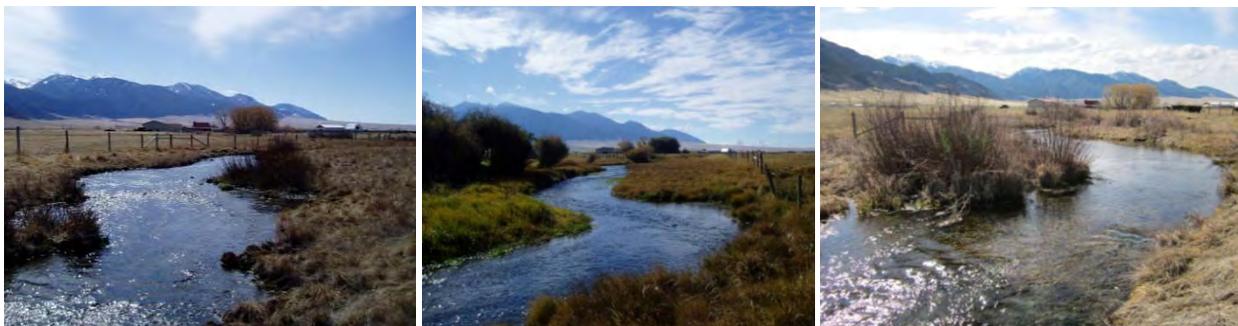
WILLOW SPRINGS CREEK (034-2004)

Pre-project

2005 (after construction)

This project involved channel improvements, riparian fencing, and the addition of spawning gravel. The intention was to improve spawning sites for trout. In 2015, the project remained in good condition. Some algae have affected the spawning gravel, particularly in the fall, but this project has contributed to an increase in spawning sites, recruitment, and Jefferson River fish populations. Completed in 2005.

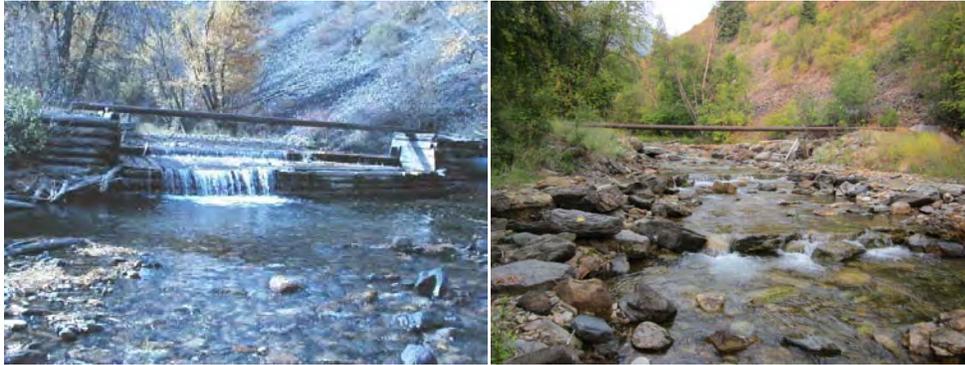
DRY CREEK (041-2004)

Pre-project

2015

This project replaced a wood crib diversion with a series of rock weirs to allow fish passage. The project required maintenance in 2010, but is in good condition and is most likely performing as intended. The impact to the fishery was unknown. Completed in 2004.

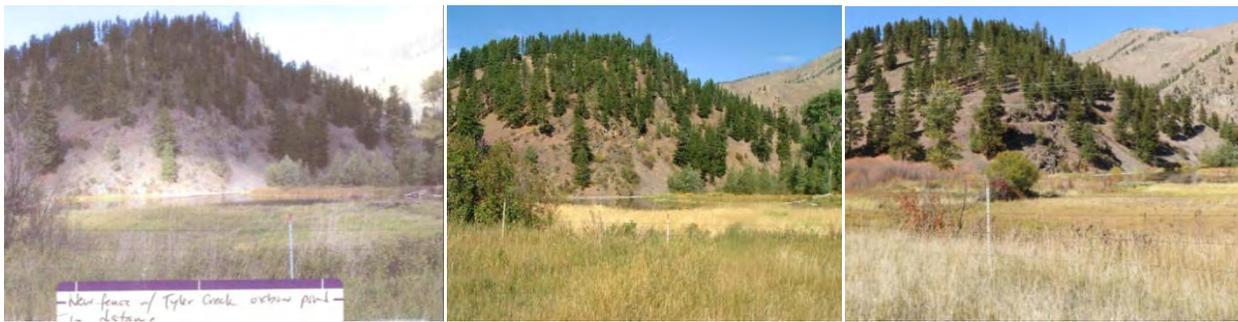
TYLER CREEK (047-2004)

Pre-project

2009

This project fenced approximately 1,720 feet of riparian area to protect existing wetlands and an oxbow area. Since project completion, the fencing has remained intact and the riparian areas appear to be healthy. However, the project scope did not protect Tyler Creek itself from grazing and it is unlikely that the project has benefited the fishery in Tyler Creek. Although the project was compliant, the impact has been minimal at best. Completed in 2004.

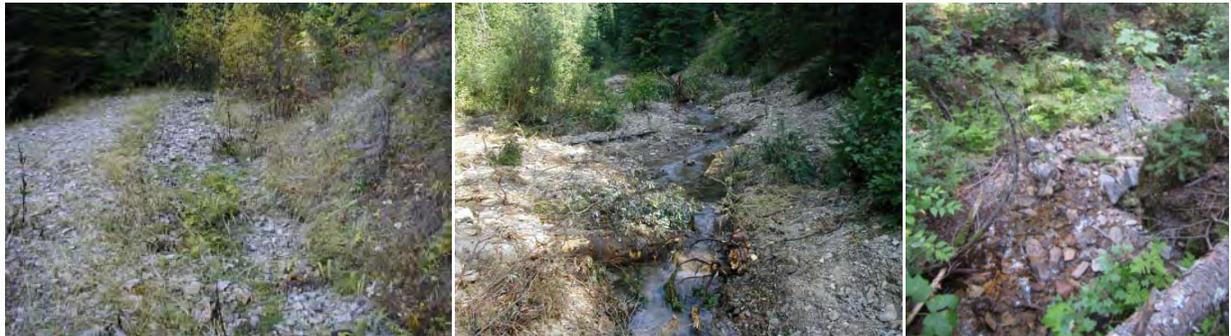
EUSTACHE CREEK CHANNEL RESTORATION (003-2006)

Pre-project

2007 (after construction)

This project involved channel and floodplain construction, revegetation, woody debris, and culvert replacement. Approximately 1.3 miles of stream was treated. The structures appear to be in retained; however, flow was intermittent. The impact on the fishery is unknown, as stream flow did not appear to support fish populations in August 2015. The latest fish sampling was done in 2006. Seasonal benefit is likely; however, condition encourages thought regarding funding of intermittent/low flow streams. Completed in 2007.

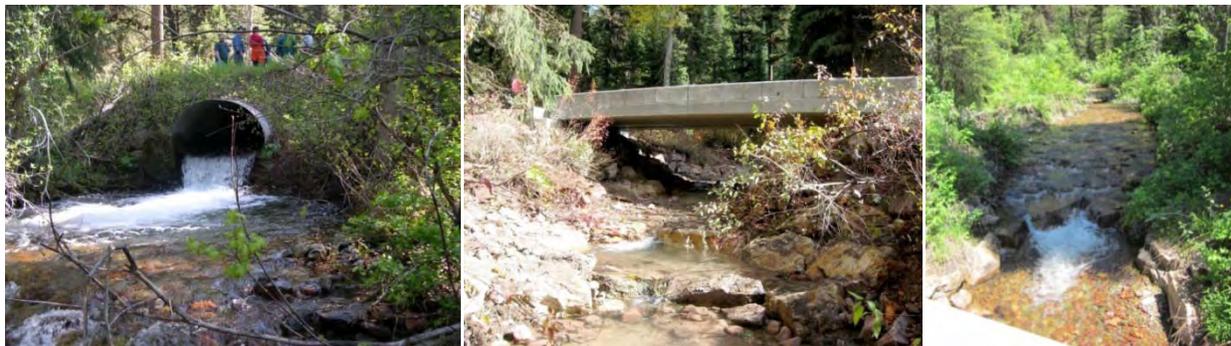
COTTONWOOD CREEK CULVERT REPLACEMENT (002-2006)

Pre-project

2007 (after construction)

This project replaced a perched culvert with a bridge, thereby allowing fish passage. In 2015, the bridge was functional and the rock weirs were still in place. This section of Cottonwood Creek was still having fishery benefit, although portions of the stream are intermittent at certain times of the year. Completed in 2007.

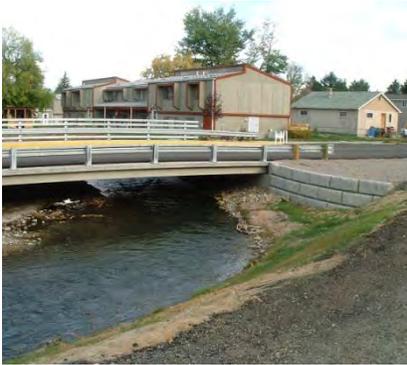
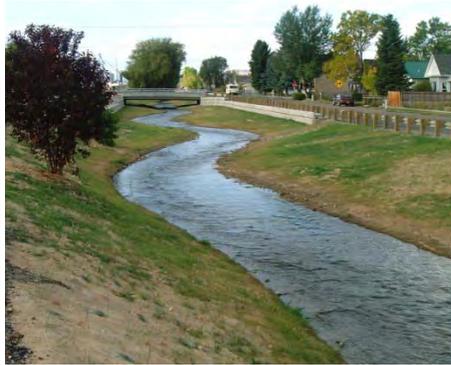
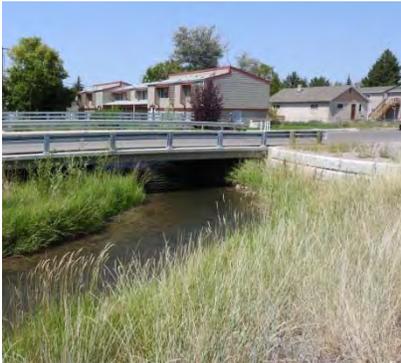
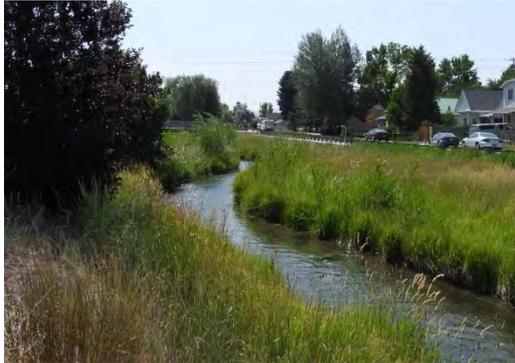
BLACKTAIL DEER CREEK FLOOD MITIGATION (004-2007)

2010 (after construction)

2016

This project intended to increase flood capacity on 2,200 feet of Blacktail Deer Creek within the city of Dillon. Two undersized culverts were replaced with free span bridges, stream gradient was re-established, channel constriction problems were eliminated, and fish habitat structures were added. In 2016, flood capacity was not determined, and fish habitat structures were not observed. Riparian condition is improved and stream appears stable. Completed in 2010.

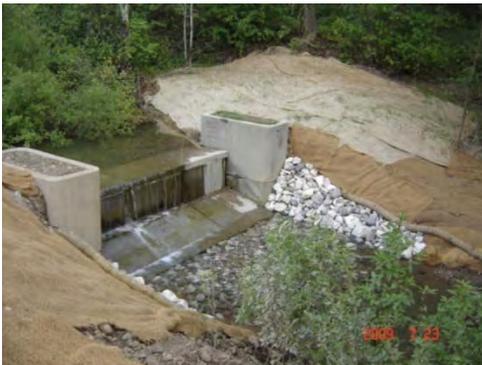
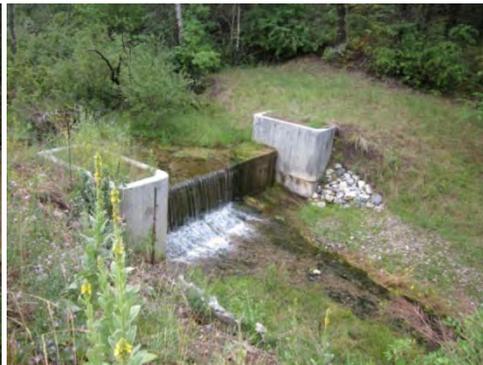
WHITES GULCH FISH BARRIER REPLACEMENT (042-2007 & 029-2008)

2009 (after construction)

2015

This barrier protects a genetically pure population of westslope cutthroat trout. The project upgraded wooden barrier to a concrete structure. It is still functioning as a complete barrier. Some erosion has occurred around the downstream side of structure since its installation. Completed in 2009.

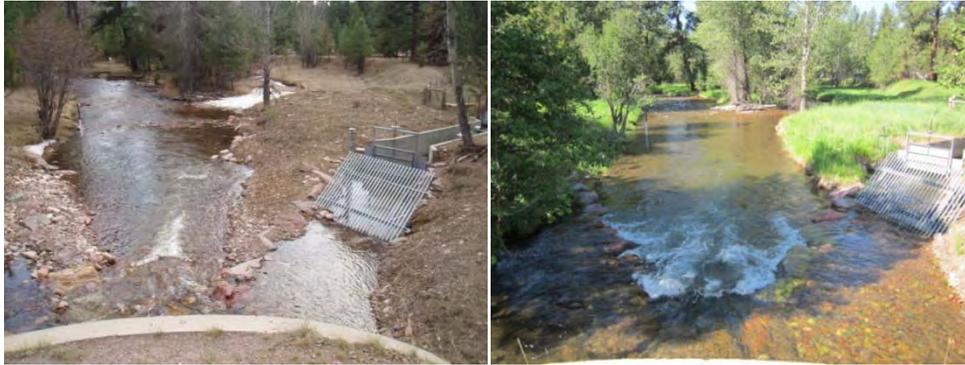
MORRELL CREEK FISH PASSAGE AND FISH SCREENS (015-2008)

2011

2015

This project replaced two wooden irrigation diversions with rock weirs, new headgates with fish screens, and water measuring devices. The project continues to function as intended, but fishery response is unknown. Completed in 2009.

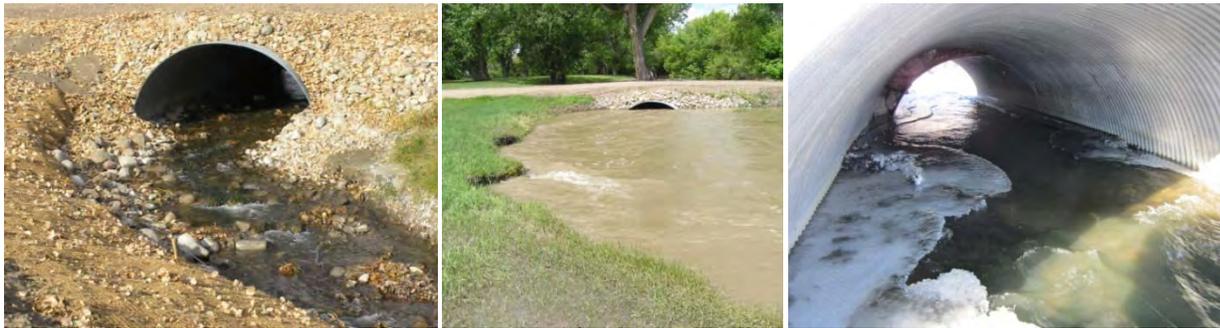
BEAVER CREEK CULVERT TO BRIDGE CONVERSION (020-2008)

2015 culvert damage

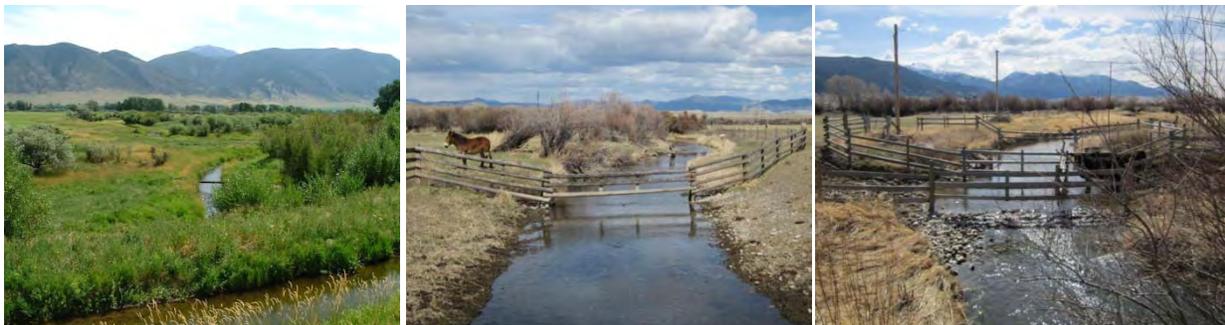
FISH CREEK (HANSON) CHANNEL RESTORATION (022-2008)

2009 (after construction)

2015

similar to 2011, when riparian condition was considered fair and grazing compliance was medium. Completed in 2009.

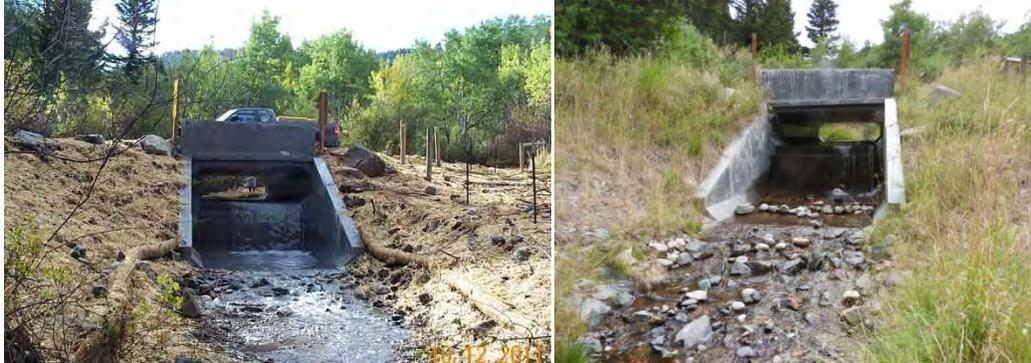
LEVERICH CREEK NATIVE FISH PROTECTION (BARRIER) (012-2009)

2011 (after construction)

2016

This project constructed an upstream fish passage barrier at an existing road crossing to prevent further invasion by nonnative fish. In 2016, the barrier was intact and continues to isolate and protect westslope cutthroat trout. Completed in 2011.

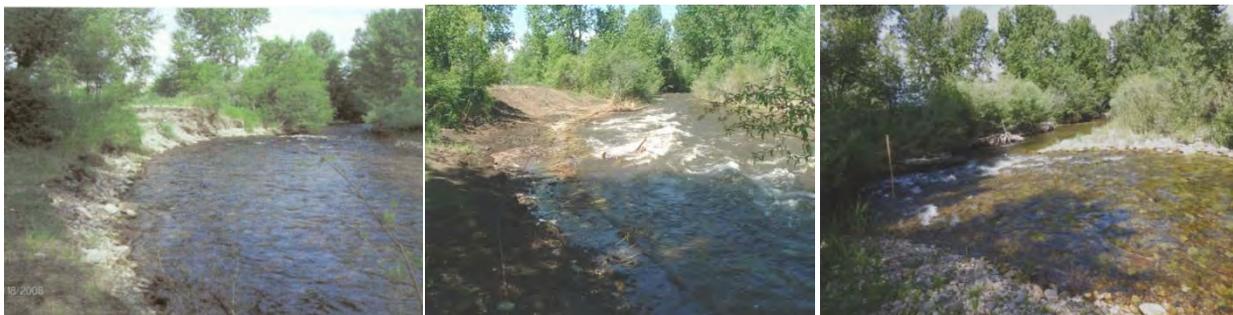
SKALKAHO CREEK BANK STABILIZATION (020-2009)

Pre-project

2009 (after construction)

This project addressed some accelerated bank erosion on the Chester and Sheahan properties along Skalkaho Creek. Approximately 150 feet of bank was stabilized using a bankfull bench and four logjams. In 2016, the project had established vegetation and the bank was generally holding together. A small amount of slumping was observed due to an eroding toe, and the landowner planned to have the area assessed. Completed in 2009.

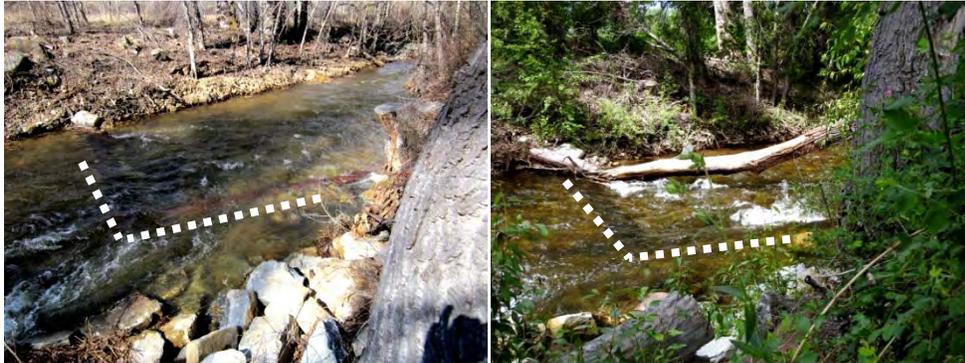
SKALKAHO CREEK CHANNEL STABILIZATION (023-2010)

2012 (after construction)

2016

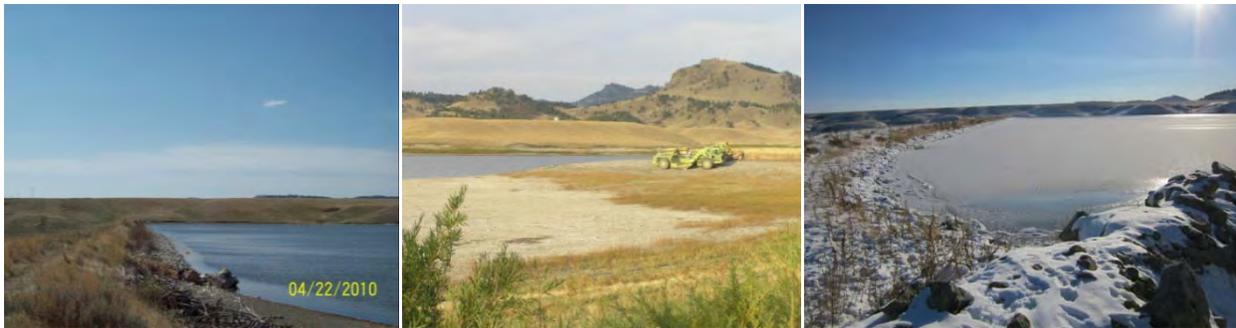
COW CREEK RESERVOIR REHAB & INSTREAM FLOW PROTECTION (031-2010)

Pre-project

2012 (during construction)

This project rehabilitated the face of the dam at Cow Creek Reservoir to facilitate the return to full pool and reduce the potential for a breach. In return, Sand Creek Ranch entered into a water management and fishing access agreement with FWP and agreed not to divert water from Cow Creek Reservoir for 10 years. In 2015, the project was in good condition. Completed in 2012.

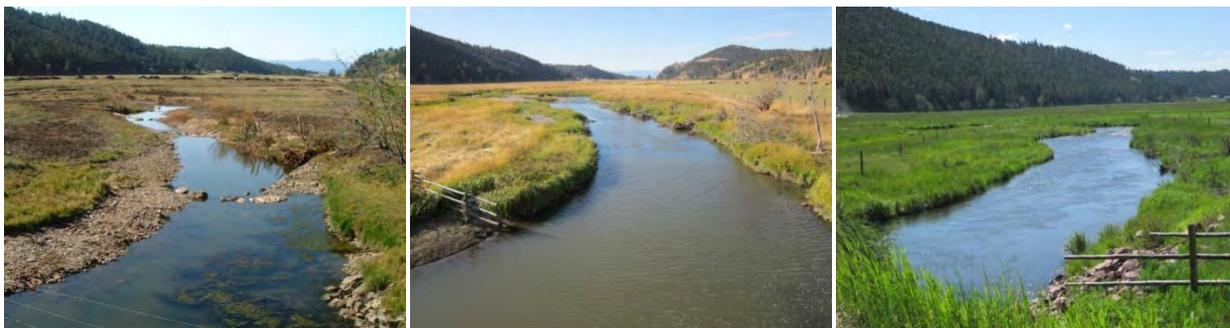
NEVADA CREEK CHANNEL RESTORATION (038-2010)

Pre-project

2011 (after construction)

This project involved channel reconstruction, toe wood and log vanes installation, shrub transplants, and riparian fencing. An existing diversion was reconstructed. The project remains intact with only a small amount of erosion occurring. The landowner considers project to be successful and the fishery response has been positive. Completed in 2011.

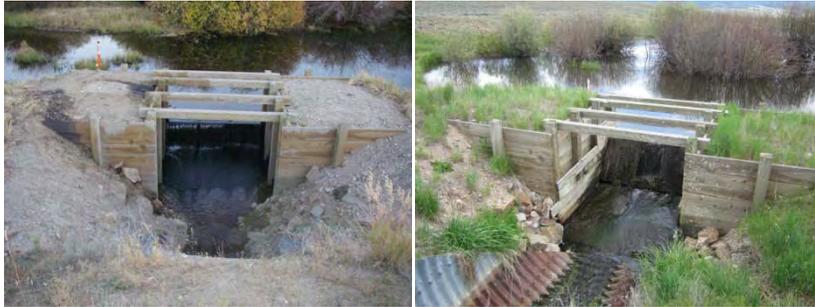
MCVEY CREEK FISH BARRIER (011-2011)

2011 (after construction)

2015

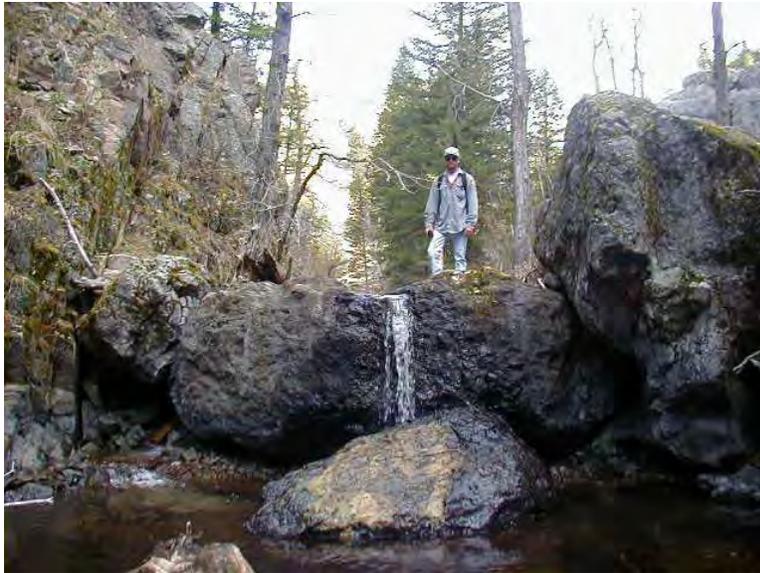
FWP secured this FFIP grant to contribute to the establishment a permanent barrier to upstream movement of fish. The approach was to secure the existing barrier of large boulders by sealing the loose material around and upstream of the barrier falls, with a combination of grout and a fabric liner (Figure 5 and Figure 6). Low flow and high flow channels were constructed to focus flows over the center boulder that formed the waterfall. Grout was applied to spaces between large boulders that formed the falls to fortify the feature. Additional rock was obtained by blasting portions of the adjacent cliff face.

FIGURE 4. UNALTERED NATURAL BARRIER ON BAD CANYON CREEK.

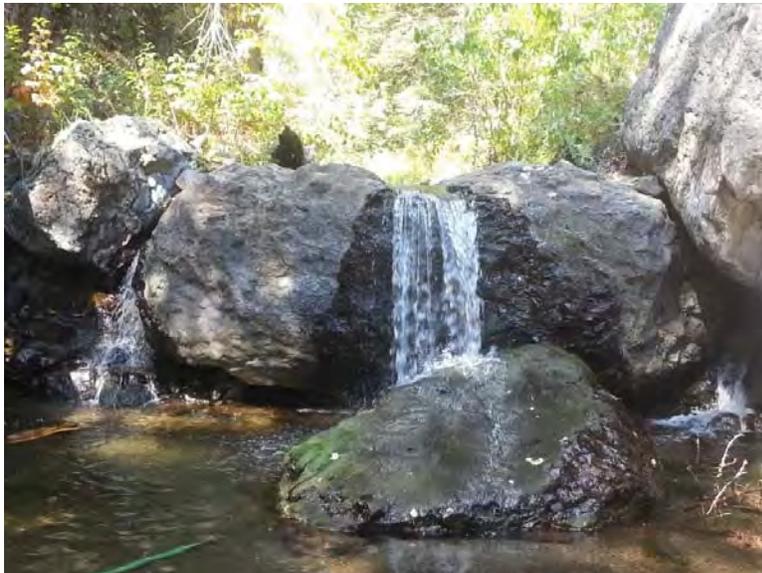
Actions to protect the barrier's ability to block fish began in 2013, with removal of the debris jam. In 2014, several repairs were made to the barrier. Installation of large rock and concrete blocked the flows through the boulders, and prevented potential failure of the barrier. Combined, these actions preserved the structural integrity of the barrier, and eliminated the potential for backwatered flows to decrease the leap height over the barrier, which could otherwise allow brown trout to reinvade Bad Canyon Creek.

FIGURE 8. BAD CANYON BARRIER AFTER REPAIR AND MAINTENANCE.

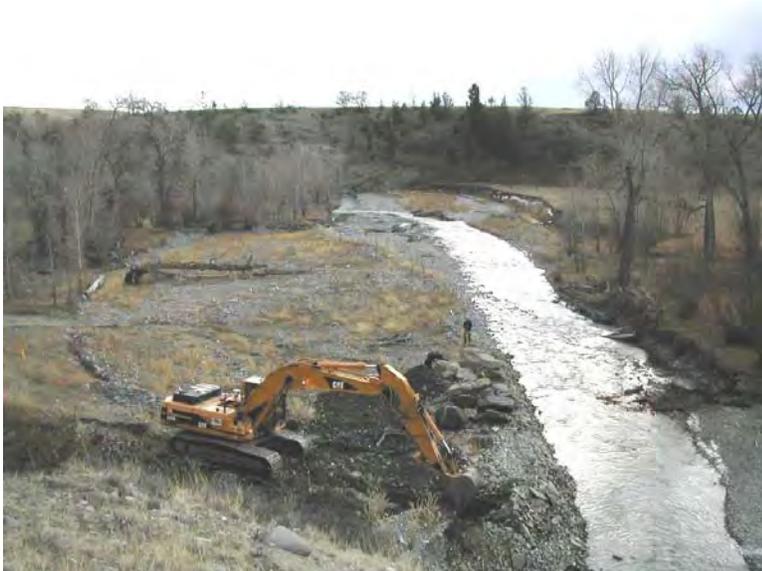
Restoration of the disturbed reach occurred in 2002. A nearby reference reach provided the parameters to develop design specifications for the altered reach. The design objective was to return the existing braided channel (Rosgen D3 classification), to a single thread C3 channel, with riffle/pool morphology. Design specifications followed the channel geometry and plan view of the reference reach.

FIGURE 9. CHANNELIZED REACH OF BIG TIMBER CREEK.

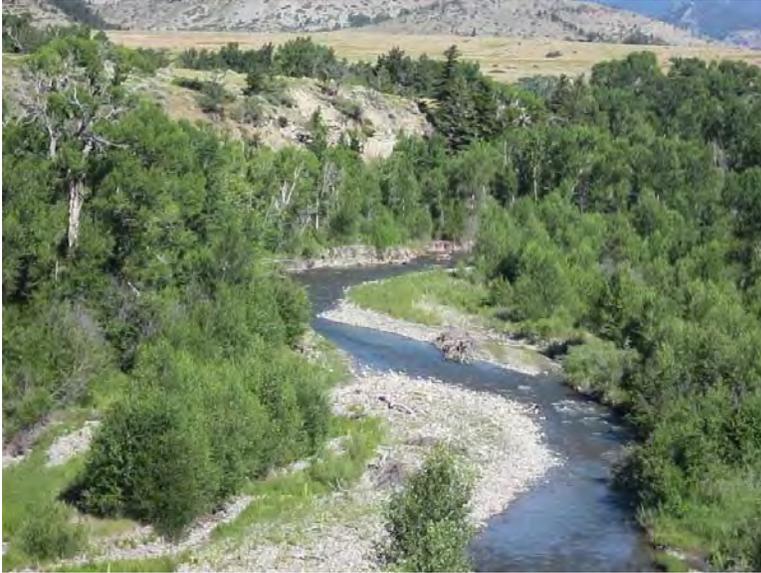
On July 6, 2016, Shannon Bockmon visited the project area, accompanied by Tom Coleman, the consultant who designed and provided oversight during the restoration. The channel was dramatically different than the pre-construction condition. Instead of the overly wide, braided, straight channel, the stream had meanders, greatly enhanced pool habitat, and recruitment of shrubs on point bars (Figure 10). This project was successful in restoring natural morphology to the stream, and improving fish habitat.

FIGURE 10. VIEW OF RESTORED REACH OF BIG TIMBER CREEK, 2016.

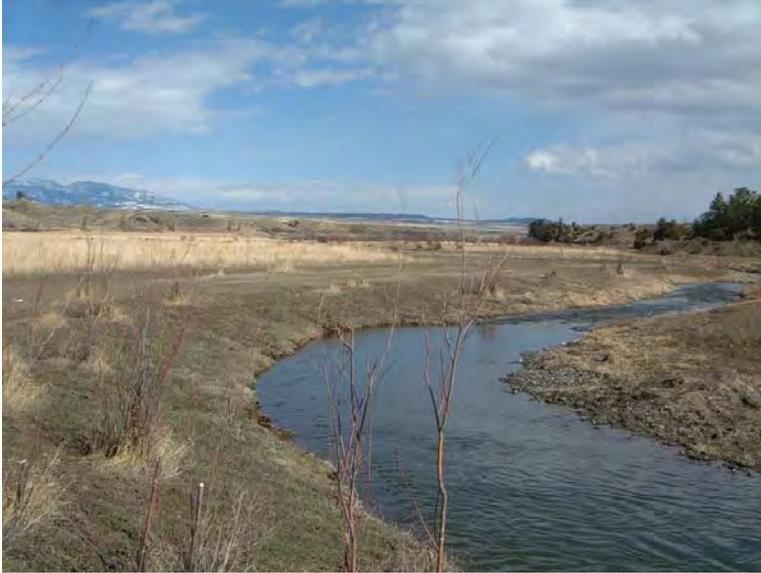
The goals were to restore Brackett Creek to the location it occupied before channelization, and to create high quality habitat for fish. A sinuous channel with a longitudinal profile that created riffles and pools was constructed within the meander scars of the historical channel. Banks were sloped at an approximately 30% grade, and were revegetated with sod harvested during channel excavation (Figure 12). Willows were harvested locally, and transplanted along the newly constructed banks.

FIGURE 12. BRACKETT CREEK RE-NATURALIZATION IMMEDIATELY POST-CONSTRUCTION.

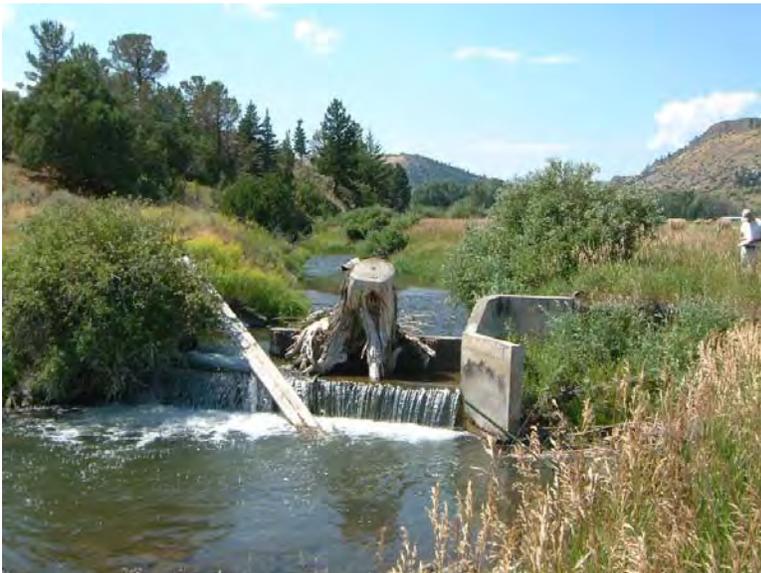
The second alteration was abandonment of an irrigation diversion that was at least a partial barrier to the upstream movement of fish (Figure 13). In the early 2000s, opening passage to allow Yellowstone cutthroat trout to move freely throughout the watershed was a management priority, so rerouting the stream away from the diversion was desirable. Since then, the presence of rainbow trout in the adjacent Shields River and Brackett Creek has changed the conservation strategy for Yellowstone cutthroat trout, with protecting the genetic integrity of Yellowstone cutthroat trout being the highest priority. Nevertheless, the project followed the management objectives of the time, and the channel was moved away from the diversion structure.

FIGURE 13. IRRIGATION DIVERSION BLOCKING FISH PASSAGE ON BRACKETT CREEK (2003).

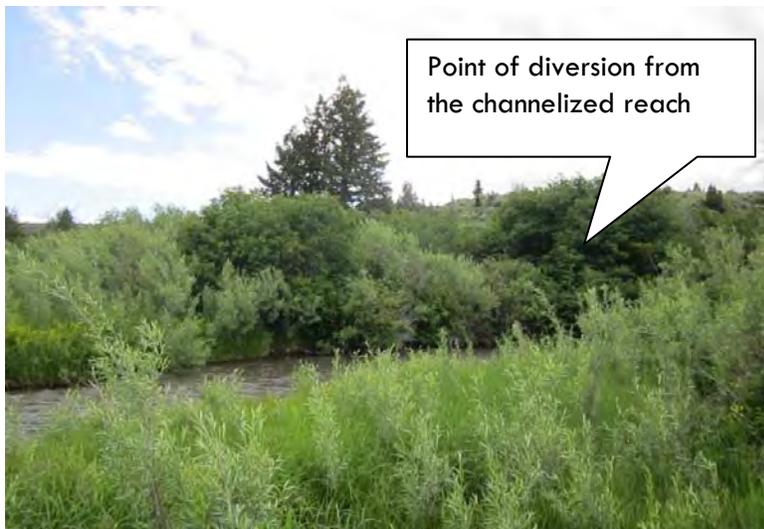
The site visit began where the plug of dense willows was placed to divert the water away from the old, straightened into the re-naturalized channel (Figure 14). Dense shrubs obscured the upstream end of the channelized reach, and provided an impenetrable barrier against the stream returning to its former location, and abandoning the reconstructed channel.

FIGURE 14. LOCATION OF PLUG THAT DIVERTED WATER AWAY FROM THE OLD CHANNEL INTO THE RE- NATURALIZED CHANNEL.
