FUTURE FISHERIES IMPROVEMENT PROGRAM

REPORT PREPARED FOR THE 2017 MONTANA STATE
LEGISLATURE AND THE FISH & WILDLIFE COMMISSION

Summary of program years 2015–2016 and anticipated future expenses

Montana Fish, Wildlife & Parks, Fisheries Division, Habitat Bureau
<http://fwp.mt.gov/fishAndWildlife/habitat/fish/futureFisheries/legislative/>

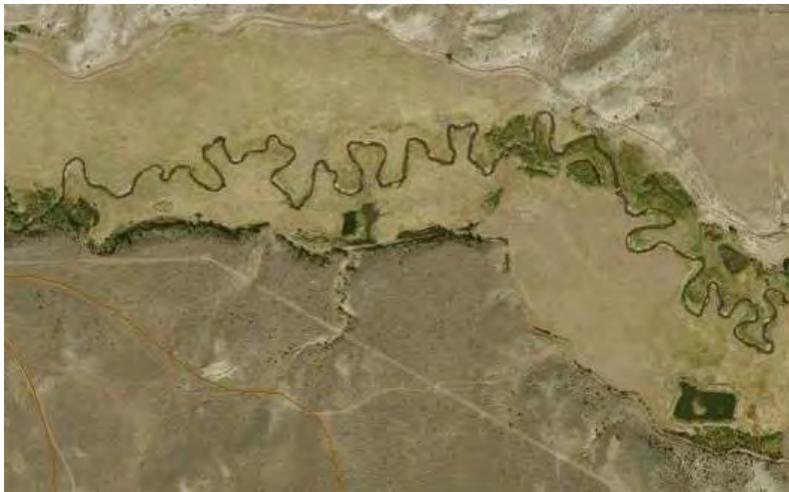
Recruitment of riparian shrubs had improved since 2007; however, most of the stream remained devoid of woody vegetation (Figure 15). Individual willows were sparsely distributed along much of the channel, with isolated willows showed heavy browse. Nonetheless, several stands of sandbar willow had become established since 2007 (Figure 16). Despite continued heavy browse pressure, willows were beginning to gain more of a foothold along the stream channel.

FIGURE 15. AERIAL IMAGERY OF RE-NATURALIZED STREAM (2015) SHOWING INTACT PLAN FORM, LIMITED RECOVERY OF SHRUBS.

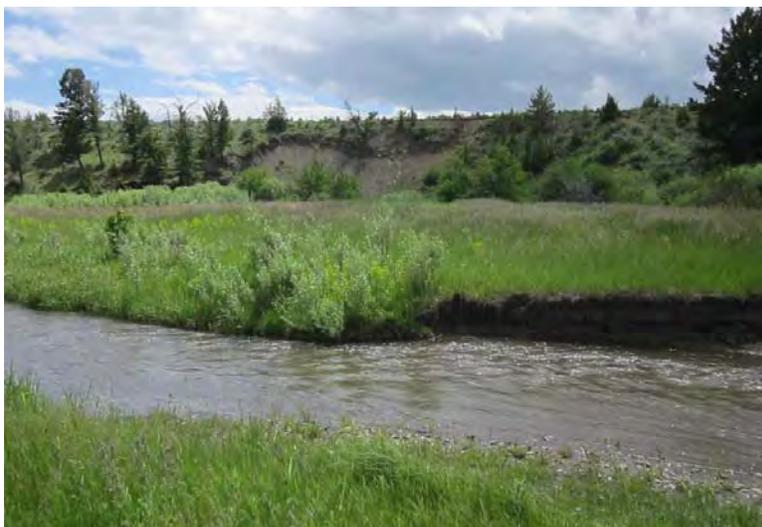
FIGURE 16. BRACKETT CREEK SHOWING WILLOW RECRUITMENT ON LEFT BANK. NOTE BANK STABILITY WHERE SEDGES OCCUPY THE CHANNEL MARGIN.

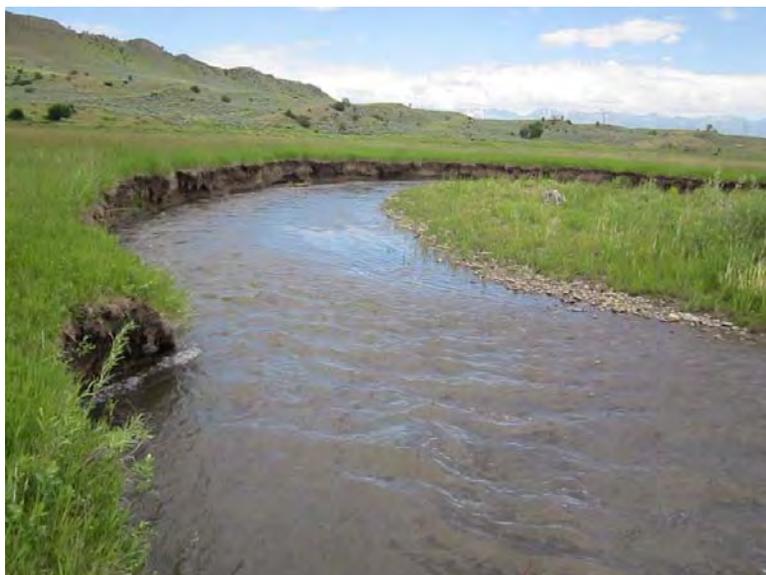
As observed in the 2007 assessment, the 80-year flood that occurred soon after channel re-naturalization resulted in considerable erosive pressure on outer meander bends, causing numerous reaches of eroding bank (Figure 17). Shallow-rooted grasses, such as smooth brome and Timothy, occupied the tops of banks, and these species do not contribute to recovery of banks, except in cases where clods of vegetated dirt calve into the stream. These vegetated clumps have potential to trap sediments, and build a new bank adjacent to the existing eroding bank; however, these features are vulnerable during floods. The ranch manager expressed concern over losing land from bank erosion. Other reaches of Brackett Creek have much higher bank retreat rates; however, the loss of land, delivery of fine sediment, channel widening, and loss of high quality bank line habitat for fish are legitimate concerns for fish and agriculture.

FIGURE 17. EXAMPLE OF ERODING OUTER MEANDER BEND ON THE RE-NATURALIZED REACH ON BRACKETT CREEK.

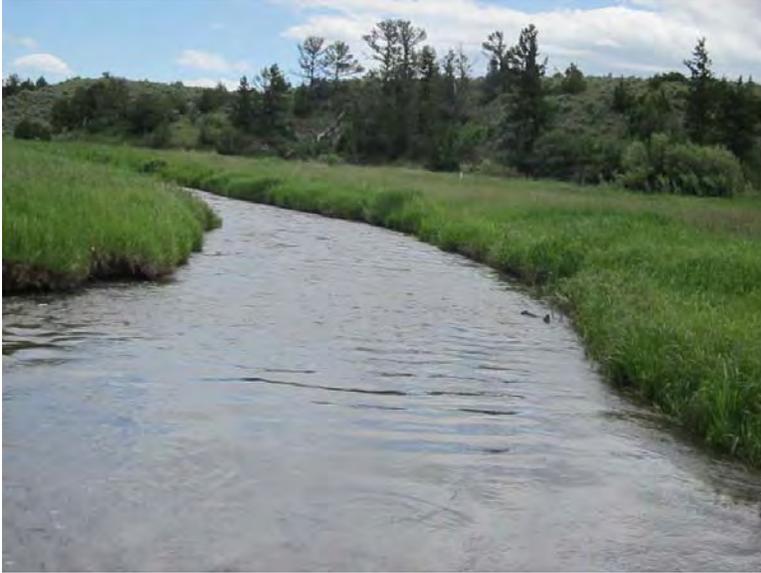
Although bank erosion was a significant feature along the re-naturalized reach, substantial portions of stream were stable, with dense sedges providing protection from elevated flows (Figure 18). These reaches were narrower and deeper than areas with eroding banks, and were consistent with the channel morphology designed for this re-naturalization project.

FIGURE 18. REACH OF RE-NATURALIZED CHANNEL SHOWING BANKS STABILIZED WITH SEDGES, AND NARROWER CHANNEL.

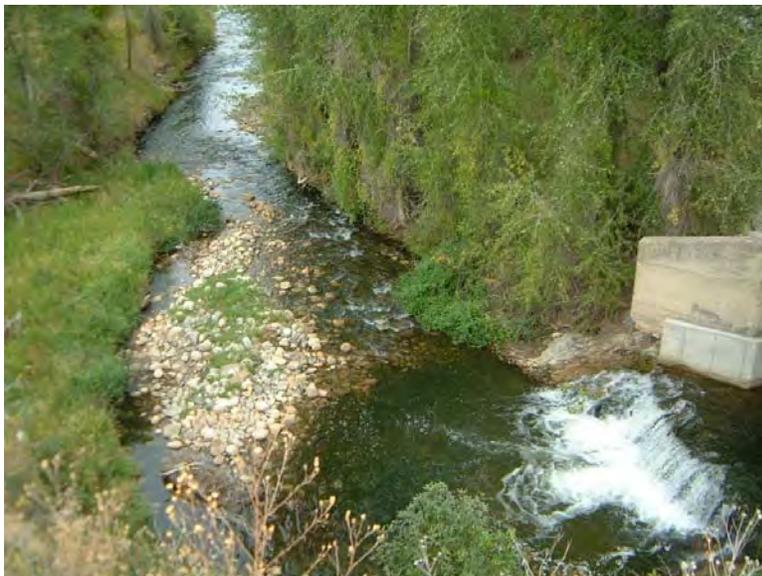
Pre-project photos illustrate the features that limited the ability to swim through the structure (Figure 19). An abrupt drop downstream of the outlet of the concrete box culvert was likely a leap barrier. In addition, rapid laminar flow and shallow water depths potentially presented a velocity barrier to the fish that were capable of leaping into the culvert.

FIGURE 19. IMPASSIBLE CULVERT ON CLEAR CREEK.

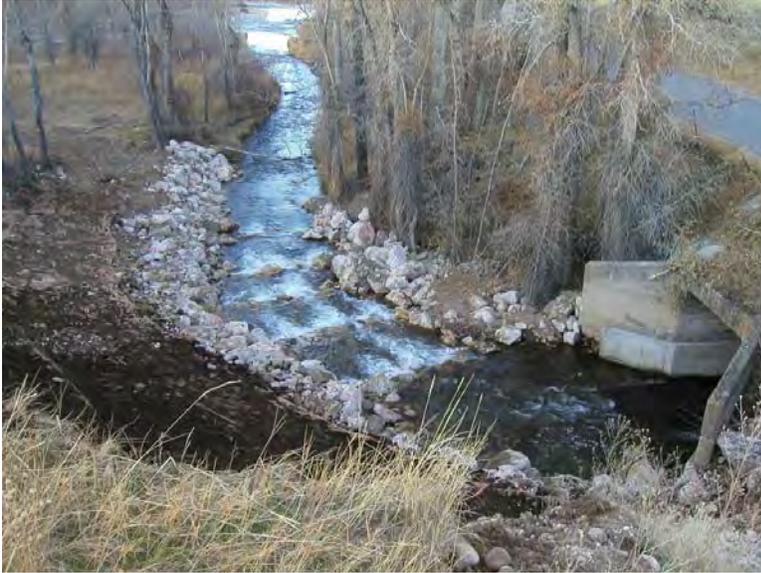
Providing passage to and through the culvert entailed narrowing the channel, and constructing a series of step-pools. Construction occurred in the fall of 2005. The step-pools provided a series of smaller leaps that provided lower velocity resting areas upstream of the leap (Figure 20). The bed elevation immediately downstream of the outlet of the culvert was raised above the existing elevation, so that fish would not have to leap to get to the culvert, and flows through the culvert were backwatered, which increased the depth, and decreased the velocity through the culvert.

FIGURE 20. POST-CONSTRUCTION PHOTO OF STEP-POOL SEQUENCE PROVIDING PASSAGE UP TO, AND THROUGH, THE

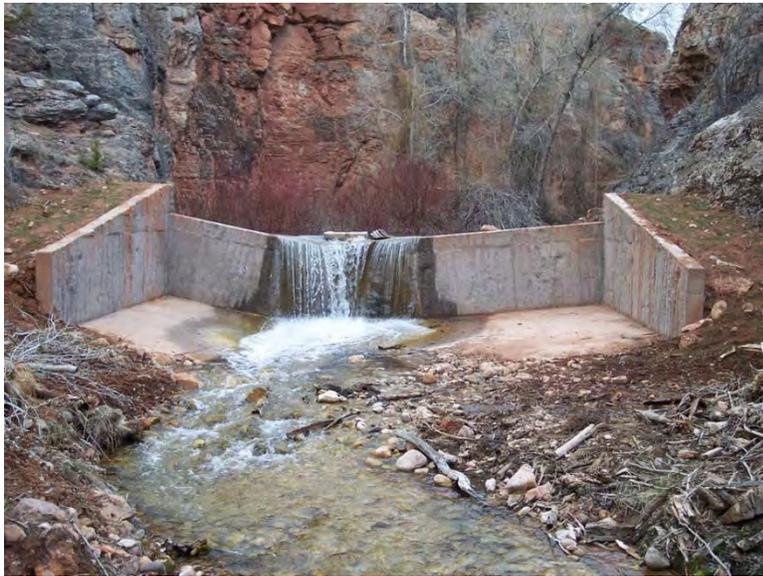
The FFIP contributed funds towards construction of the barrier within the Crooked Creek canyon (Figure 23). The barrier was a weir with a v-notch on a flat front. The apron was angled towards the center, and wing walls were constructed to prevent scour around the barrier. Public comment on the barrier included concerns over aesthetics, so the concreted was tinted and textured to match the surrounding red sandstone canyon walls.

FIGURE 23. NEWLY CONSTRUCTED BARRIER ON CROOKED CREEK, 2008.

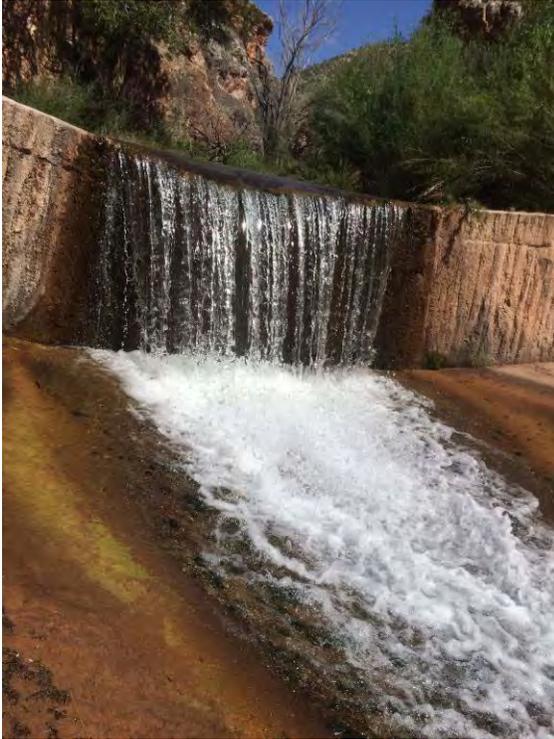
The Crooked Creek barrier showed slight signs of wear, but no structural instability. No scouring of the concrete of the apron, or splash pad, was evident (Figure 24). In the first decade after construction, bed load had been relatively slow to fill in behind the front wall of the weir, with fine sediment being the dominant particle size, and water remaining deep behind the wall for several years. By 2016, larger material had accumulated within the impounded portion of the stream, and it is now possible to walk across the accumulated cobble and gravel (Figure 25).

FIGURE 24. SPLASH PAD OF THE CROOKED CREEK BARRIER.

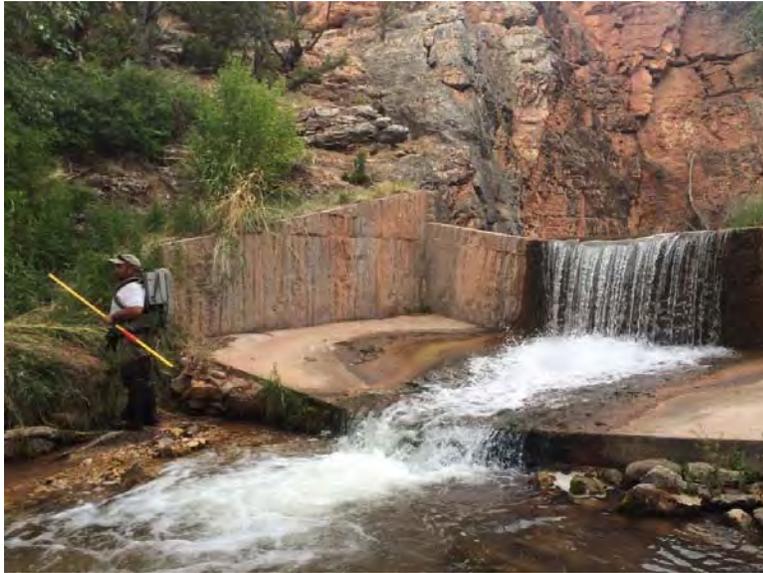
Formation of a plunge pool at the downstream end of the apron was a concern, as the turbulence could allow fish a vantage to leap over the weir. The streambed on the downstream end of the apron

remained well armored with large boulders (Figure 26). The combination of the lack of pool habitat, and shallow, high velocity flows on the apron is desirable in preventing fish from being able to pass over the barrier.

FIGURE 26. DOWNSTREAM END OF APRON SHOWING LACK OF A PLUNGE POOL.

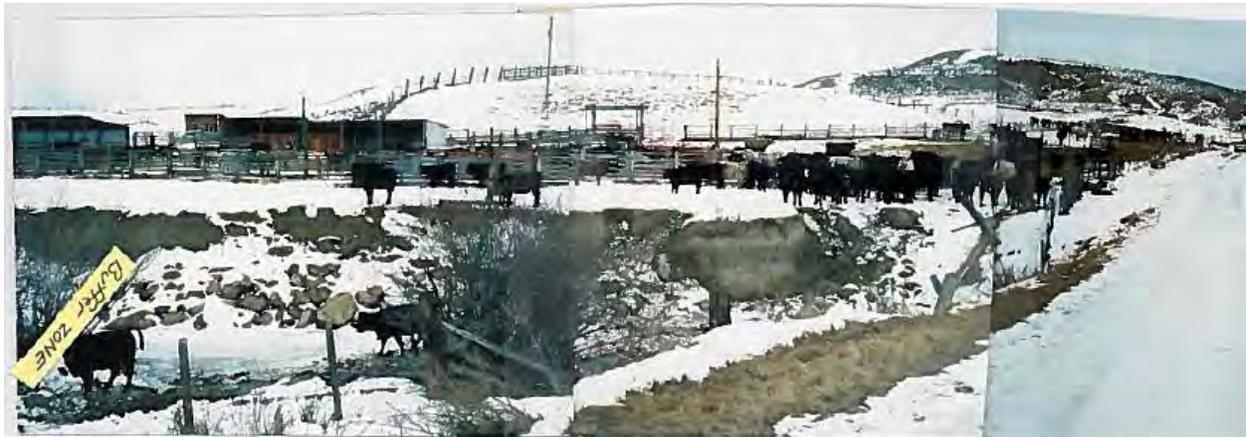
processes, biological resources, and property values, while accommodating agricultural land uses. Specific actions included development of off-stream stock water, development of a grazing management strategy, and installation of riparian fencing. The pre-project photo showed concentration of cattle on a severely impaired stream, and sparse herbaceous and woody vegetation (Figure 27).

FIGURE 27. PRE-PROJECT PHOTO OF DAISY DEAN CREEK.

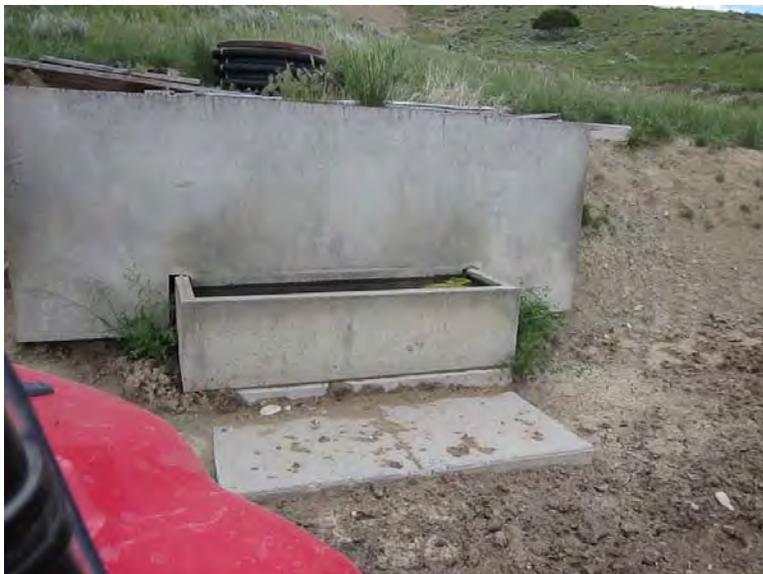
On June 14, 2016, Shannon Bockmon visited the project site to evaluate if project goals had been met, and if the conditions of the agreement were met. The landowner had installed 3 off-channel watering devices (Figure 28). Fencing excluded livestock from the stream channel, and thick stands of willows or sedges covered the stream banks (Figure 29). The channel was a narrow and deep, which are features that promote transport of sediment. The streambed is mostly fine sediment; however, this is likely the result of a limited supply for gravel recruitment, and not necessarily related to sediment inputs from upstream.

FIGURE 28. EXAMPLE OF OFF-STREAM STOCK WATER.

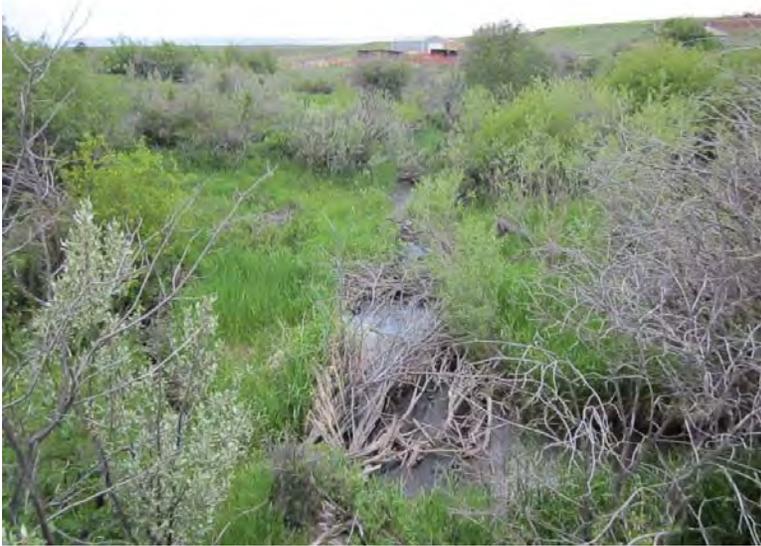
FIGURE 29. RECOVERED RIPARIAN AREA AND STREAM CHANNEL ON DAISY DEAN CREEK.

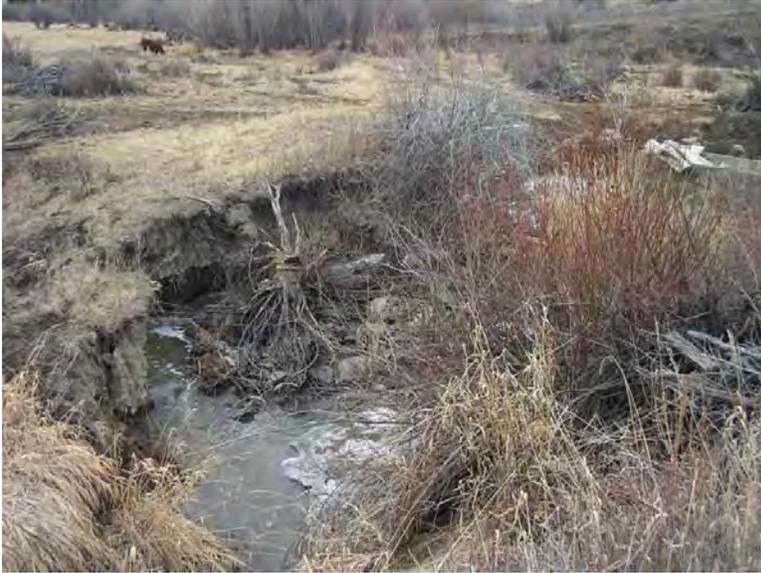
FIGURE 30. EXAMPLE OF CHANNEL DOWN-CUTTING, AND A VERTICAL BANK SLATED FOR SLOPING.

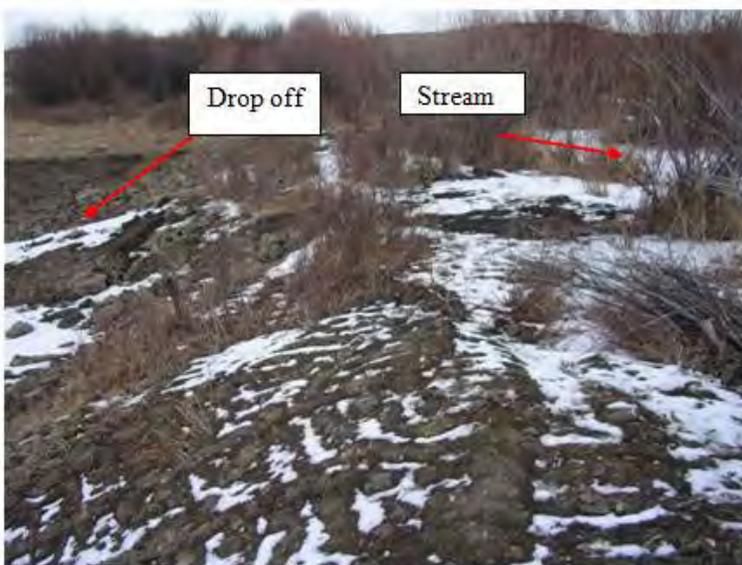
On January 23, 2007, Carol Endicott visited the project sites, accompanied by the landowner. Most of the restoration actions had been implemented at this time; however, snow and ice obscured much of the bank restoration and sod mats. This site visit was too soon after project implementation to evaluate recovery of vegetation. Moreover, winter field conditions do not reflect the health and function of a riparian area during the peak of the growing season, which also confounded evaluation of recovery. Nonetheless, the fencing, bank sloping, and off-channel water components of project were in place. A concern that emerged during this site visit was for the stability of the head-gate, which was perched at the head of the down-cut reach

FIGURE 33. PERCHED HEAD-GATE ON ELK CREEK.

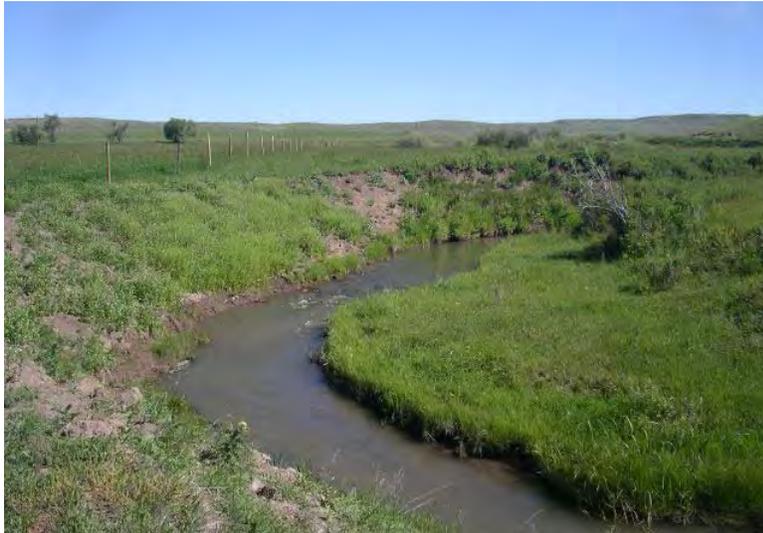
becoming established on the sloped banks and within the riparian area (Figure 34). As expected for a recently disturbed site, weeds had colonized the sloped banks; however, these plants were holding soil much better than the pre-restoration condition.

FIGURE 34. RIPARIAN FENCING, SLOPED BANKS, AND EARLY STAGE RECOVERY OF RIPARIAN VEGETATION ON ELK CREEK IN JUNE 2007.

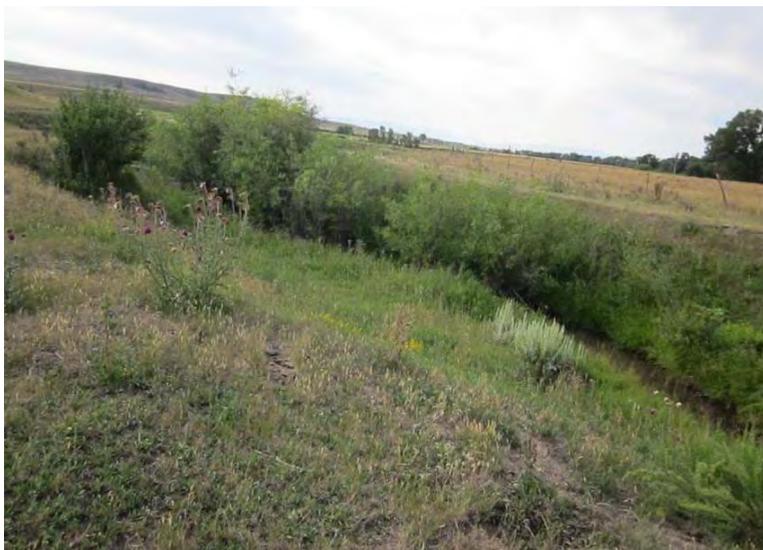
On August 9, 2016, Shannon Bockmon visited the project site with the landowner. All components had been implemented at this time. The riparian area has made a strong recovery in both streams (Figure 35), and grazing is limited to light grazing during the non-growing season. Remaining banks that had not been sloped have not migrated, and are minor features, especially compared to pre-restoration conditions.

FIGURE 35. EXAMPLE OF REDUCED EROSION AND RECOVERY OF RIPARIAN VEGETATION ALONG A MECHANICALLY SLOPED BANK.

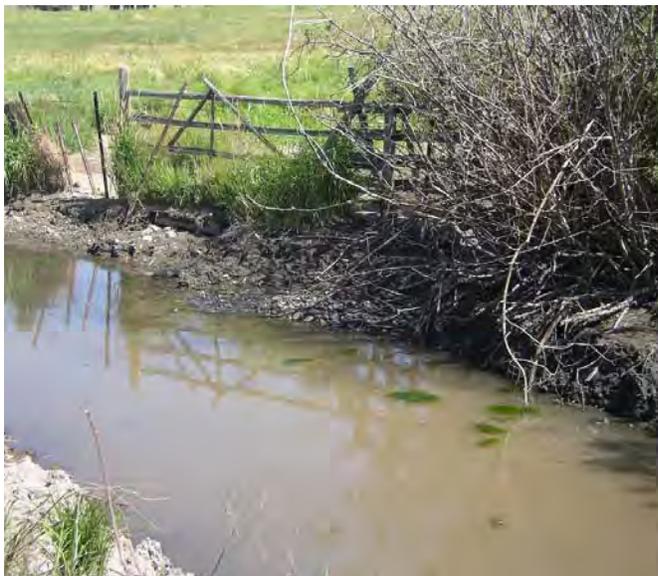
Emigrant Spring Creek is an unmapped stream that joins the Yellowstone River between Emigrant and Corwin Springs. Before restoration, livestock had considerable negative effect on riparian health and function, substrate composition, stream morphology, and habitat for fish (Figure 36). Field surveys found low numbers of Yellowstone cutthroat trout and rainbow trout spawning in Emigrant Spring Creek, but neither species appeared to spawn in the stream yearly. Because it maintains adequate flow throughout the summer, this stream had potential to support a spawning run of Yellowstone cutthroat trout and rainbow trout.

FIGURE 36. EMIGRANT SPRING CREEK BEFORE RESTORATION.

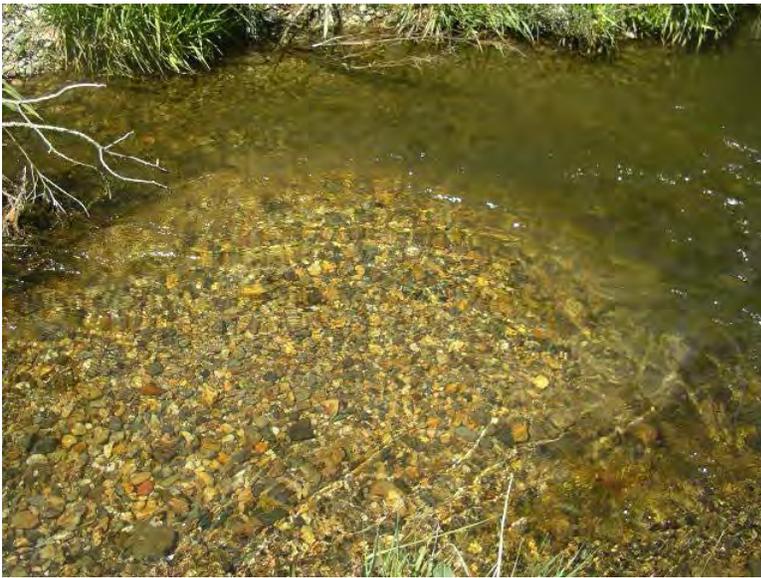
In 2007, FWP counted redds and made observations on the health and function of the riparian area, channel stability, and streambed material. Yellowstone cutthroat trout and rainbow trout were likely using Emigrant Spring Creek, and the great size of some of the redds suggested superimposition of several redds (Figure 37). Most of the redds were downstream of the restored reach, although “test redds” or digs, were found throughout the restored reach (Figure 38). For much of the stream, bed material was suitable for spawning, the riparian area was functioning, and the channel was stable. The light grazing pressure did not have an appreciable effect on stream conditions.

FIGURE 37. EXAMPLE OF NEWLY CONSTRUCTED REDD IN EMIGRANT SPRING CREEK IN 2007.

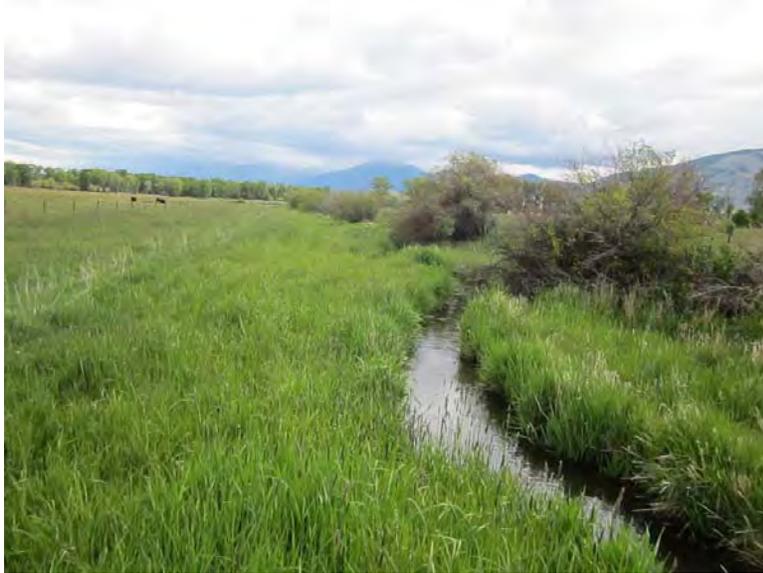
On May 26, 2016, FWP field observers Shannon Bockmon and Carol Endicott walked the length of the riparian enclosure and restored reach. Riparian vegetation, primarily sedges, which are typical of spring creeks with saturated soils, remained dense, and effective at protecting stream banks from erosion (Figure 39). The grazing management plan allowed for grazing within the riparian enclosure. Manure within the enclosure indicated cattle grazing occurred within the riparian enclosure; however, grazing pressure was light, and there was no evidence of hoof shear, or other disturbance to stream banks. Sandhill cranes had a nest adjacent to the stream, within the dense sedges.

FIGURE 39. EXAMPLE OF RESTORED REACH SHOWING THE NARROW AND DEEP CHANNEL, AND DENSE SEDGES STABILIZING BANKS.

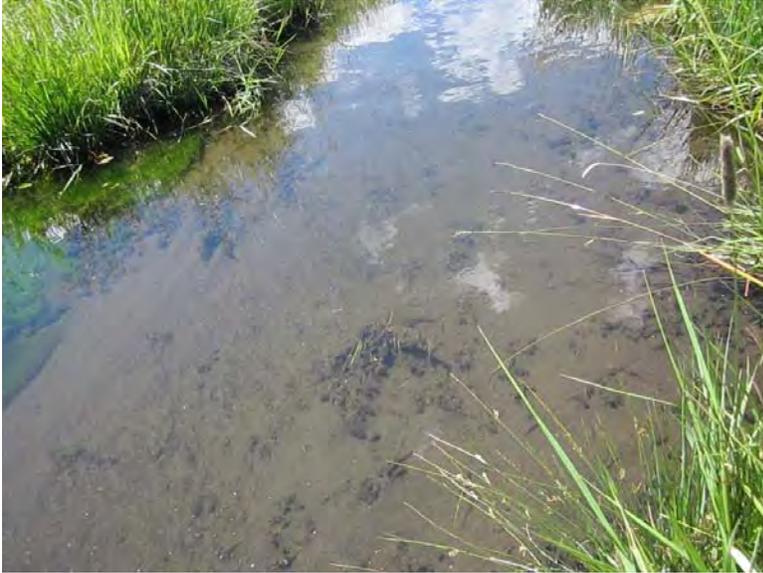
A substantial change in bed material occurred since the 2007 assessment. In 2007, clean spawning gravel was present along most of the restored reach, and in relatively high gradient reaches downstream of the restored reach. By 2006, the gravel bed in the restored reach had been buried under 4 to 6 inches of muck, which rendered this reach unsuitable for spawning (Figure 40). Suitable spawning gravel remains in the higher gradient reach downstream of the restored reach (Figure 41).

FIGURE 40. EXAMPLE OF EXTREME SILTATION OF STREAMBED IN RESTORED REACH.

Multiple sources may be contributing to accumulation of fine sediment within the restored reach. Given enough time, atmospheric deposition of fines may be sufficient to create the current conditions, and as

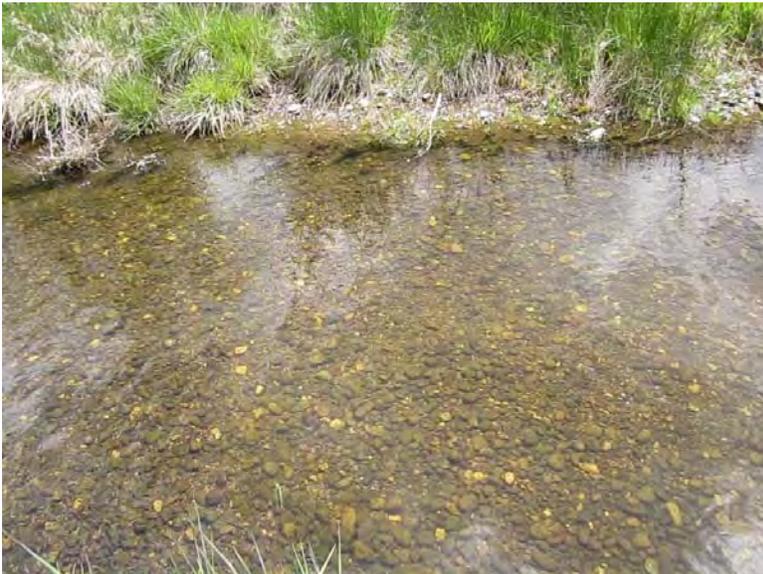
FIGURE 41. GRAVEL SUITABLE FOR SPAWNING DOWNSTREAM OF THE RESTORED REACH.

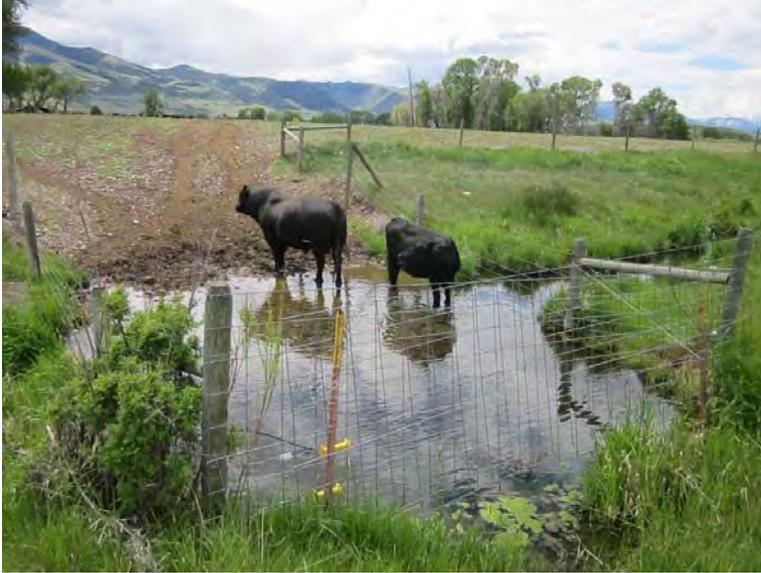
A component of the grazing management plan was installation of a water gap to allow cattle limited access to the stream (Figure 42). The water gap is effective at controlling livestock, while providing stock water. The water gap restricts cattle to about 20 feet of stream in order to access water.

FIGURE 42. WATER GAP ALLOWING CATTLE ACCESS TO WATER.

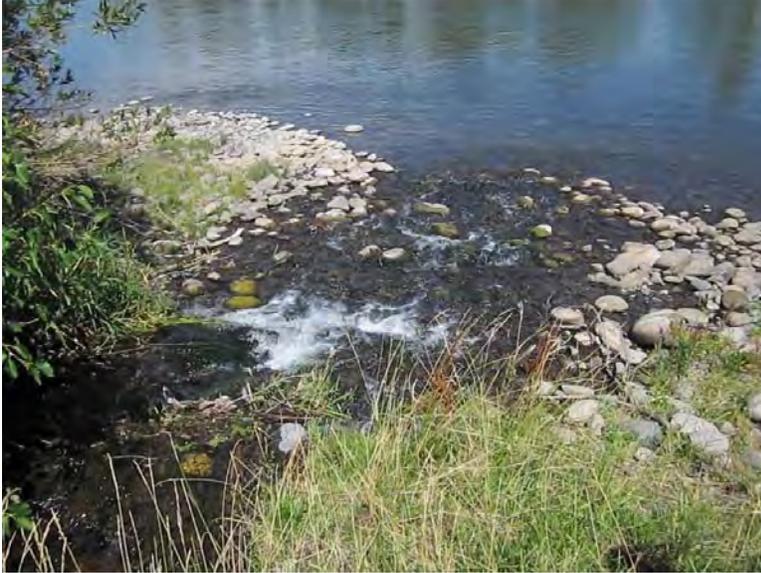
FIGURE 44. CONFLUENCE OF ESP SPRING CREEK WITH THE YELLOWSTONE RIVER, SHOWING ABSENCE OF CONSTRUCTED STEP-POOLS.

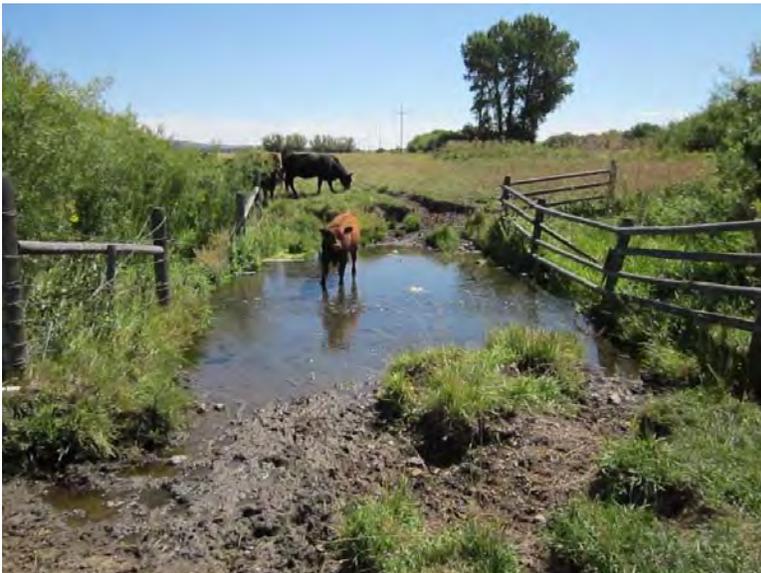
FIGURE 45. WATER GAP ON ESP SPRING CREEK.

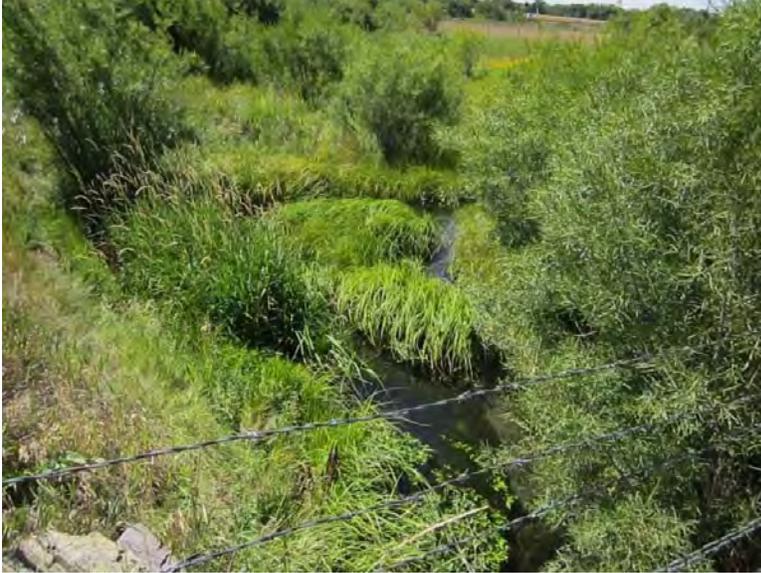
Channel reconfiguration, riparian area recovery, and availability of spawning habitat continued to meet the goals for high quality habitat. Dense willows occupied the riparian area and substantially exceeded what was present pre-project (Figure 46). Fencing livestock off the channel, except for at a water gap (Figure 45), promoted riparian health and vigor. Hardening with addition of gravel would decrease sediment loading from this discrete location. Likewise, the channel retained the constructed plan form and width-to-depth ratios. The stream supported numerous areas with high quality spawning gravel (Figure 47). Macrophytes occupied much of the stream; however, stream flow is sufficient to limit growth of aquatic plants, and flush sediment through the stream.

FIGURE 46. RESTORED AND FENCED REACH OF ESP SPRING CREEK.

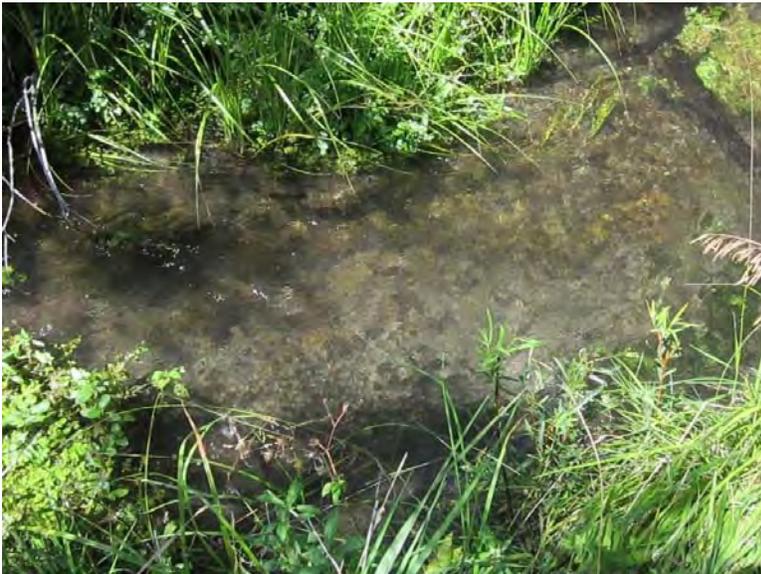
FIGURE 47. PATCH OF SPAWNING GRAVEL

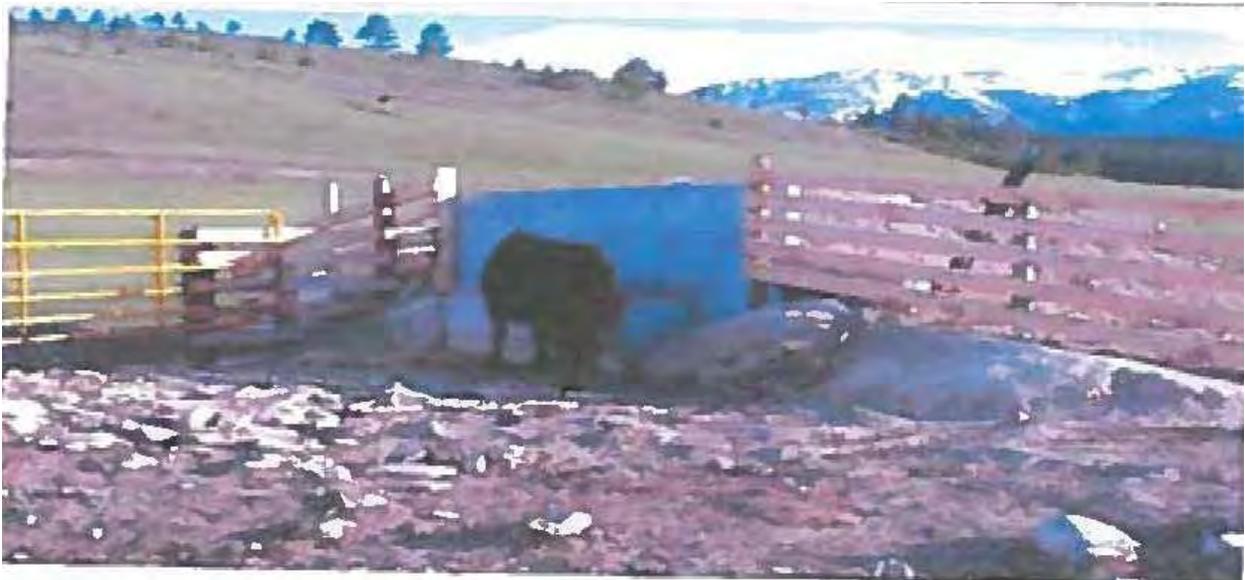
The goal was to improve water quality, by decreasing nutrient, sediment, and thermal loading to Fishtail Creek. This project entailed moving a corral off-stream, and providing stock water at the new location. The corral experienced heavy use by livestock, and had considerable accumulation of manure, and negligible vegetation to trap sediment or nutrients before entering the stream (Figure 48). Runoff from the new corrals would be diverted away from the stream. Other components included installation of watering devices within the new, off-channel corrals.

FIGURE 48. VIEW OF THE CORRAL THAT WAS ON FISHTAIL CREEK.

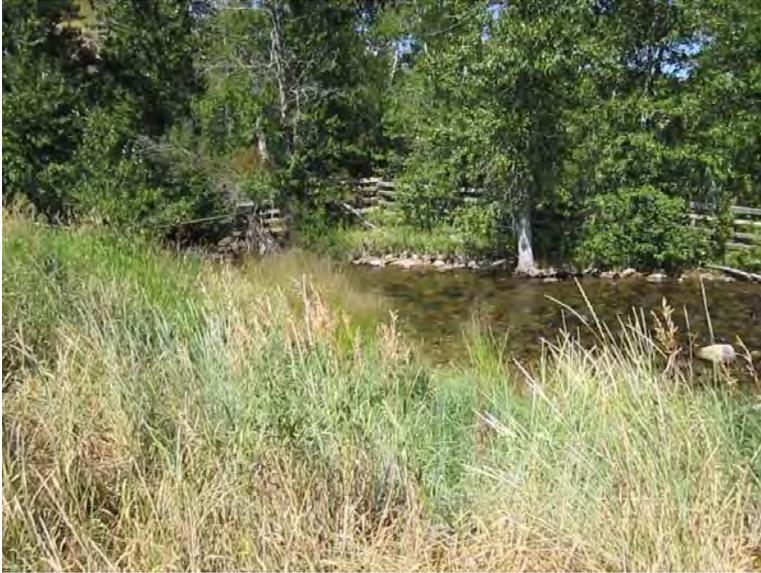
On August 11, 2016, Shannon Bockmon, accompanied by the landowner, evaluated the Fishtail Creek corral relocation project. The corral had been moved, and the berm that redirected runoff away from the stream had been constructed, and remained functional. The riparian area had improved substantially since project implementation, and aspens were beginning to recruit (Figure 48). Weeds remained a problem within the footprint of the former corral, although efforts to control weeds are ongoing. The landowner found the off-channel watering devices to be superior to watering stock from the stream. With the exception of last winter, the holding tank has not frozen. Determination of whether the watering device has a heated element to keep stock water from freezing would be useful. These features are optional in commercially available livestock waterers.

FIGURE 49. FORMER LOCATION OF CORRALS ON FISHTAIL CREEK.

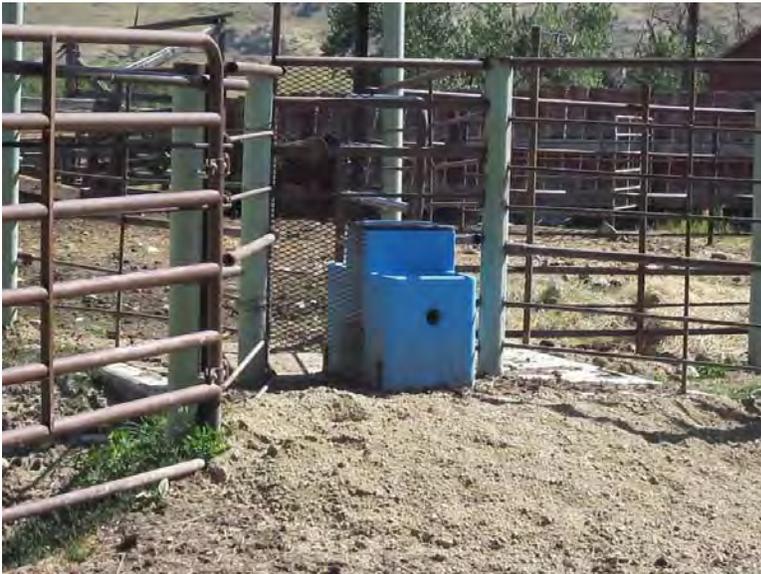
FIGURE 50. OFF-STREAM LIVESTOCK WATERING DEVICE IN THE CORRAL ADJACENT TO FISHTAIL CREEK.

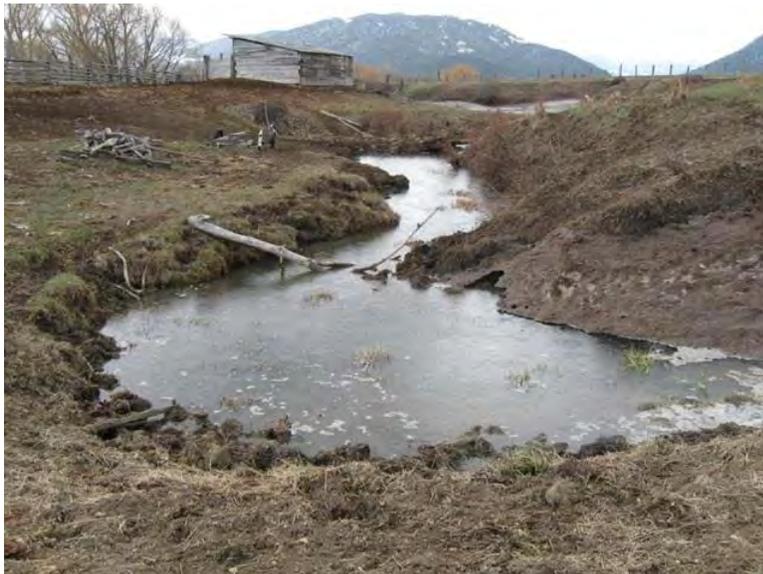
Livestock use in the project area had been heavy for decades, resulting in severe degradation of riparian health and function, extreme siltation, and a lack of channel definition for much of its length (Figure 51). The deep accumulation of mud within the existing channel made electrofishing challenging, as fieldworkers wading the stream would get bogged in the mud. In addition, actively eroding terraces were contributing large quantities of fine sediment (Figure 52). Decades of accumulation of manure adjacent to the stream was a source of nutrients, which further contributed to degraded water quality.

FIGURE 51. PRE-RESTORATION VIEW OF FLESHMAN CREEK.

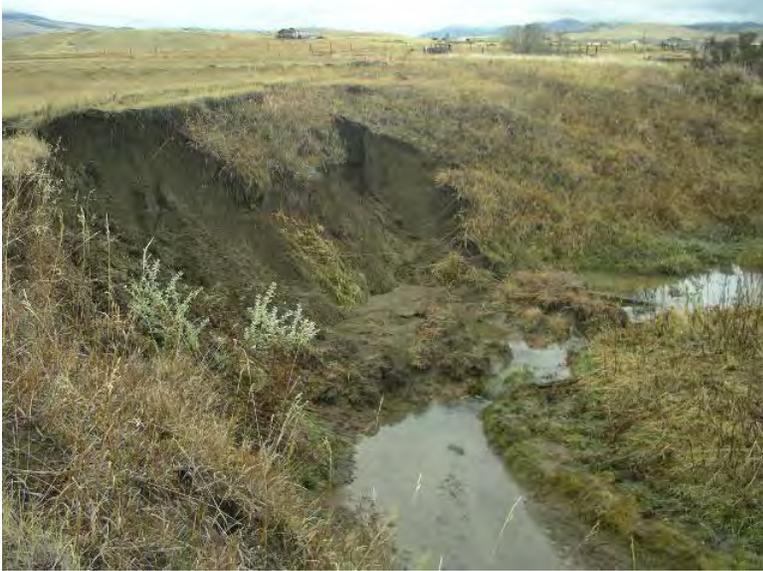
FIGURE 52. EXAMPLE OF AN ERODING TERRACE ON FLESHMAN CREEK WITHIN THE PROJECT AREA.

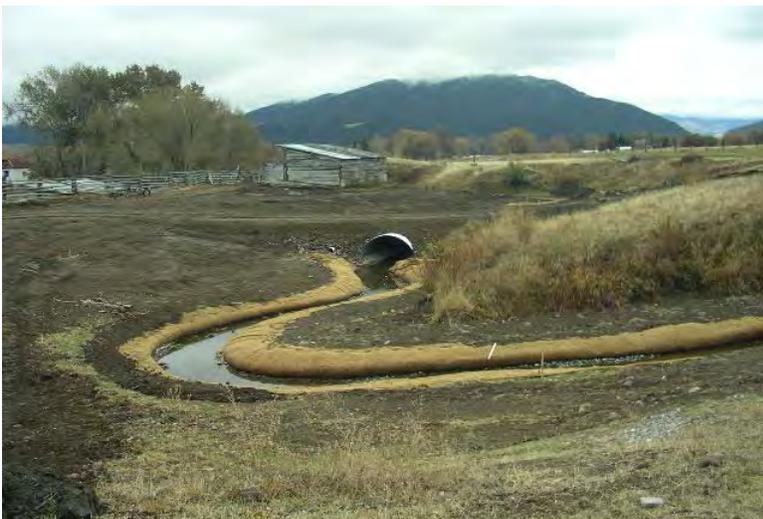
FIGURE 53. EXAMPLE OF NEWLY CONSTRUCTED CHANNEL ON FLESHMAN CREEK AND STREAM CROSSING WITH BOTTOMLESS ARCH CULVERT AND OVERFLOW PIPES.

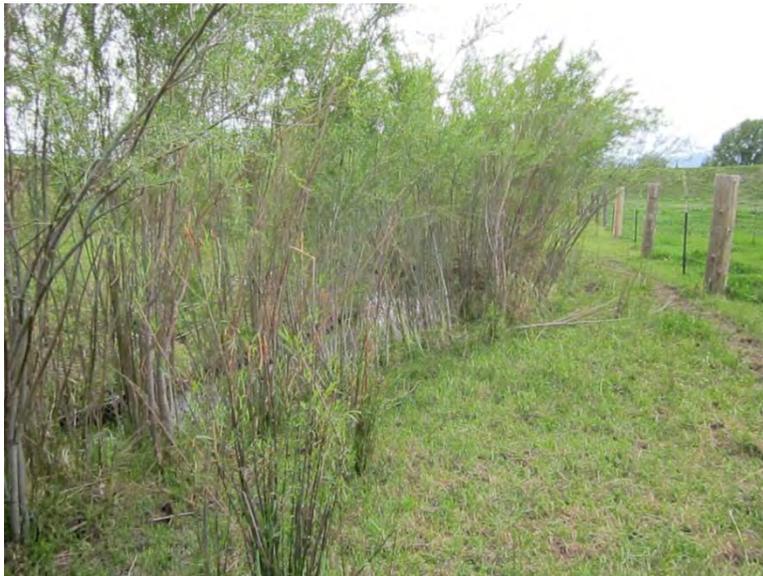
On June 2, 2016, Shannon Bockmon and Carol Endicott visited the Fleshman Creek restoration project, and documented remarkable improvement from pre-project conditions, and evidence that the restoration efforts were effective in restoring Fleshman Creek. The riparian fencing was in place (Figure 54), as were the off-channel water sources.

FIGURE 54. RIPARIAN FENCING INSTALLED TO CONTROL LIVESTOCK AROUND FLESHMAN CREEK.

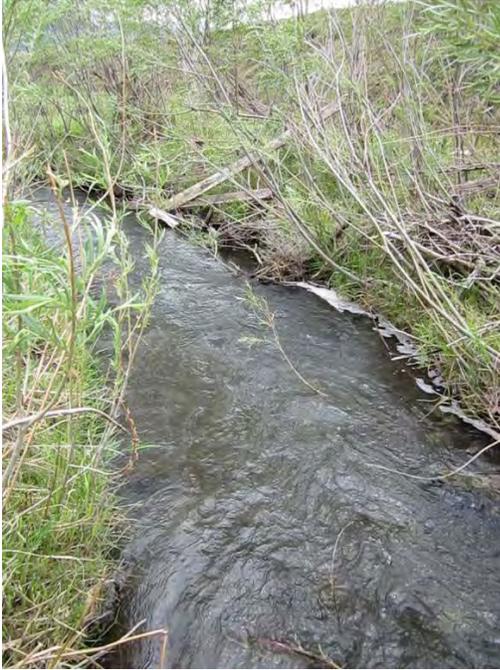
The channel was relatively narrow and deep, and other than the formation of desirable, undercut banks, minimal lateral movement had occurred since the channel was constructed in 2009 (Figure 55). Willow survival and recruitment was impressive, with well established stands of willows exceeding 9 feet occurring along most of the stream. In the few locations where willows had not become established, the coir fabric and seeding was effective in creating a stream bank that was indistinguishable from a natural bank (Figure 56).

FIGURE 55. EXAMPLE OF CONSTRUCTED RIFFLE, ESTABLISHED WILLOWS, AND UNDERCUT BANKS ON FLESHMAN CREEK.

Although the current condition was a marked improvement from pre-project conditions, livestock were having a small, but noticeable effect on stream banks. Localized areas of bank trampling and stock trails were present at several locations. Consultation with NRCS on the grazing management strategy developed for this site, and evaluation of modifications to limit trailing are warranted to protect the investment.

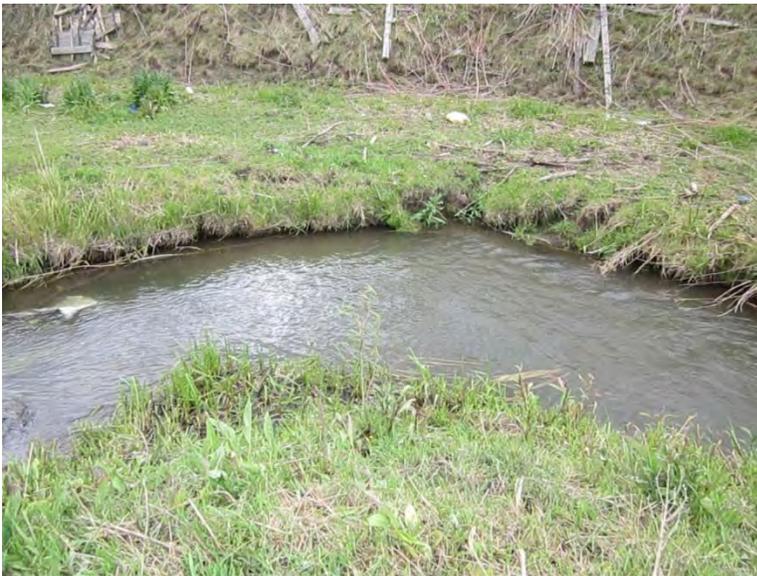
FIGURE 56. OUTER MEANDER BEND SHOWING STABLE BANK CONSTRUCTED WITH COIR FABRIC ENCAPSULATED SOIL LIFTS. (NOTE THAT PHOTO WAS TAKEN IN EARLY JUNE, AND GROUND COVER WAS BEGINNING TO GROW FOR THE SEASON.)

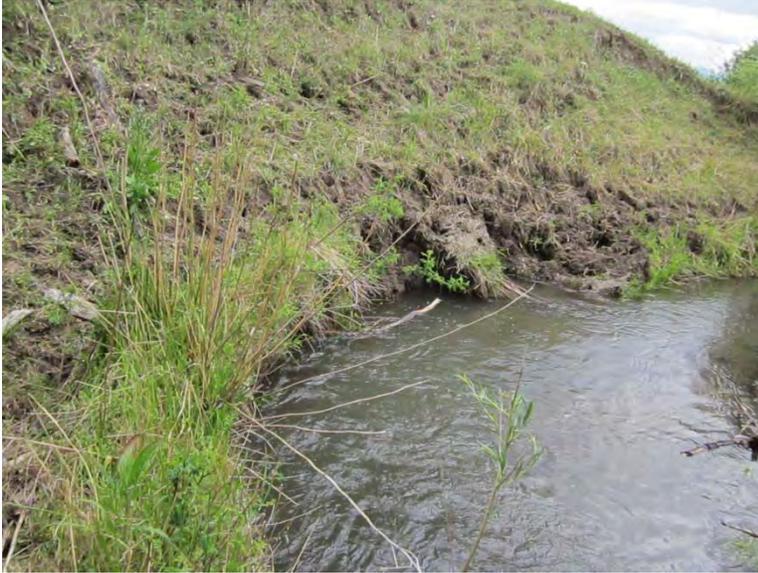
FIGURE 57. BANK TRAMPLING AND STOCK TRAILS ON FLESHMAN CREEK.

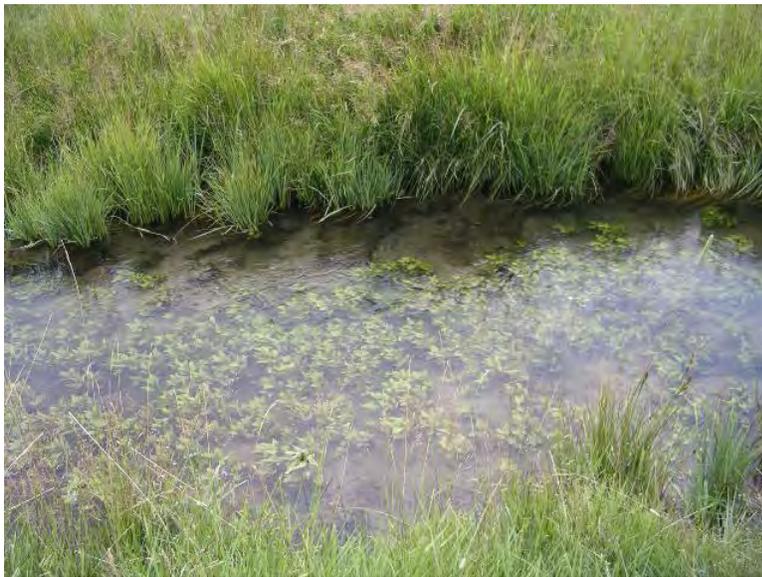
Before project implementation, channel morphology and gradient varied along the length of Kickabuck Spring Creek. In its upper half, the stream had low gradient, a relatively wide and shallow channel, and a mud streambed (Figure 58). In the lower half of the stream, the channel became deeper and narrower (Figure 59). The higher gradient exposed gravel suitable for spawning (Figure 60).

FIGURE 58. TYPICAL CHANNEL MORPHOLOGY IN THE UPPER HALF OF KICKABUCK SPRING CREEK BEFORE ENHANCEMENT.

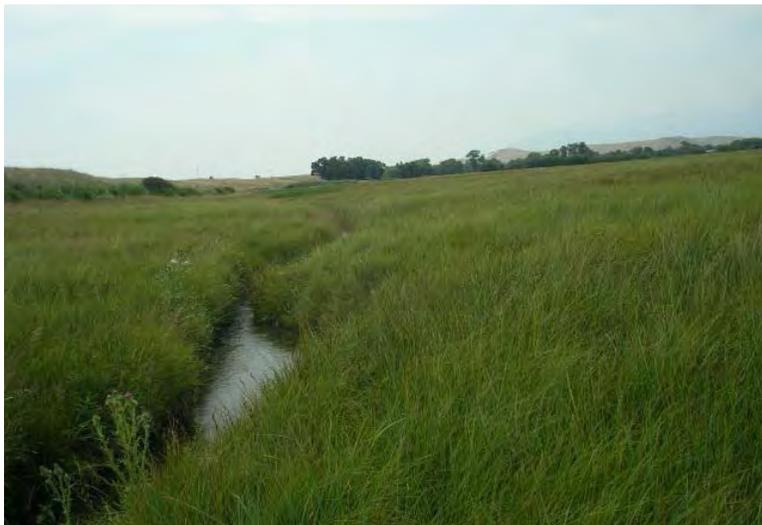
FIGURE 59. TYPICAL CHANNEL MORPHOLOGY IN LOWER HALF OF KICKABUCK SPRING CREEK.

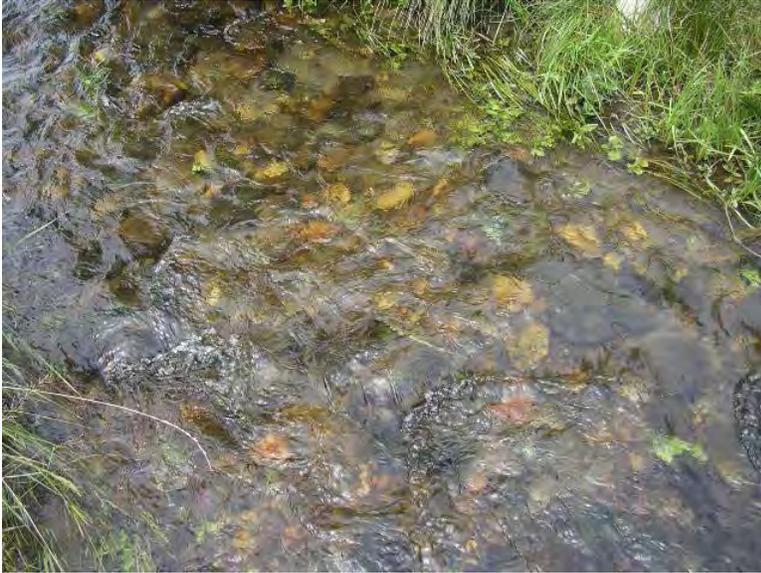
FIGURE 60. STREAMBED IN THE LOWER HALF OF KICKABUCK SPRING CREEK.

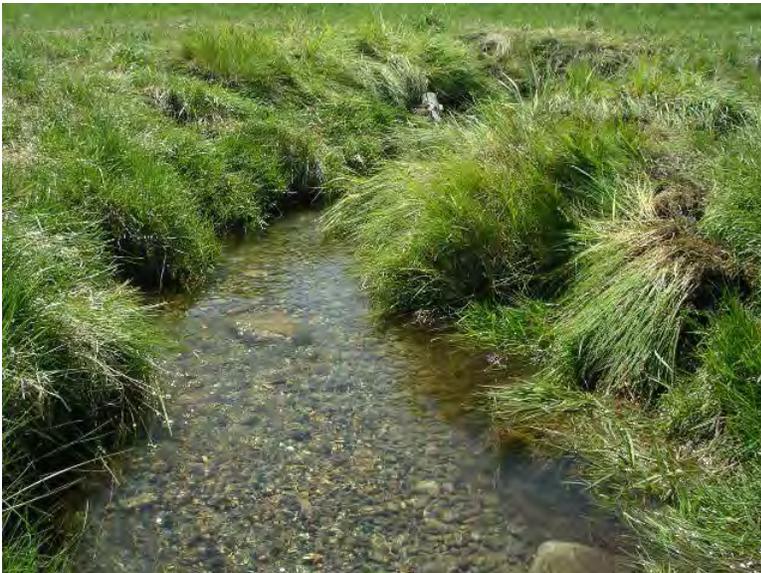
Kickabuck Spring Creek has been visited several times since construction. For several years, the channel cross-sectional dimensions (Figure 61) and plan form (Figure 62) remained unchanged, and spawning gravel was exposed and clean. In late fall of 2009, the stream teemed with juvenile mountain whitefish, which was atypical, as whitefish typical seek larger water to overwinter. Subsequent visits during the Yellowstone cutthroat trout spawning season did not yield observations of fluvial fish or redds.

FIGURE 61. RECONSTRUCTED CHANNEL AND IMPORTED SPAWNING GRAVEL.
