FUTURE FISHERIES IMPROVEMENT PROGRAM

REPORT PREPARED FOR THE 2017 MONTANA STATE
LEGISLATURE AND THE FISH & WILDLIFE COMMISSION

Summary of program years 2015–2016 and anticipated future expenses

Montana Fish, Wildlife & Parks, Fisheries Division, Habitat Bureau
<http://fwp.mt.gov/fishAndWildlife/habitat/fish/futureFisheries/legislative/>

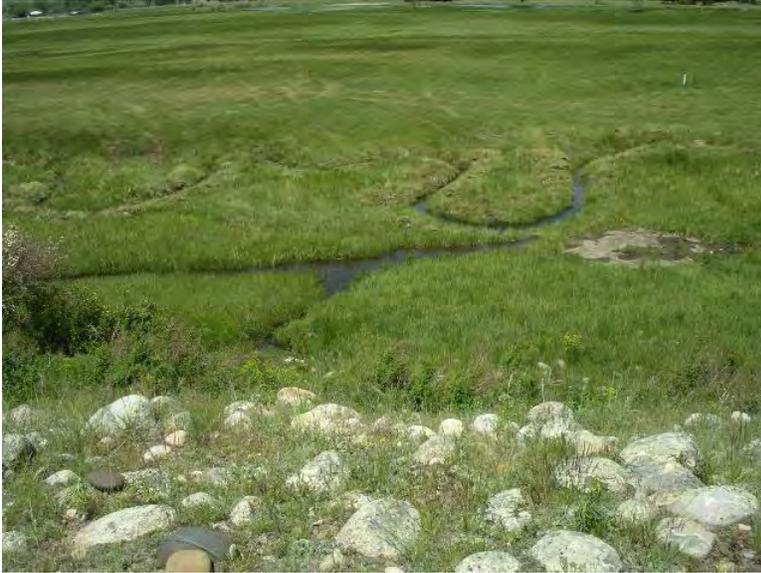
Kickabuck Spring Creek has been visited several times since construction. For several years, the channel cross-sectional dimensions (Figure 61) and plan form (Figure 62) remained unchanged, and spawning gravel was exposed and clean. In late fall of 2009, the stream teemed with juvenile mountain whitefish, which was atypical, as whitefish typical seek larger water to overwinter. Subsequent visits during the Yellowstone cutthroat trout spawning season did not yield observations of fluvial fish or redds.

FIGURE 62. VIEW OF THE RECONSTRUCTED PLAN FORM ON KICKABUCK SPRING CREEK.

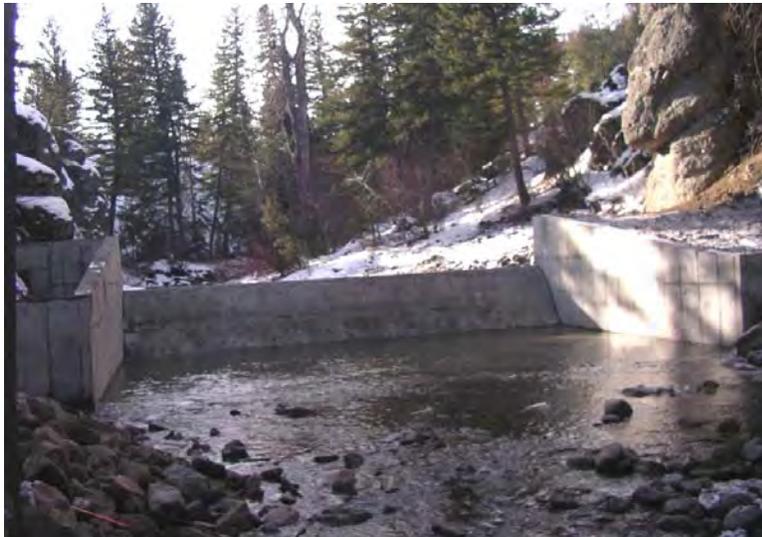
FIGURE 63. NEWLY CONSTRUCTED BARRIER ON LOWER DEER CREEK.

The barrier was constructed in November 2010. In spring of 2011, high snowpack and spring rains resulted in peak flows approaching a 500 year flood. Examination of the barrier after this event found the pool upstream of the barrier had filled in entirely with cobbles, which was desirable, as flow and debris will not exert pressure on the wall in future floods. Conversely, cobbles had accumulated on the downstream apron, which caused concerns for backwatering or providing roughness that would allow nonnatives to breach the barrier. An old wheelbarrow became jammed against the upstream wall of the barrier, and bed load transported over the wheelbarrow scoured a hole in the concrete of the apron. This scour hole was repaired the following summer.

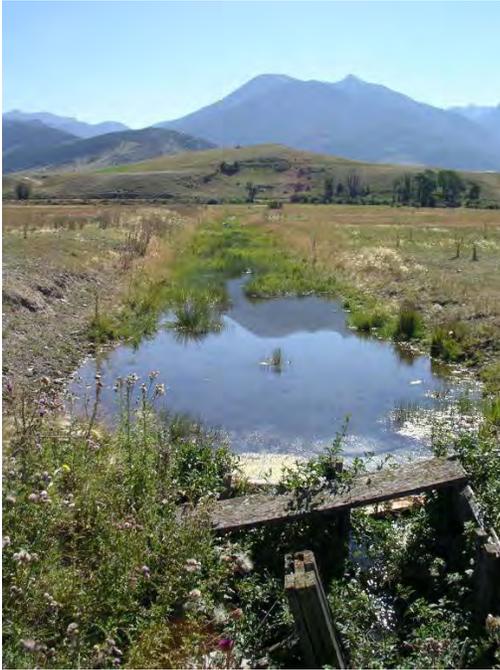
Nelson/Dana Spring Creek (also known as Nelson Ditch) is a small stream that joins the Yellowstone River just south of Livingston, MT. Several springs feed this stream, and historically, the entire site likely was a patchwork of emergent wetlands within ancient river meanders. The flows had been routed through several channels that had been substantially altered from their historical condition, and did not provide suitable habitat for fish (Figure 64). Presumably, the ditches were excavated to capture and route groundwater, which would lower the water table, and replace wetland with pastureland. The channels were overly wide, and had a mud substrate. Riparian vegetation was limited to sedges

FIGURE 64. PRE-PROJECT PHOTO OF AN EXCAVATED CHANNEL FEEDING THE NELSON/DANA SPRING CREEK.

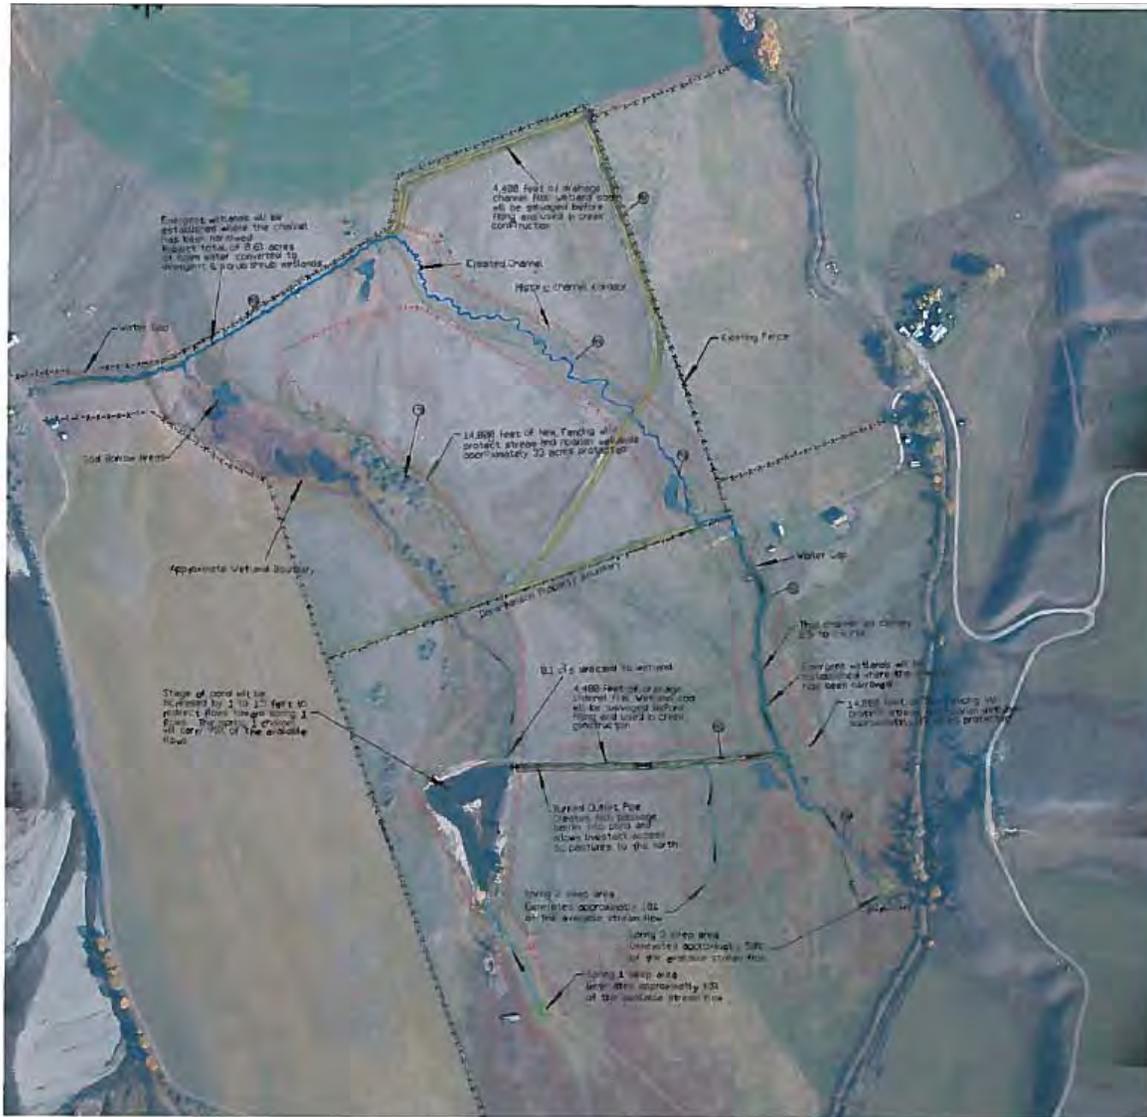
The landowners were interested in enhancing the fish and wildlife resource values of this aquatic feature, with emphasis on creating spawning habitat for Yellowstone River resident fish. Specific actions varied among the 7 reaches delineated within the project area (Figure 65). Typical treatments included narrowing and deepening channels, excavating pools, providing woody debris, construction of new banks with sod mats, construction of reaches of channel, and willow plantings.

- R1 - Reach length - 362 ft**
Treatments for this reach will be discontinuous. Wide areas will be narrowed and pool cover enhanced through excavations and addition of shrub and woody debris cover. Sloosity = 1:1
Channel width = 25 ft
Slope = 0.0018

FIGURE 65. DESIGNS FOR THE NELSON/DANA SPRING CREEK RESTORATION.

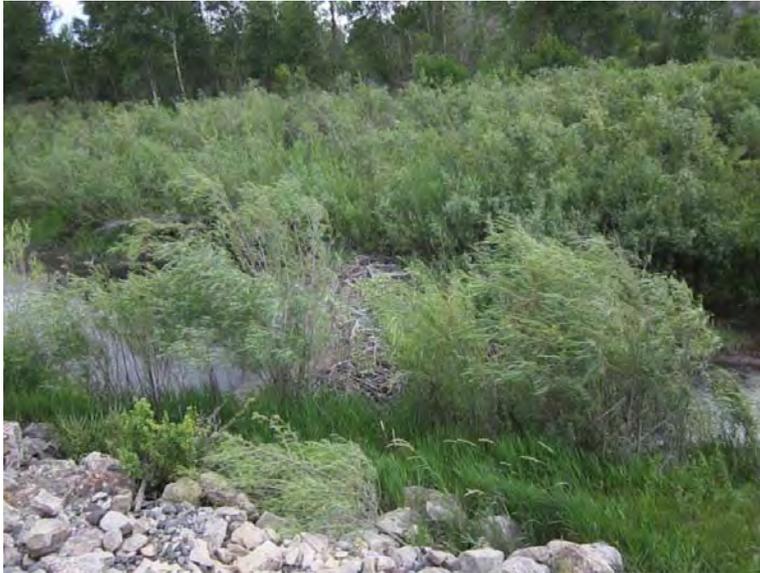
On July 5, 2016, Shannon Bockmon visited the Nelson/Dana Spring Creek project, accompanied by the landowner. A beaver dam near the mouth was the first feature noted (Figure 66). According to the landowner, high flows in the Yellowstone River remove beaver dams near the mouth in most years; however, low peak flows did not flush out the dam. He also reported seeing Yellowstone cutthroat trout ascending the spring creek in most years.

FIGURE 66. BEAVER DAM ON NELSON/DANA SPRING CREEK.

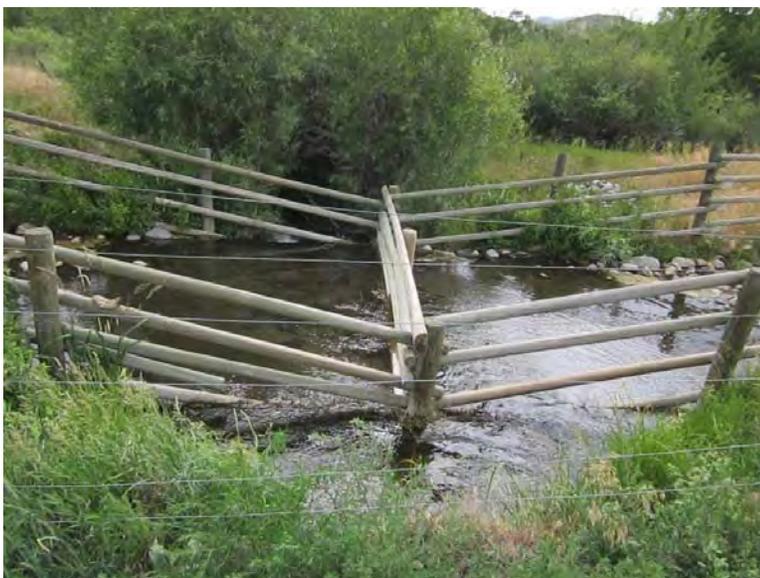
Installation of a hardened water gap was a component of the project that allowed livestock access to water, while protecting the riparian area and stream banks (Figure 67). Outside this small area of livestock access, the riparian area was thriving. A mature, thick stand of willows provided considerable benefit to the stream and fisheries by shading the stream, providing overhead cover, and maintaining channel stability.

FIGURE 67. WATER GAP FOR WATERING LIVESTOCK ON NELSON/DANA SPRING CREEK.

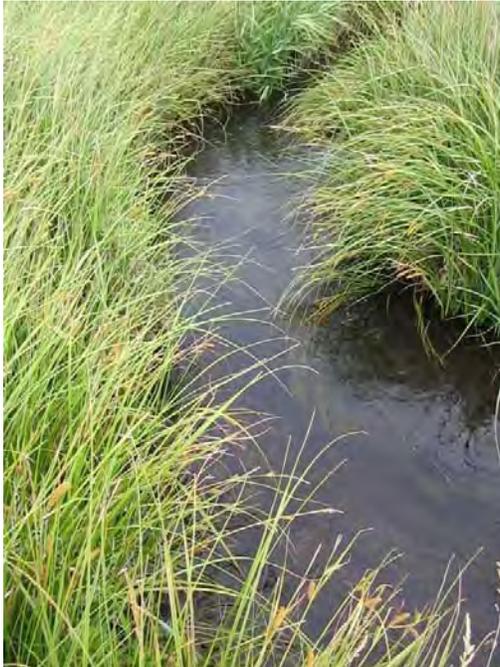
The constructed and enhanced stream channel had maintained its narrow and deep cross-sectional morphology for the stream's entire length (Figure 68). The sedge banks provided considerable undercut bank

habitat. Aquatic macrophytes, which are typical of spring creeks, were dense in places; however, sufficient flow existed to limit their cover, and areas of spawning gravel remained exposed.

FIGURE 68. TYPICAL VIEW OF THE CONSTRUCTED AND ENHANCED CHANNEL ON NELSON/DANA SPRING CREEK.

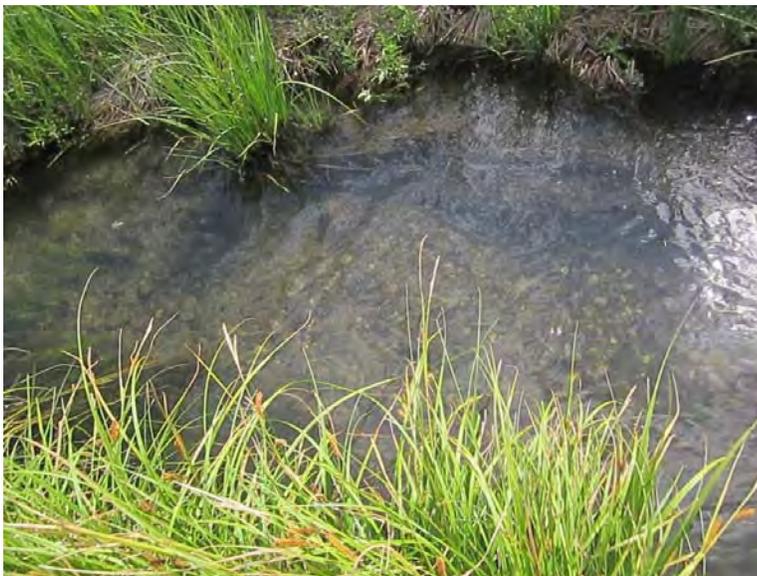
FIGURE 69. SPAWNING GRAVEL IN NELSON/DANA SPRING CREEK.

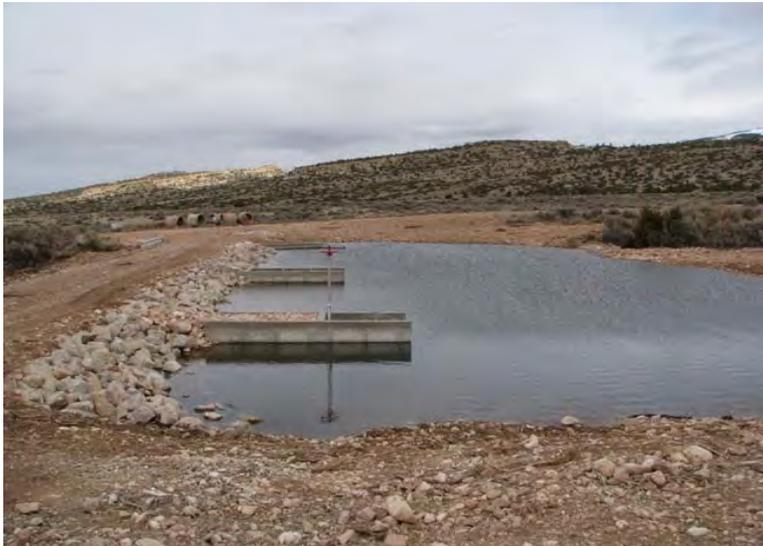
Prevention of entrainment entailed construction of a berm to reactivate a pond in an existing depression, and installing standpipes that delivered water to the irrigation canals (Figure 72 and Figure 73). Waterman gates controlled inflows to the pipes. Fry and juvenile fish would be unlikely to be in the water column, near the top of the standpipe, and would not risk entrainment. Likewise, adult fish would be less likely to enter the standpipes, compared to the irrigation ditches, which were indistinguishable from natural streams. The creation of a large pool stored water for irrigation, but also increased overwintering habitat, and provided standing water habitat that was not present previously.

FIGURE 73. STORAGE POND AND GATED STAND PIPES SOON AFTER CONSTRUCTION.

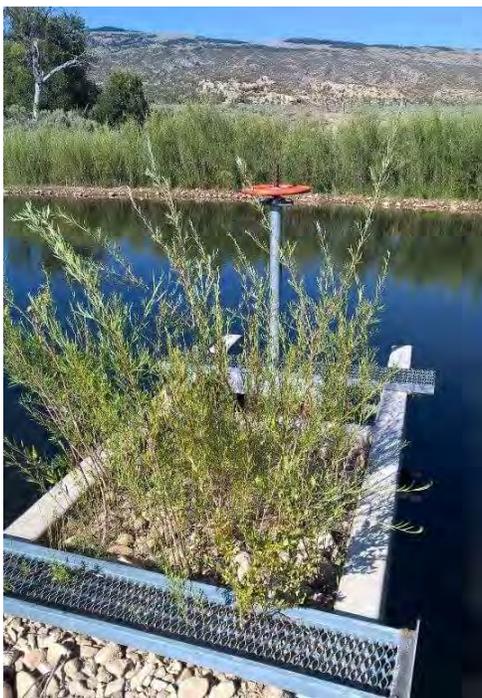
The pond was full and delivering water to the canal through the gated standpipes (Figure 74). Numerous, relatively large Yellowstone cutthroat trout were visible in the pond. Willows had colonized the perimeter of the pond. This type of aquatic feature is rare to absent in this arid landscape, and provides a patch of habitat diversity.

FIGURE 74. STAND PIPE DIVERSION, AND INLET OF PINEY CREEK INTO THE STORAGE POND.

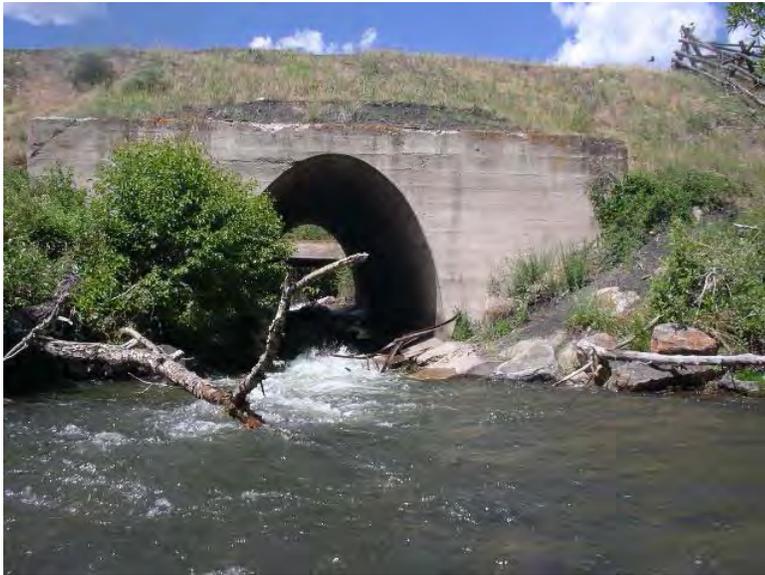
Rock Creek is a tributary of the Yellowstone River, and is located downstream of Corwin Springs, in upper Paradise Valley. In the early 1900s, the Northern Pacific Railroad Company constructed a concrete culvert that funneled Rock Creek under the rail line that ran from Livingston to Gardiner. This culvert was 70 feet long and had a slope of 7.5%. The combined length and velocity of water flowing through this structure made it a barrier to upstream movement, and fluvial Yellowstone cutthroat trout were excluded from spawning in Rock Creek. In the late 1970s, a fish ladder was installed, and connectivity was restored for several years, and substantial numbers of Yellowstone cutthroat trout fry were documented outmigrating from Rock Creek. This ladder failed in the early 1980s. As the culvert floor scoured, and debris clogged the culvert, some Yellowstone cutthroat trout were likely able to swim through the culvert, owing to the increased complexity and roughness. Nevertheless, these would need to be especially strong swimmers. Fry monitoring in 2009 found no fry upstream of the culvert.

FIGURE 75. RAILROAD CULVERT ON ROCK CREEK.

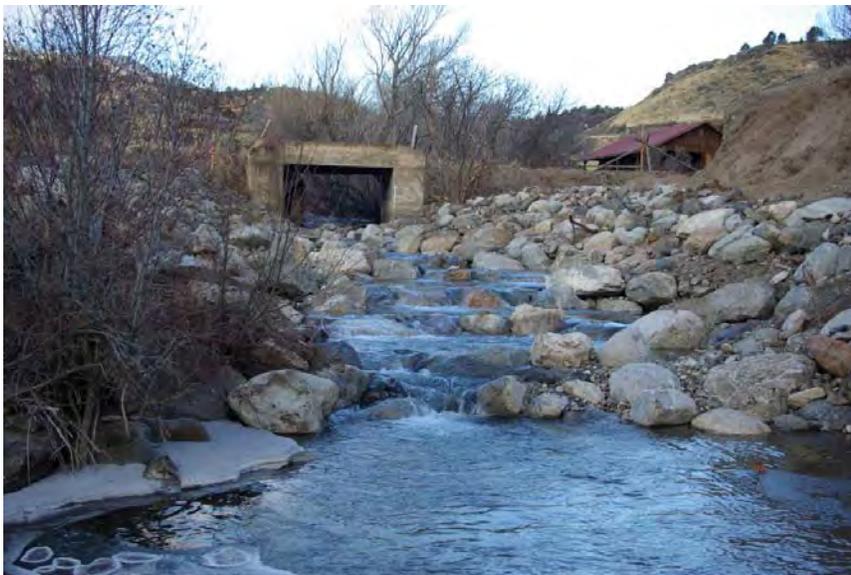
The solution to provide passage into Rock Creek was to remove the culvert, and construct a series of step-pools through the former footprint of the steep culvert (Figure 76). Design considerations included ensuring rock was large enough to remain in place, and placed so that current refugia existed at the channel margins at high flows.

FIGURE 76. NEWLY CONSTRUCTED STEP-POOL SEQUENCE.

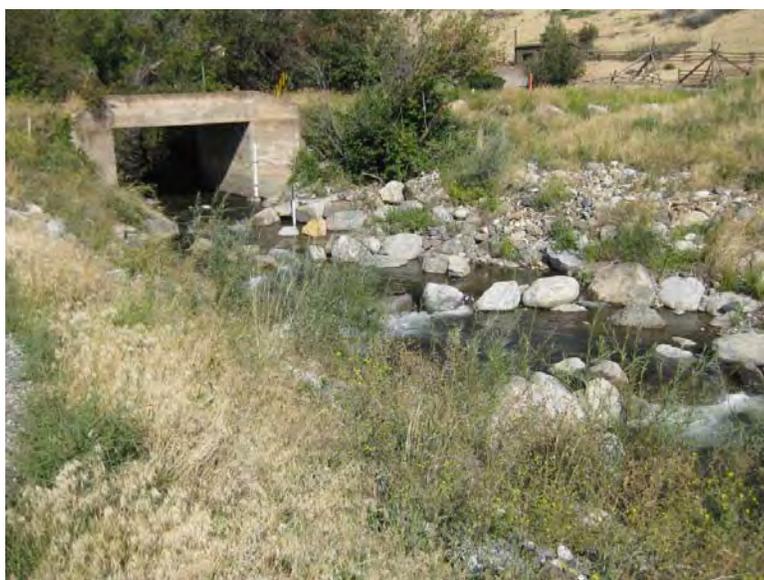
In 2014, Michelle McGree, Jim Darling, and Carol Endicott evaluated the step-pool and the recovery of vegetation planted on the surrounding railroad berm. The boulders remained in place, and the feature appeared passable. Willows were beginning to recruit along the stream margin, and upland plantings on the re-sloped sides of the berm were doing well.

FIGURE 77. STEP-POOL SEQUENCE CONSTRUCTED TO PROVIDE FISH PASSAGE INTO ROCK CREEK.

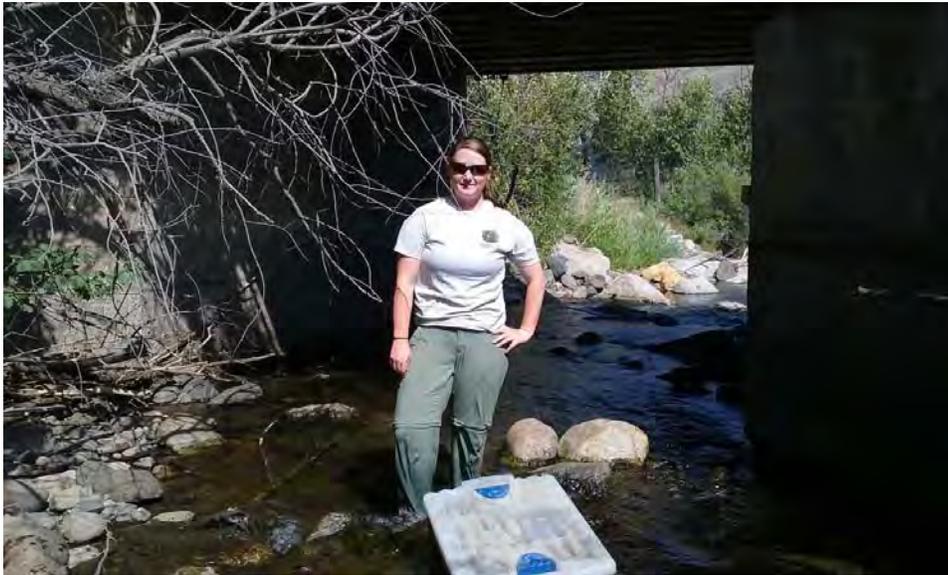
As the step-pool structure had remained unchanged since the last assessment, monitoring in 2016 focused on fry recruitment. From August 3, 2016 through August 12, 2016, a fry trap was deployed upstream of the county road bridge (Figure 78). Fry traps consist of a rectangular frame, with a funnel net that leads to PVC pipes that in turn empty into a perforated, plastic box (Figure 79). The frame is set where it can capture the bulk of the stream flow.

FIGURE 78. LOCATION OF FRY TRAP ON ROCK CREEK, UPSTREAM OF CONSTRUCTED STEP-POOLS. SHANNON BOCKMON IS READY TO PROCESS TRAPPED FRY.

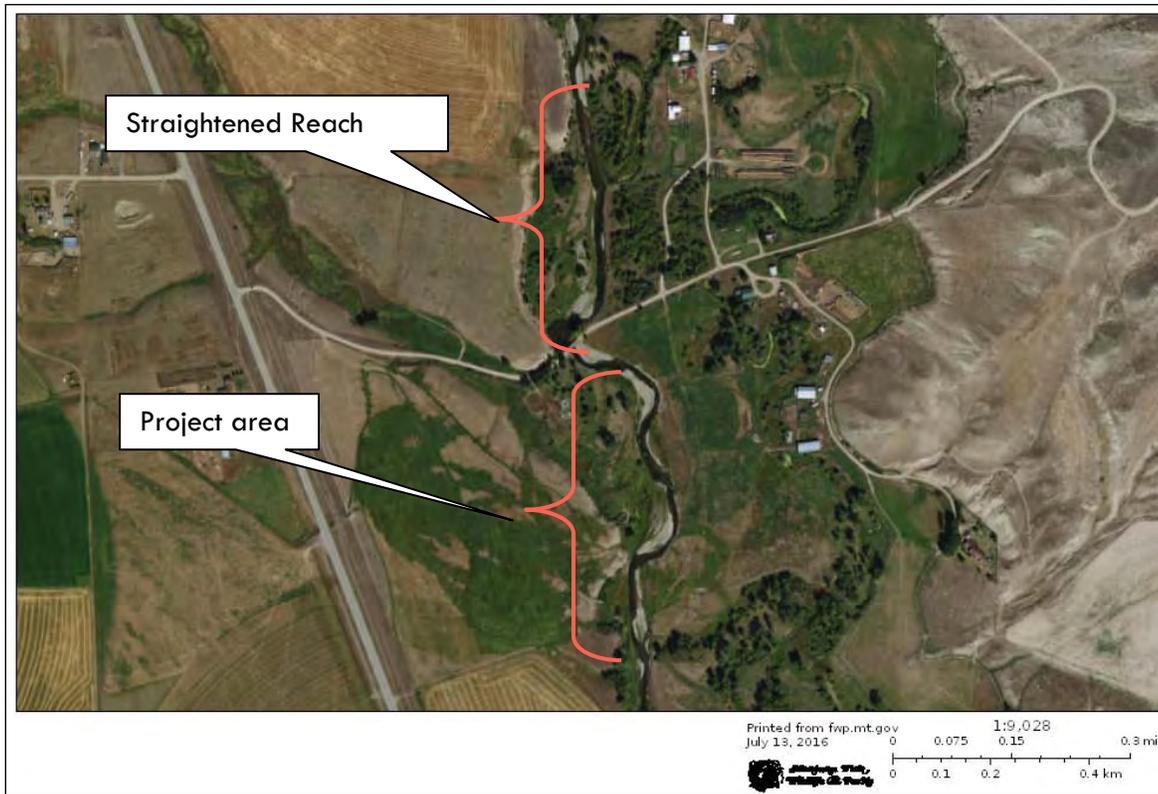
Evaluation of aerial photos upstream of the project area, and within the project area, provides insight into the cause of the lateral movements of stream banks. Approximately 1/3 of a mile of stream channel was likely straightened in the relatively distant past (Figure 81). Closer view of the channelized reach shows old meander scars, which support the assumption that the stream occupied more of its floodplain, and humans had altered the channel (Figure 82).

FIGURE 81. AERIAL PHOTO OF PROJECT AREA AND THE STRAIGHTENED REACH LOCATED UPSTREAM.

Straight channels have greater stream power during high flows, as they lack meanders to dissipate flow velocities. As a result, bed load movement of gravel and cobbles is substantial, and these particles do not accumulate on point bars within the straightened channel. When the flows hit the more sinuous reach, the water slows down, and the gravel and cobble settle out to form large point bars. (Figure 81). These point bars divert high flows into the opposite bank, which results in greater erosive pressure than the banks can handle.

Within the restored reach, point bar development indicated an imbalance in transport and deposition of bed load (Figure 84 and Figure 81), and growth of point bars put more pressure on the opposing banks, which were the subject of restoration efforts. Bank armoring, although not desirable from fisheries or river form and function perspectives, was successful in protecting land. Nonetheless armoring did extend the area of disturbance by exerting pressure on banks downstream of the project area, contributing to a small area of bank erosion.

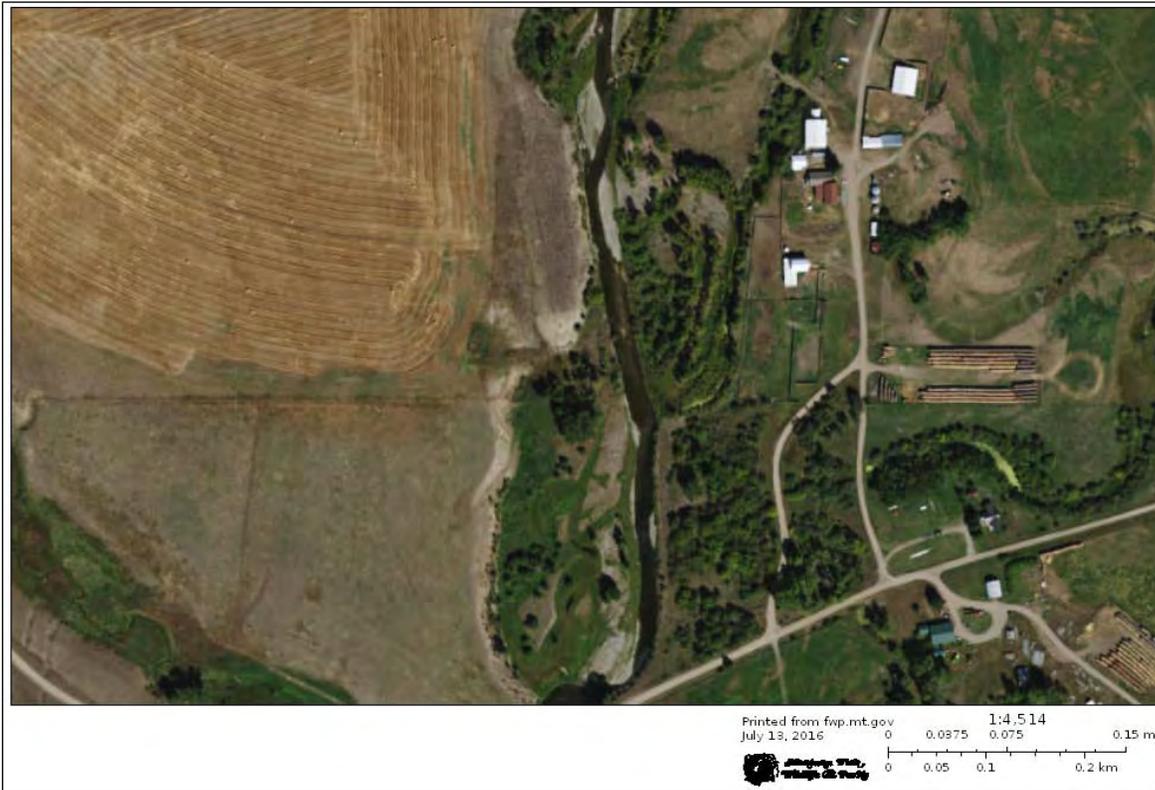
FIGURE 82. CLOSE-UP OF CHANNELIZED REACH UPSTREAM OF THE PROJECT AREA.

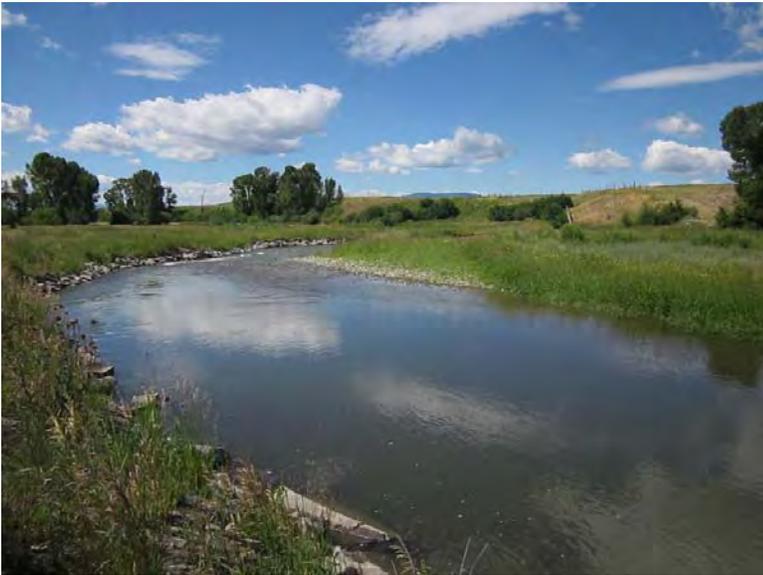
FIGURE 83. EXAMPLE OF BANK STABILIZATION ON THE SHIELDS RIVER AFTER FAILURE OF THE ROOT WADS AND TREE REVETMENTS.

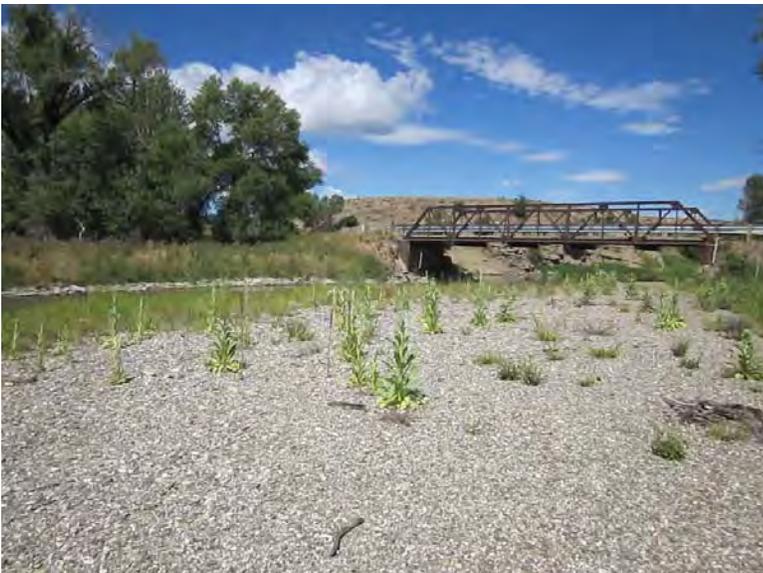
FIGURE 84. EXAMPLE OF LARGE POINT BAR WITHIN PROJECT AREA.

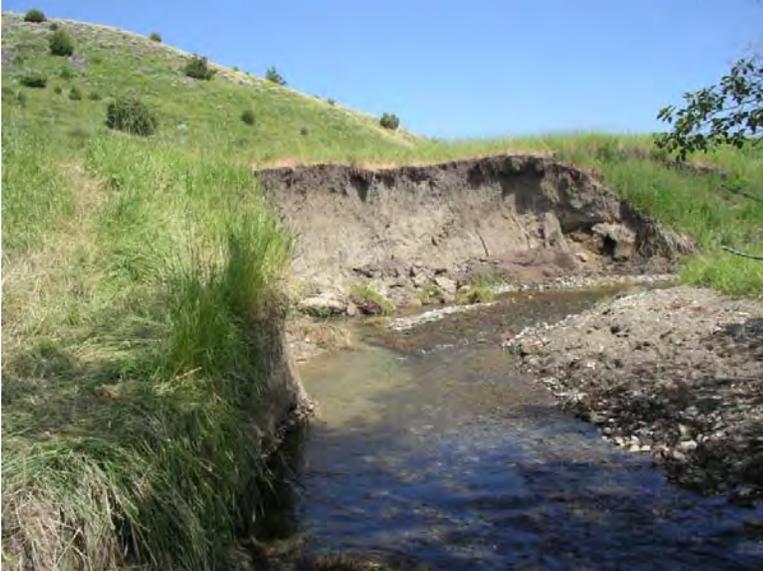
The Middle Fork Horse Creek project addressed sediment delivered from where the stream abutted a vertical, eroding terrace, and a lack of willows within the project area (Figure 85). This pasture was likely used during calving by previous owners, and cattle had removed much of the riparian vegetation. The landowners at the time did not plan to use this pasture for grazing, so it had several years of rest. Nonetheless, willows had not recovered, and weeds infested most of the floodplain.

FIGURE 85. MIDDLE FORK HORSE CREEK PROJECT AREA BEFORE PROJECT IMPLEMENTATION.

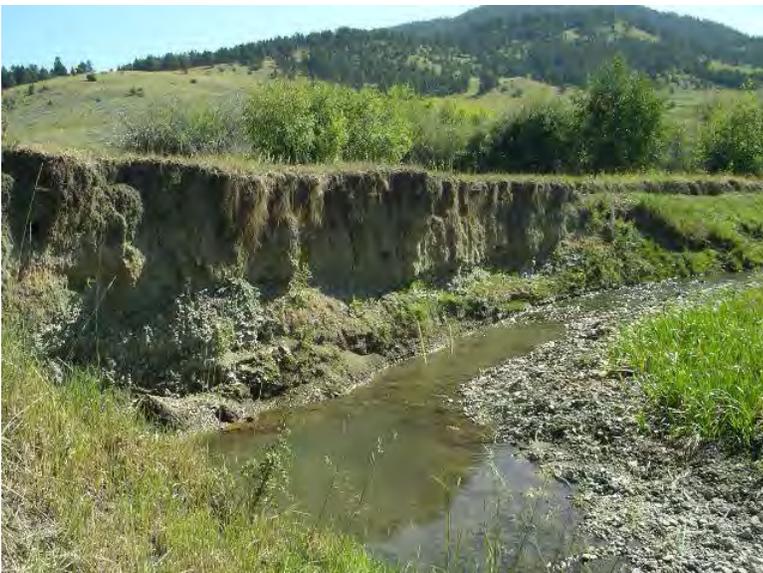
Similar to Middle Fork Horse Creek, South Fork Horse had several reaches where the stream exerted considerable force on vertical, eroding terraces (Figure 86). In addition, current grazing practices were damaging stream banks, and impairing the health and function of the riparian area. Cattle accessed the stream at numerous locations, resulting in hoof shear, and exposed dirt (Figure 87). Riparian shrubs were absent from a considerable portion of the stream, and many banks were actively eroding (Figure 88). The suspended sediment load was substantial, as the stream was turbid, even during low flows.

FIGURE 86. EXAMPLE OF STREAM ABUTTING AN ERODING TERRACE ON SOUTH FORK HORSE CREEK.

On both streams, the strategy to reduce erosion from high vertical terraces entailed construction of a floodplain bench between the stream and the terrace (Figure 89). The benches removed the shear stress at the toe of the terrace, and provided a floodplain with roughness that dissipates the erosive force of flood flows. The banks were built from wetland sod mats that were harvested from within the project area.

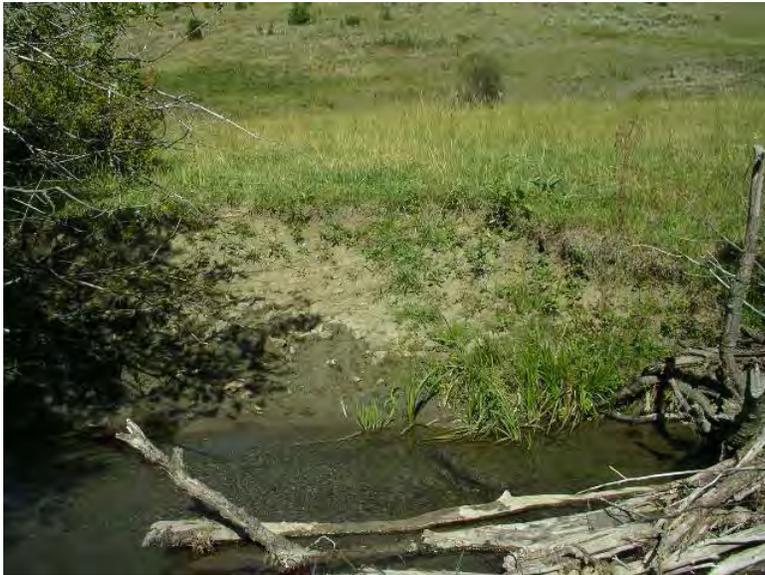
FIGURE 87. EXAMPLE OF CATTLE ACCESS POINT.

A separate component of this project addressed livestock management on the ranch. The landowner chose to exclude cattle in the project area of the Middle Fork Horse Creek, so livestock would not alter riparian vegetation, or access the stream banks. Actions on South Fork Horse Creek included installation of a fence to control the ability of cattle to access the riparian area and stream, development of a ranch-wide grazing management plan, and installation of off-stream stock water. The landowner worked with the Natural Resources and Conservation Service (NRCS) on these activities.

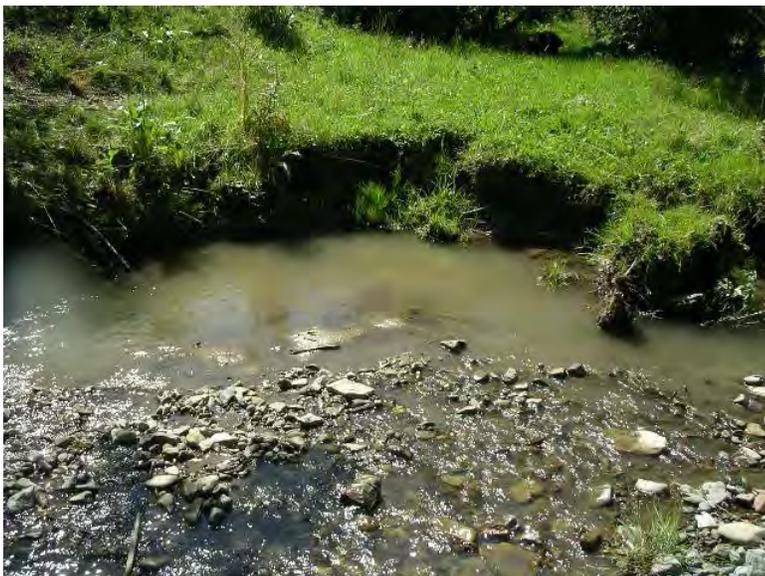
FIGURE 88. EXAMPLE OF LACK OF RIPARIAN SHRUBS AND ERODING BANKS ON SOUTH FORK HORSE CREEK.

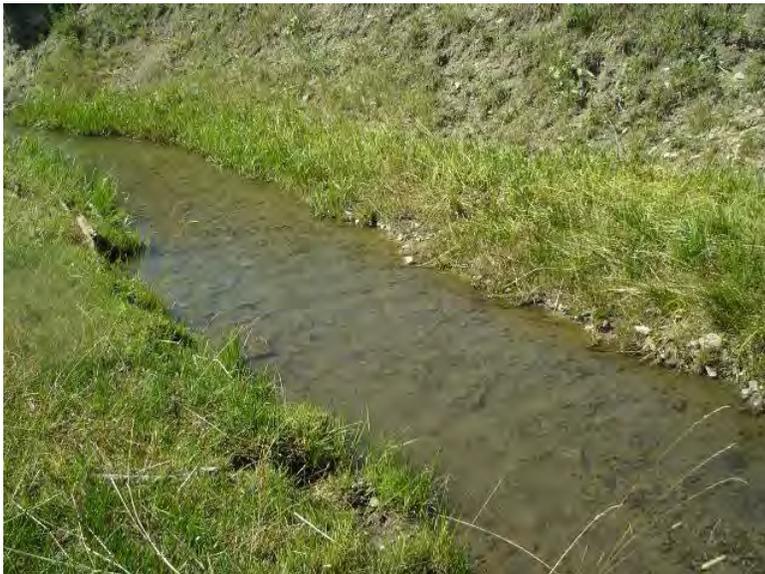
Deposition of fine sediment occurred along most of the channel (Figure 90). This siltation reduces the suitability of the gravel for spawning, and limits invertebrate production, as the spaces among gravel particles are clogged with sediment. Even relatively high gradient, narrow and deep portions of channel had substantial amounts of fine sediment.

FIGURE 90. SEDIMENTATION OF STREAMBED IN A RELATIVELY HIGH GRADIENT PORTION OF SOUTH FORK HORSE CREEK.

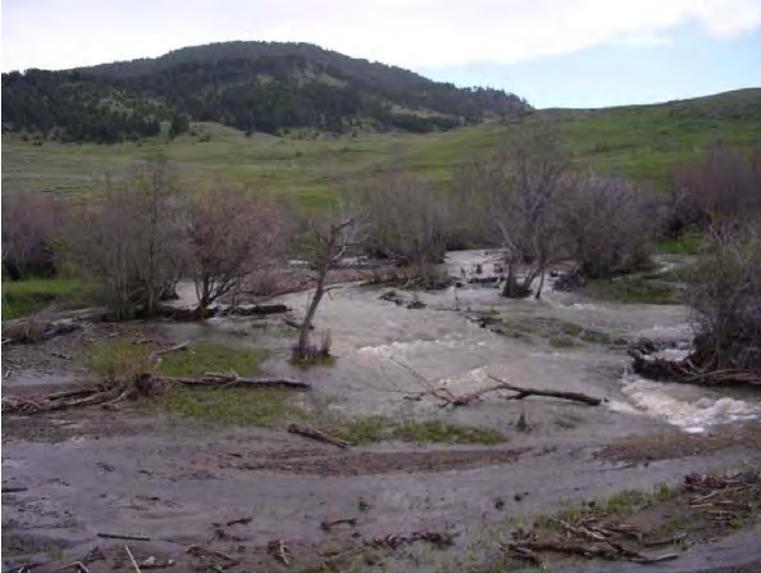
Disturbance is common in streams, and the South Fork Horse Creek flooded the spring after construction (Figure 91), resulting in considerable shear stress on the newly constructed benches. These flows also resulted in abandonment of existing channels, formation of multiple channels, and a substantial head cut, where the streambed made a dramatic drop in elevation (Figure 92).

FIGURE 91. DECLINING LIMB OF FLOOD, SPRING 2012.

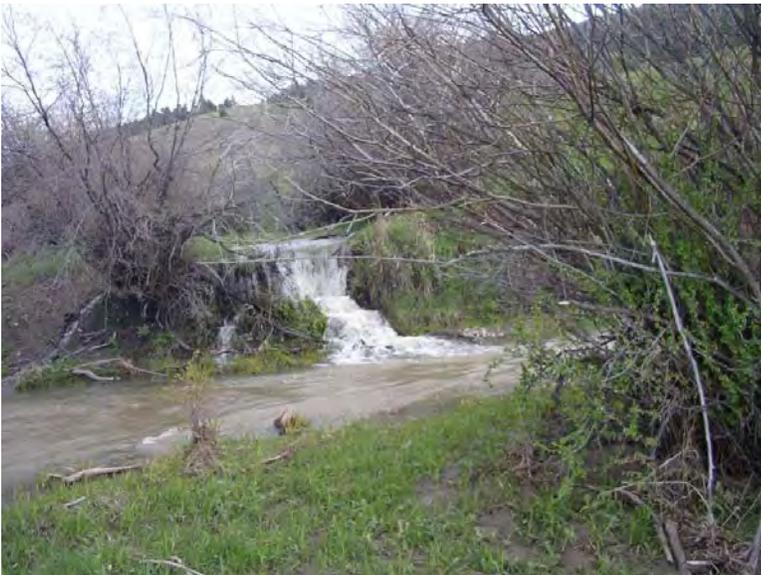
FIGURE 92. HEAD CUT ON SOUTH FORK HORSE CREEK CAUSED BY FLOOD.

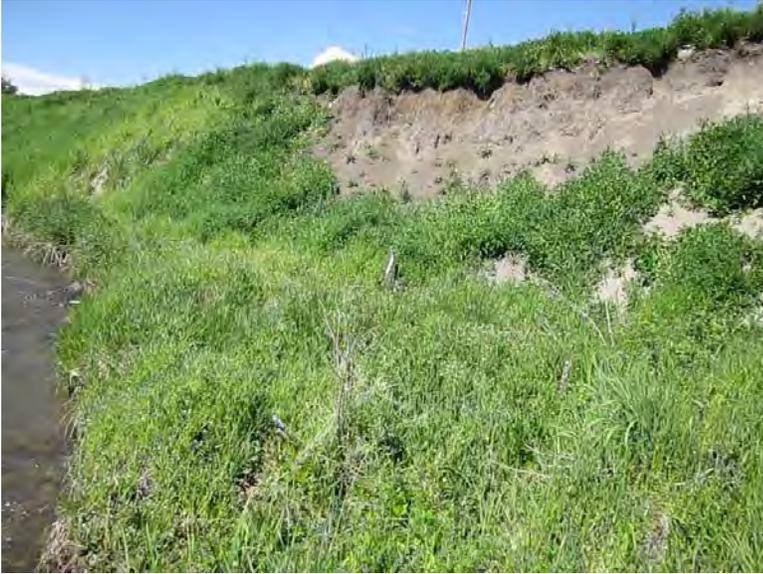
The Middle Fork Horse Creek floodplain bench is serving its purpose of reducing sediment delivery to streams, and the adjacent channel is considerably more narrow and deeper than the pre-project channel (Figure 93). Keeping erosive forces off the toe of the vertical terrace has allowed the upper portion of the terrace to

settle into an angle of repose. Furthermore, this formerly vertical wall is growing vegetation, albeit weeds, but the plants will continue to stabilize the bare soil. Willows are recruiting on the bench, and the transplanted sedge mats are indistinguishable from a natural bank.

FIGURE 93. FLOODPLAIN BENCH 5 YEARS AFTER CONSTRUCTION.

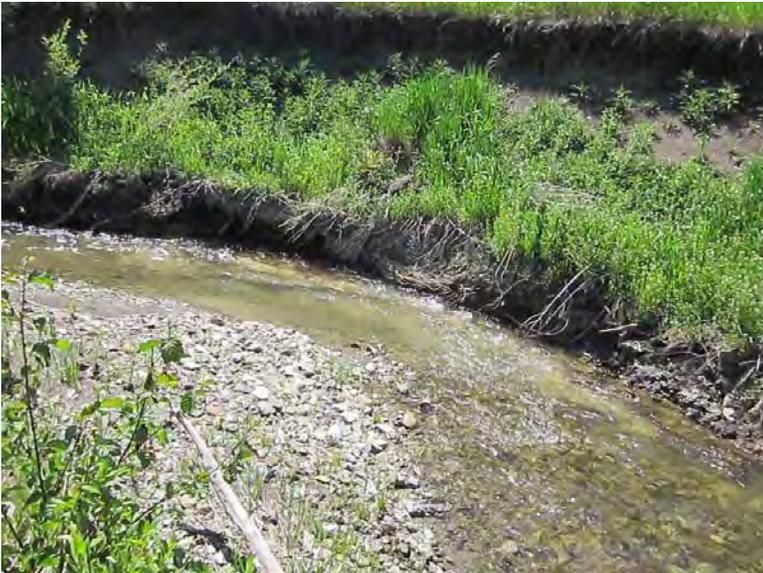
FIGURE 94. CONSTRUCTED FLOODPLAIN BENCH ON SOUTH FORK HORSE CREEK.

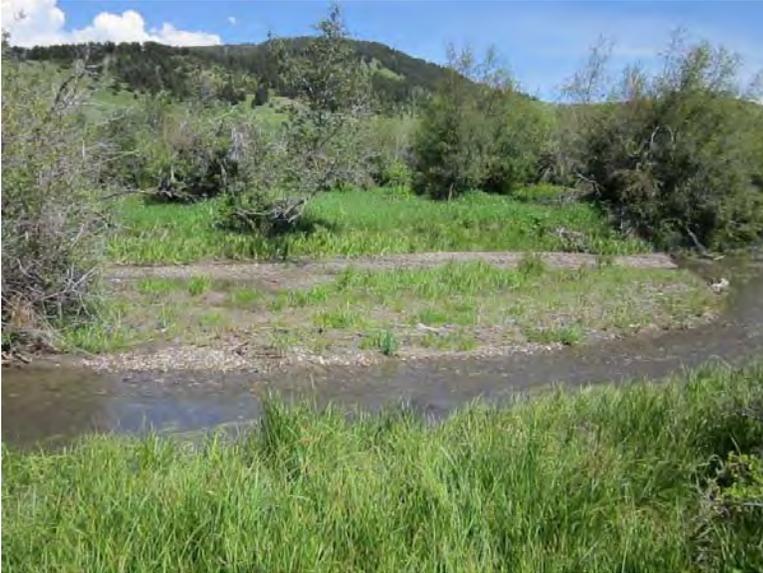
Resting this reach of stream from livestock grazing has resulted in profound improvements in riparian health and function (Figure 95). A decrease in deposition of fine sediment was also striking condition, compared to pre-project sedimentation (Figure 96). Cleaner substrate should increase spawning success and the forage base for fish.

FIGURE 95. HEALTHY RIPARIAN VEGETATION AND RECOLONIZATION ON GRAVEL BARS.

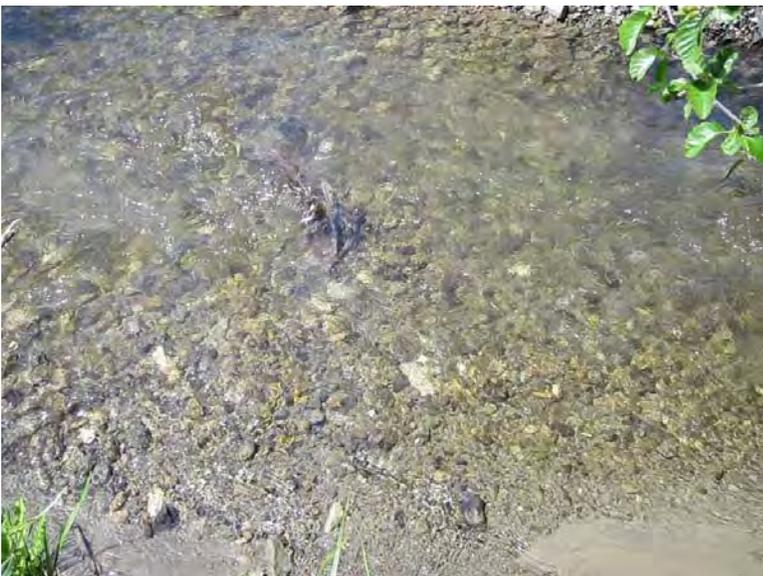
FIGURE 96. EXAMPLE OF STREAMBED 5 YEARS AFTER PROJECT IMPLEMENTATION SHOWING MARKED DECREASE IN FINE SEDIMENT (COMPARE TO FIGURE 90).

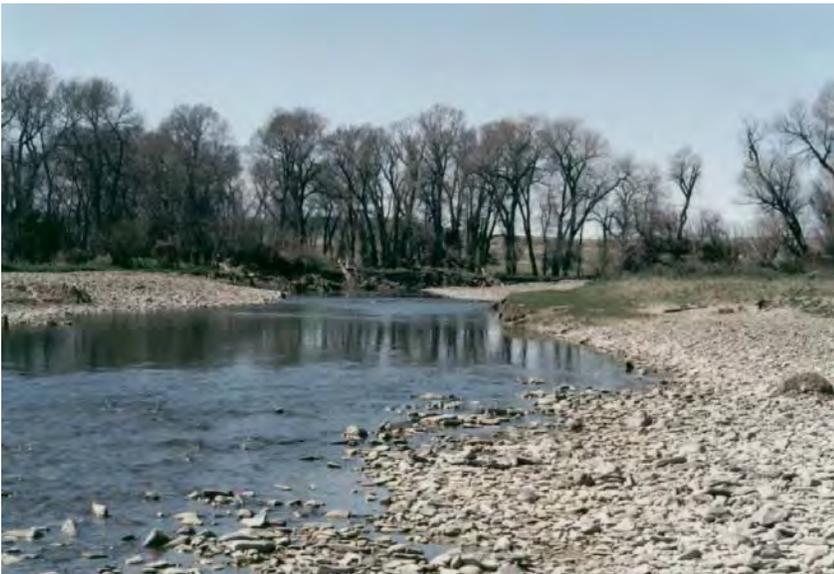
The project was implemented in 1998, and within 4 years, the riparian area and stream channel recovered markedly (Figure 97 and Figure 98). In its pre-project condition, the banks mostly were exposed cobble, and the channel was overly wide and inefficient in transporting bed load or sediment. With rest from livestock grazing, plants become established on the bare banks. These plants created roughness that trapped sediment during high flows, which is the mechanism through which stream banks are built. With deposition of soil building banks, the channel became narrower. Narrower channels have greater capacity to transport sediment, and the stream carved a deeper channel within the new bank full margin. The consequences of the narrower, deeper channel are improved habitat for fish, and likely slowed warming of water temperatures, with a decrease in the stream's surface water exposed to sunlight. The rate at which the stream recovered is typical of how quickly streams repair themselves when released from continued disturbance.

FIGURE 97. PRE-PROJECT PHOTO OF THE SWEET GRASS CREEK PROJECT AREA (1998).

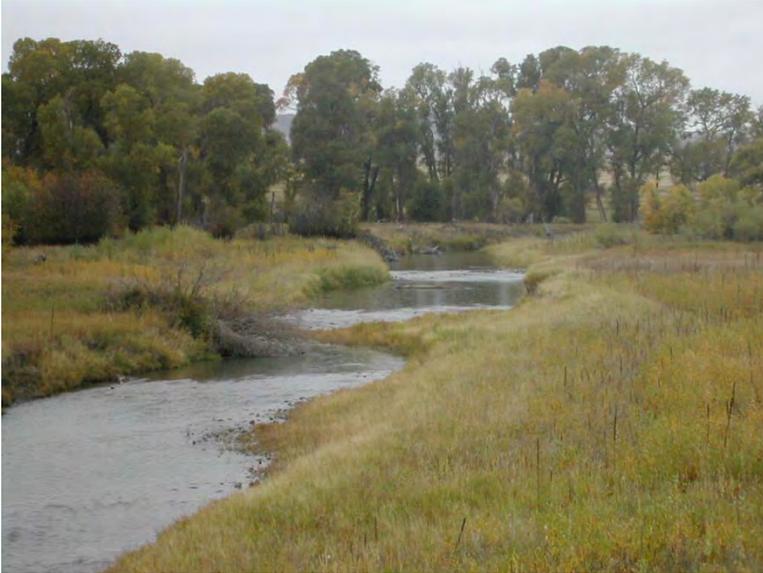
FIGURE 98. POST-PROJECT PHOTO OF THE SWEET GRASS CREEK PROJECT AREA (2002)

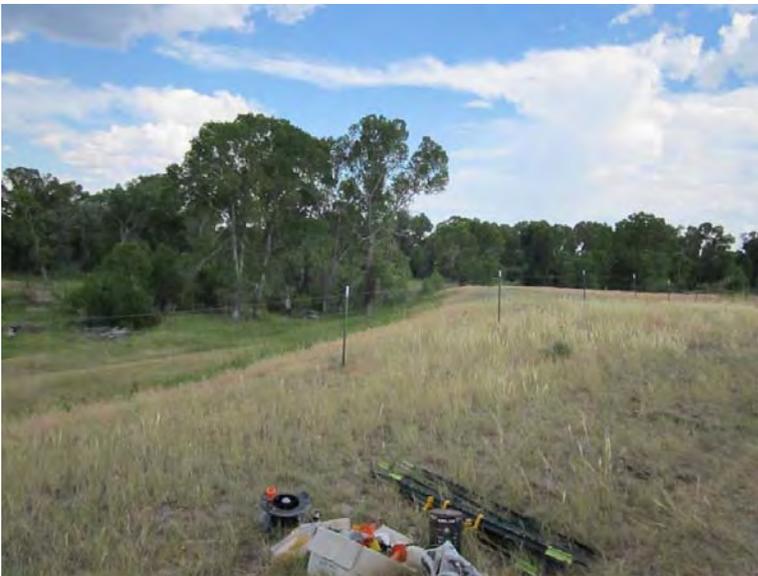
On July 2, 2016, Shannon Bockmon and the landowner evaluated the status of the project. Fencing to control cattle access to the stream was still in place (Figure 99), and the landowner reported grazing occurred within the riparian enclosure for short duration each year. An overview of the stream channel from the uplands indicated livestock management continued to maintain stream channel morphology and riparian vegetation (Figure 99), and recovery was continuing. Evidence of livestock near the stream was minimal, with isolated hoof shear near banks.

FIGURE 99. RIPARIAN FENCING ON SWEET GRASS CREEK.

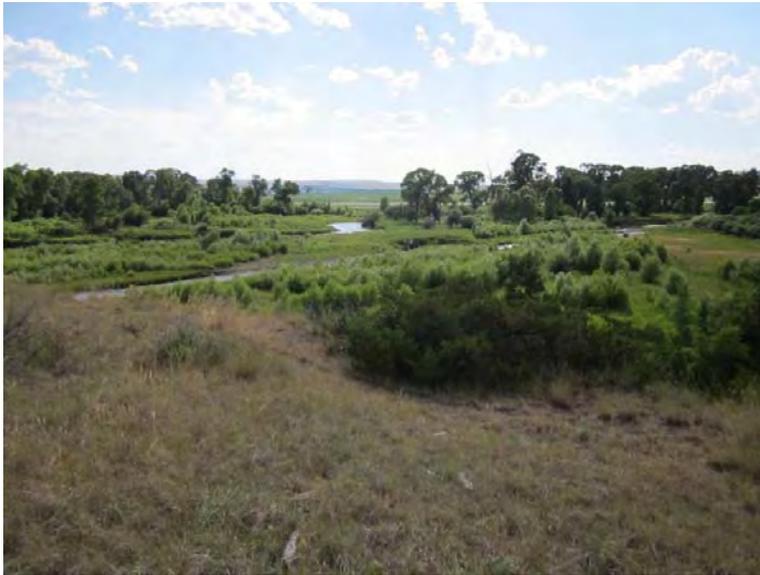
FIGURE 100. OVERVIEW OF THE MIDDLE PORTION OF THE PROJECT.

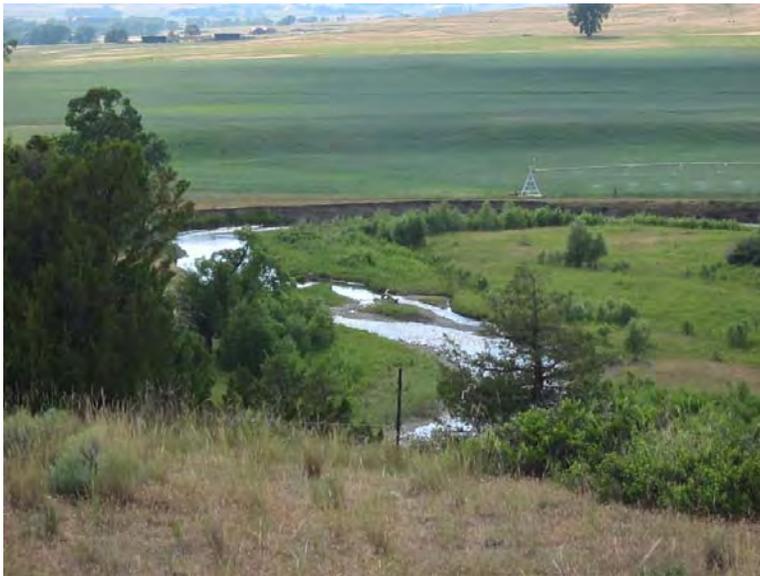
A substantial area of bank erosion was present associated with cultivation of irrigated hay adjacent to the channel (Figure 101); however, the landowner was unconcerned with the amount of bank erosion. Should erosion along this bank accelerate, construction of a floodplain bank adjacent to the eroding bank may be appropriate to take pressure off the eroding bank, and provide more floodplain area for dissipation of the erosive force of floods.

FIGURE 101. AREA OF BANK EROSION ADJACENT TO HAY PASTURE.

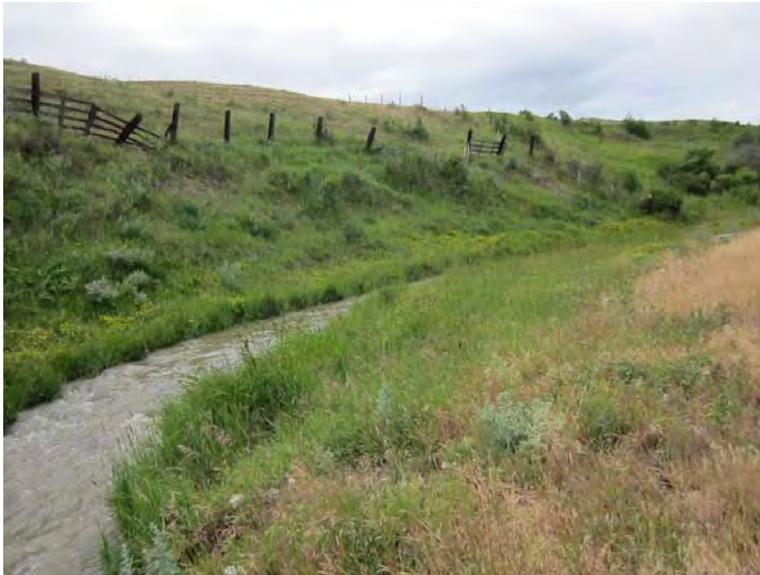
FIGURE 103. NARROW CHANNEL AND VEGETATED BANKS WITHIN THE FORMER CORRALS ON VOLNEY CREEK.
