Draft Environmental Assessment

Cornell Park Fishing Access Site Proposed Land Acquisition and Development

Draft Environmental Assessment
MEPA, NEPA, MCA 23-1-110 CHECKLIST

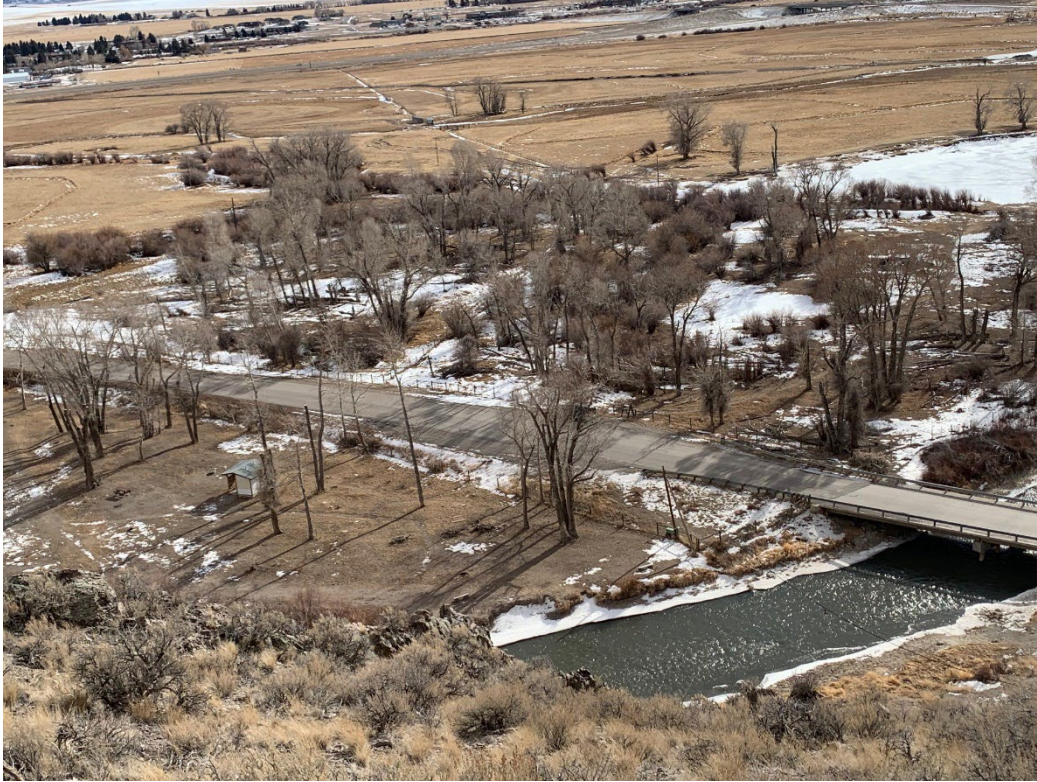
Photo1: Recent cottonwood tree pruning results. Where possible, remnants of trees were left with 20' high stumps to provide sites for hole nesting birds. This work was sponsored through an \$8000 donation by John and Phyllis Erb. BTC also applied for a \$20,000 grant through T-Mobile to further refine arborist work and acquire funds for willows for future streambank restoration.
Photo by Daniel Downey.

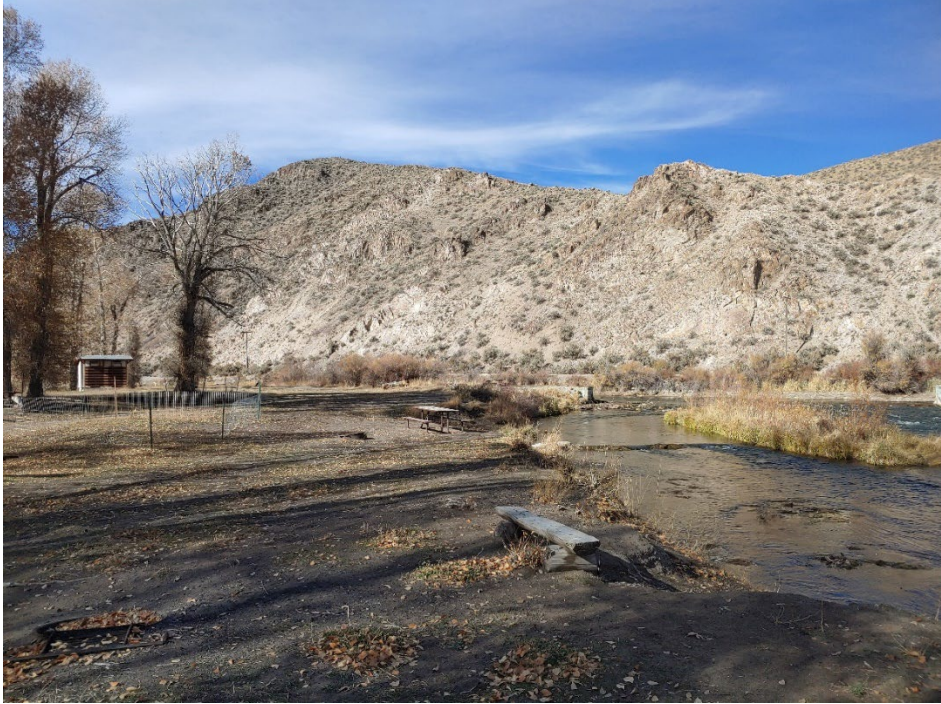
Photo 2: Current condition of streambank with latrine in background.

Long term soil compaction, introduced plant species and noxious weeds, and excessive foot traffic have exacerbated erosion and soil runoff in the areas of the existing picnic tables, latrine, and shoreline resulting in accelerated lateral erosion along the riverbank.

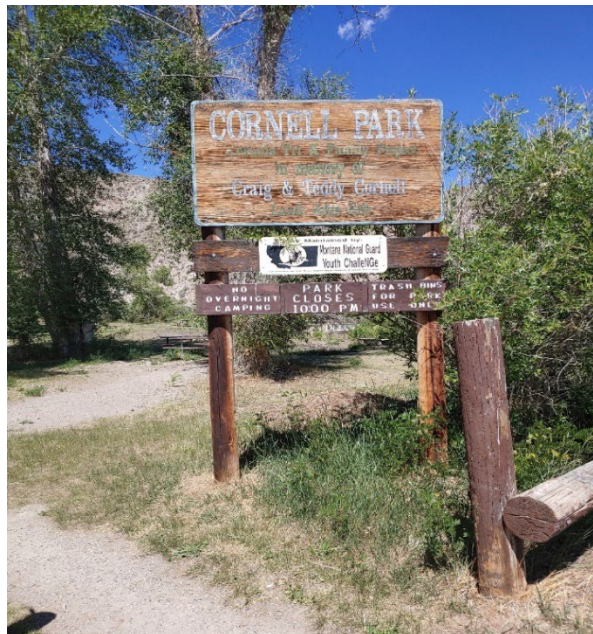
Photo 3: Current signage.

The current signage will be replaced with standard FAS signage stating site specific regulations and general information. Additional interpretive signage will inform the public of the collaborative efforts involved with the acquisition and site improvements.

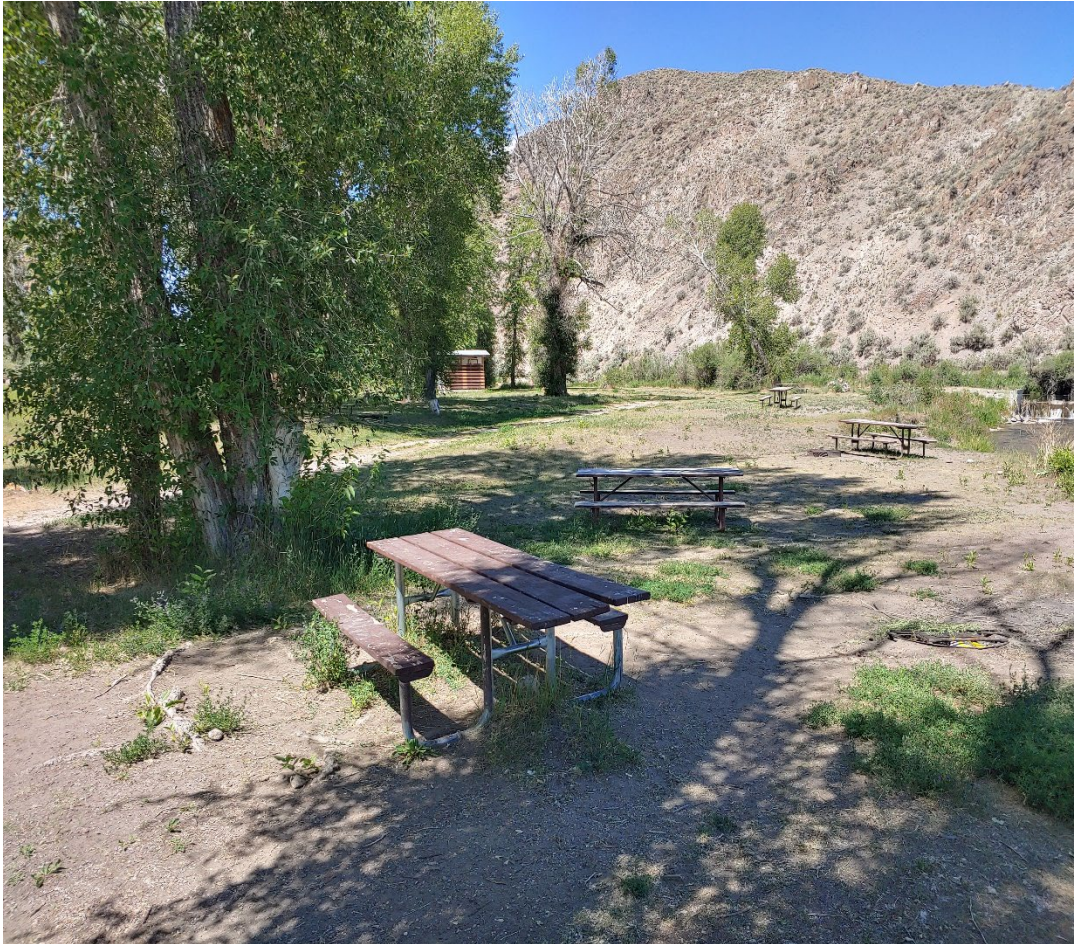
Photo 4: Existing picnic area.

The current picnic area consists of several picnic tables and fire rings, extensive social trails, and undefined paths. The site contains extensive compaction and erosion.

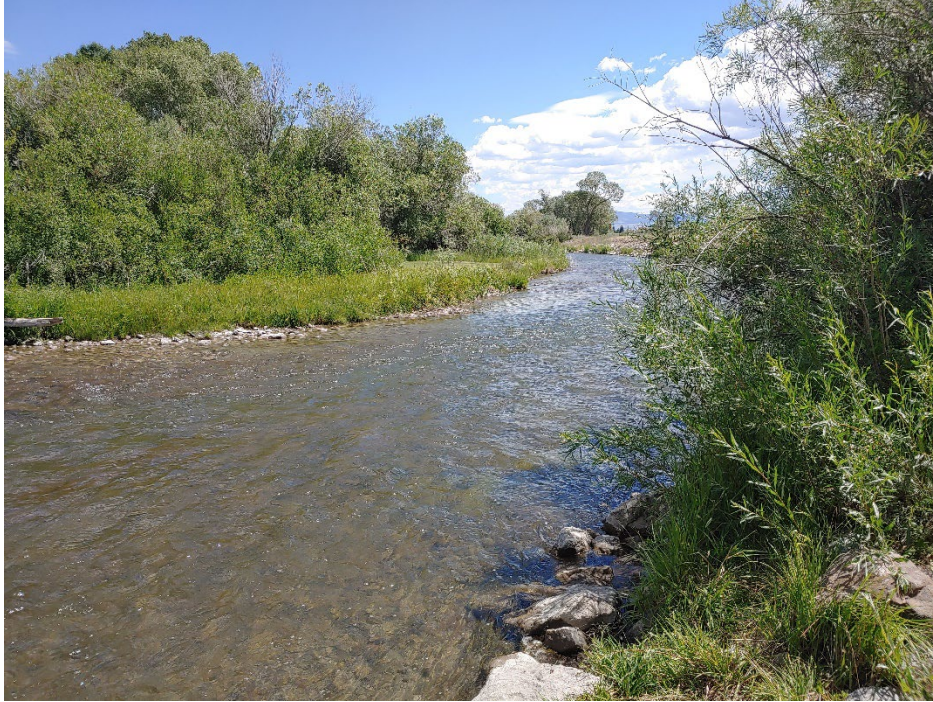
Photo 5: Movement of the river within its floodplain is a critical process for maintaining healthy terrestrial and riparian habitats, and provides a wide swath of the river bottom for anglers to enjoy.

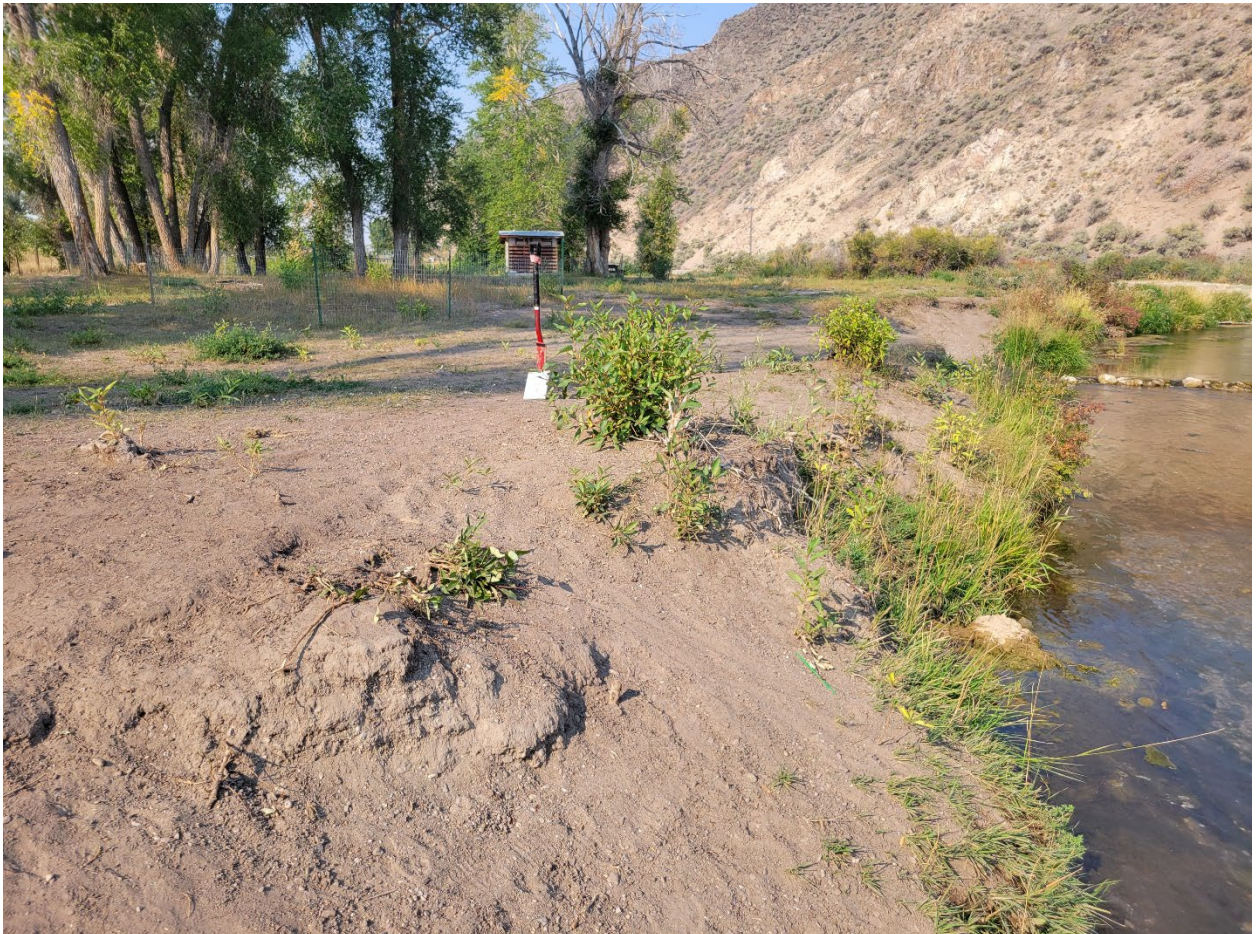
Photo 1: Typical conditions along the Cornell Park riverbanks.

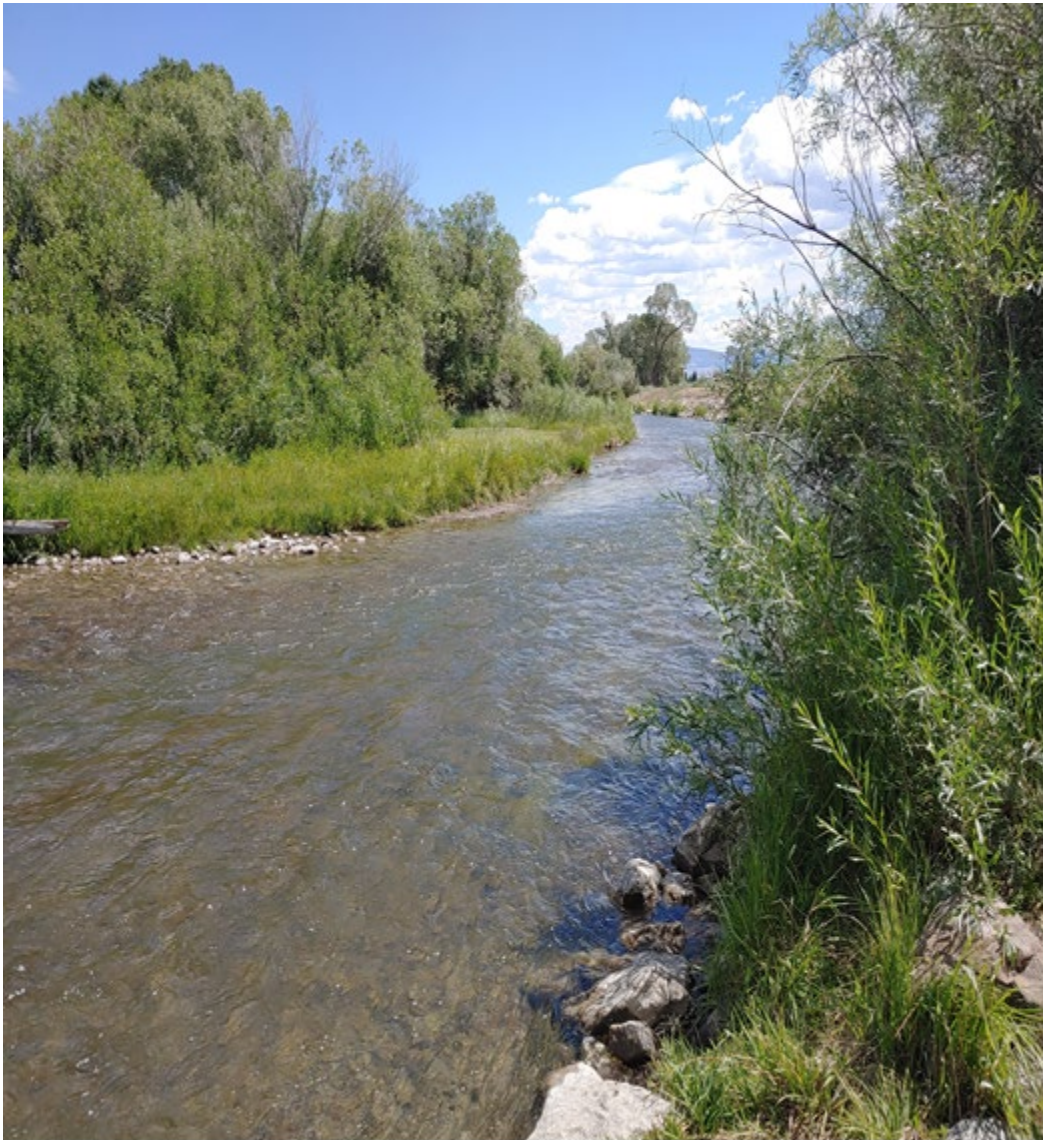
Photo 2: Reference Site 1

Due to the high level of disturbance, it is difficult to determine an overall seral habitat type for the project area; However, it is likely the potential of the site is the *Salix lutea/Carex rostrata* Habitat Type if the disturbance regime of fresh alluvial deposits is lost as described by Hansen et al. (1995). In addition, the stream channel type is identified as C3 channel as described by Rosgen (1994). A reference reach was identified during the scoping of the project just downstream of the streambank restoration (45.217257, -112.657960). The riparian vegetation is comprised of *Carex aquatilis/Carex utriculata* understory with a robust *Populus trichocarpa* (black cottonwood) and *Salix exigua* (sandbar willow) overstory. Channel width was ~60' with a Bankfull depth of 3' (see Photo 2).

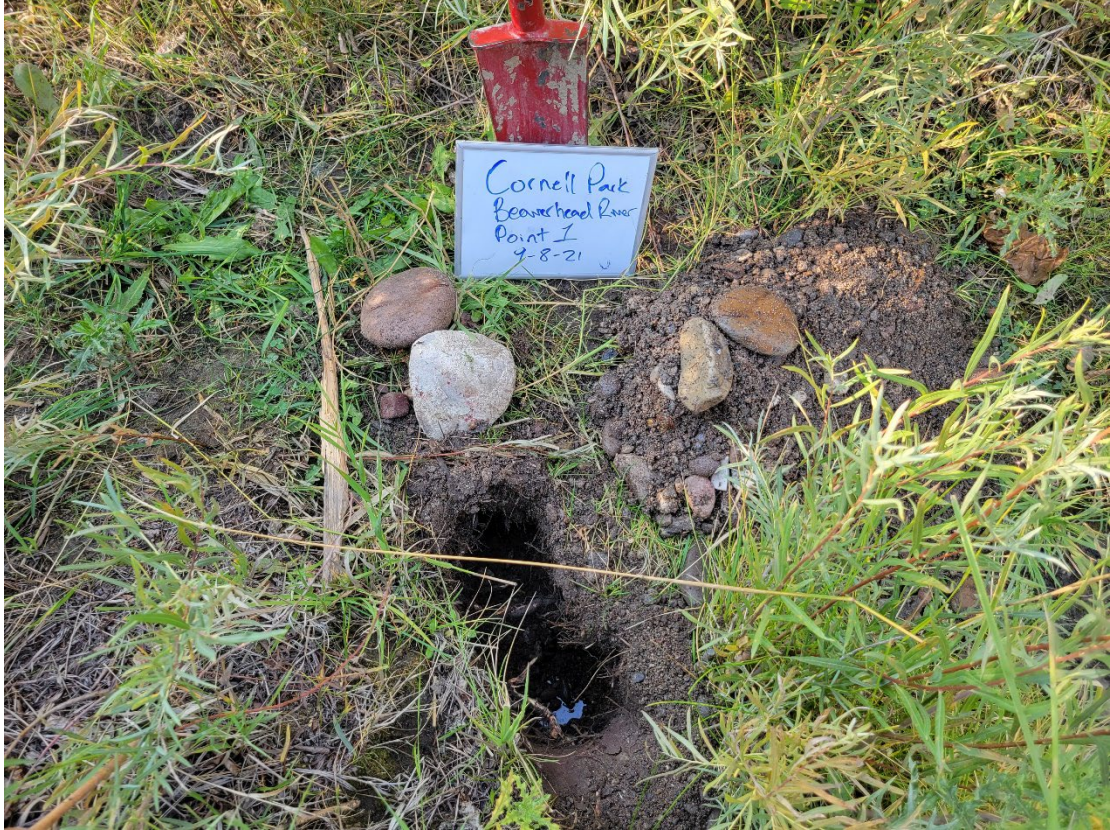
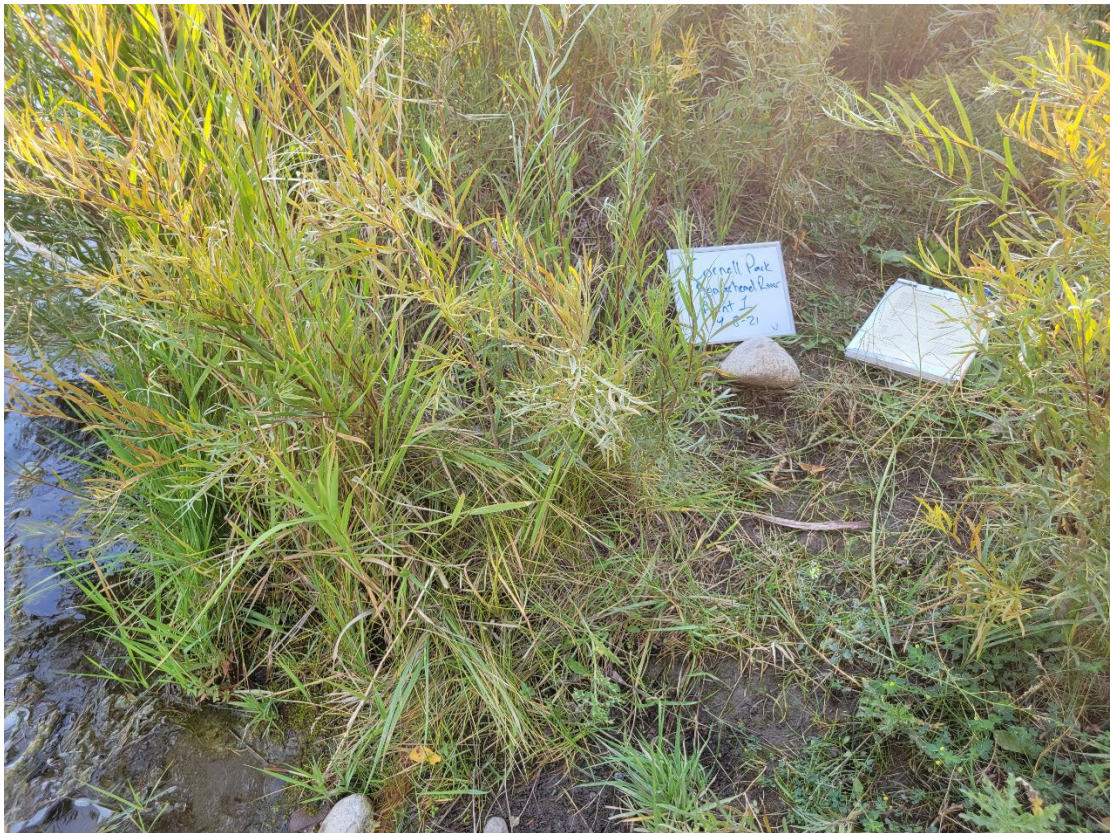
Remarks: Water table and saturation present, but ≥ 14" from surface. Does not meet the 12" threshold.

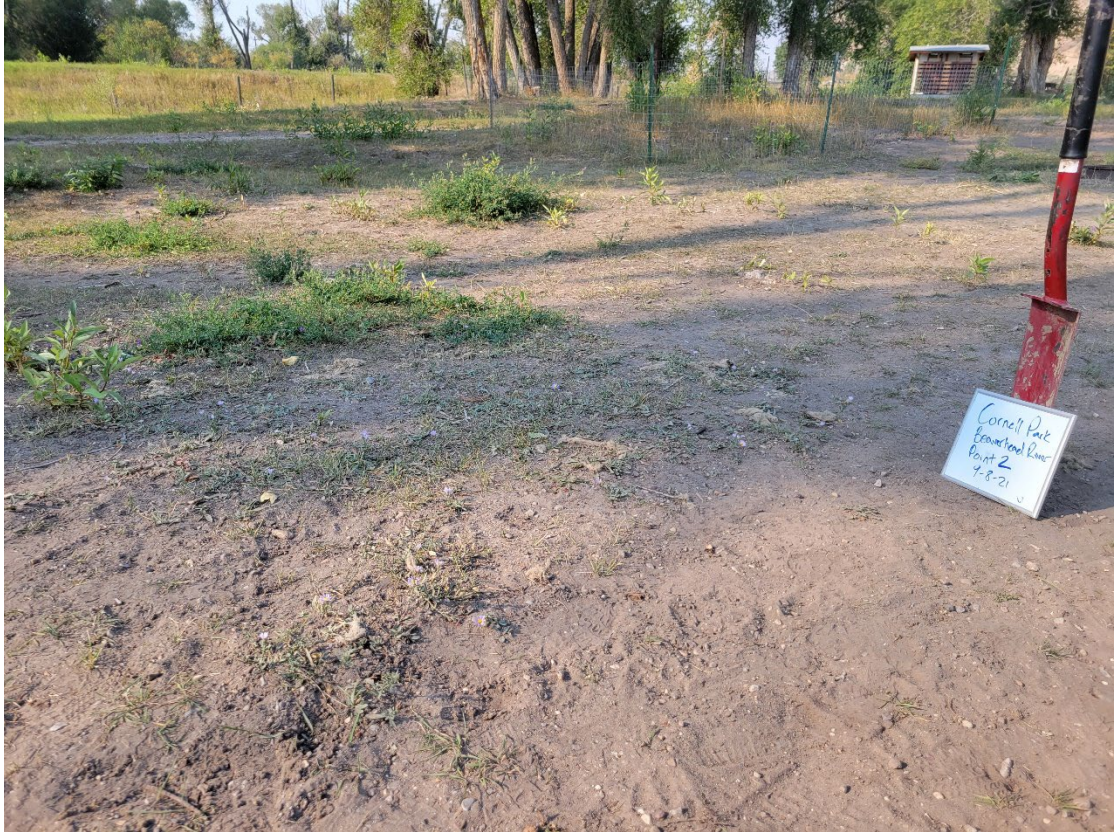
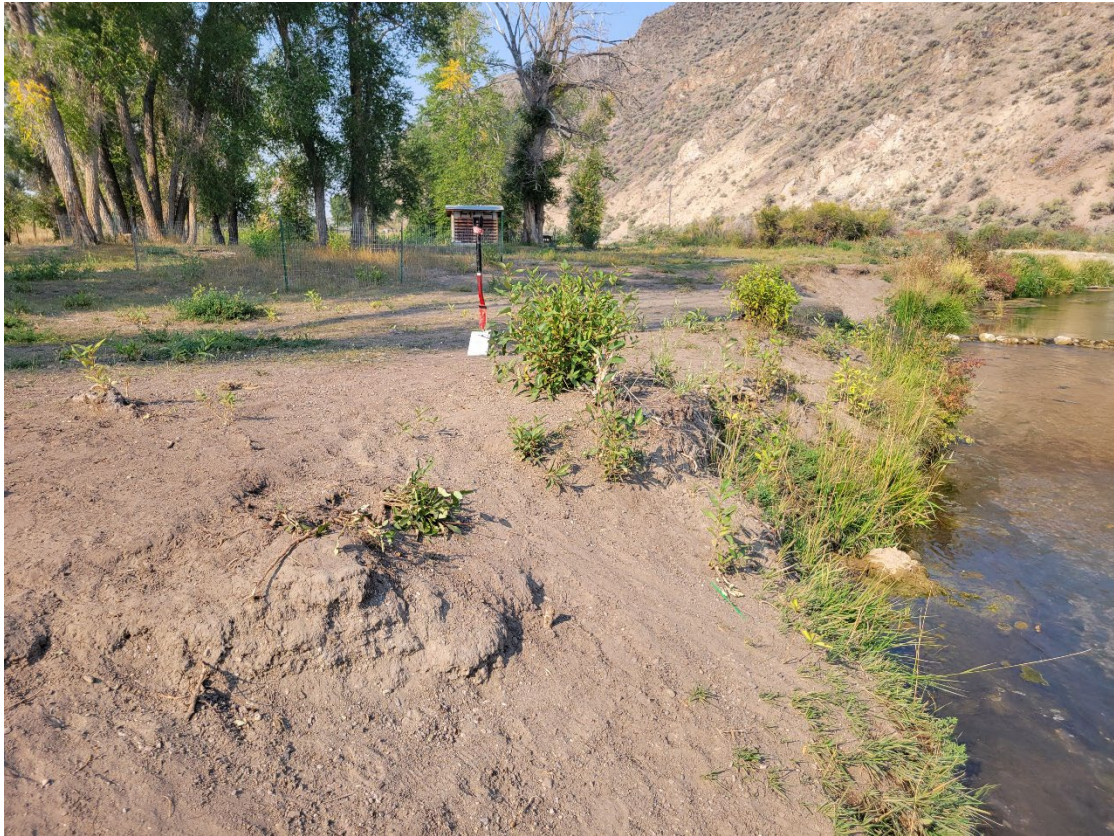
Remarks:
 No hydric indicators present.

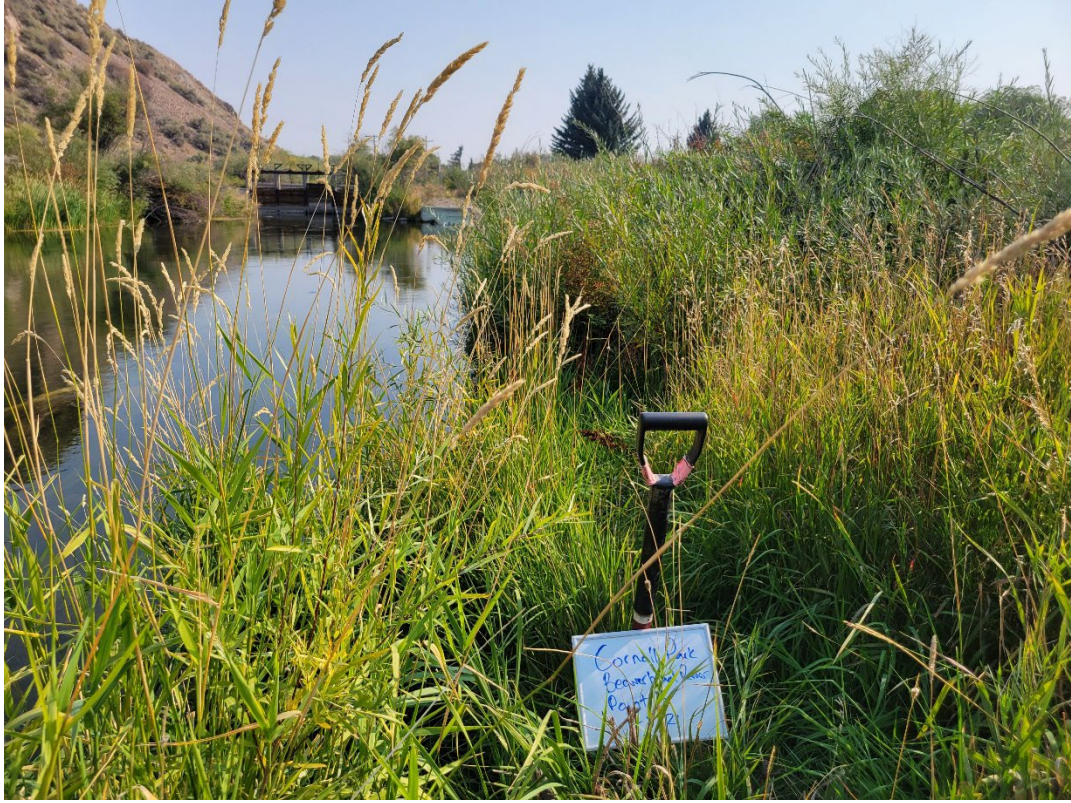
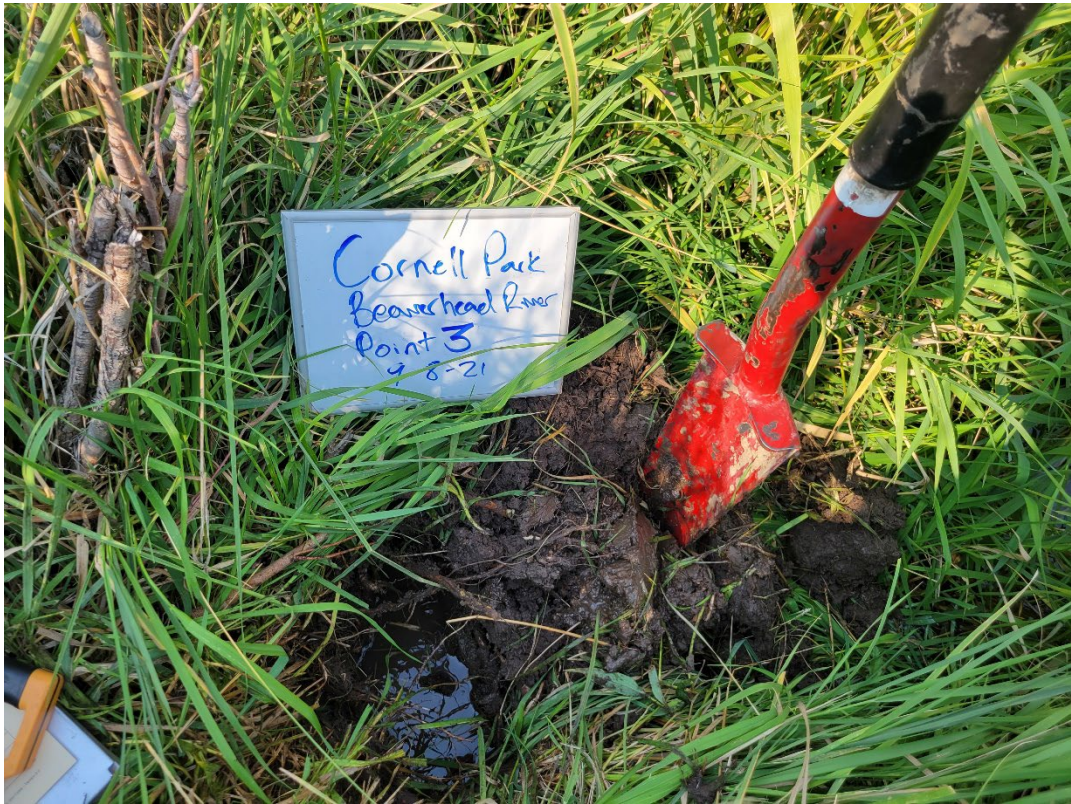
Remarks:
 Wetland Hydrology present → very saturated.

Only point 3 had all wetland criteria present. This point exhibited hydrophytic vegetation (primarily *Phalaris arundinacea*), Loamy Mucky Mineral (F1), and high saturation and water table within 7” or 9” (respectively). Point 3 was noted as inset floodplain, thus likely explaining the high level of saturation and water table for this point. Please see Appendix 3 for point data and photos.

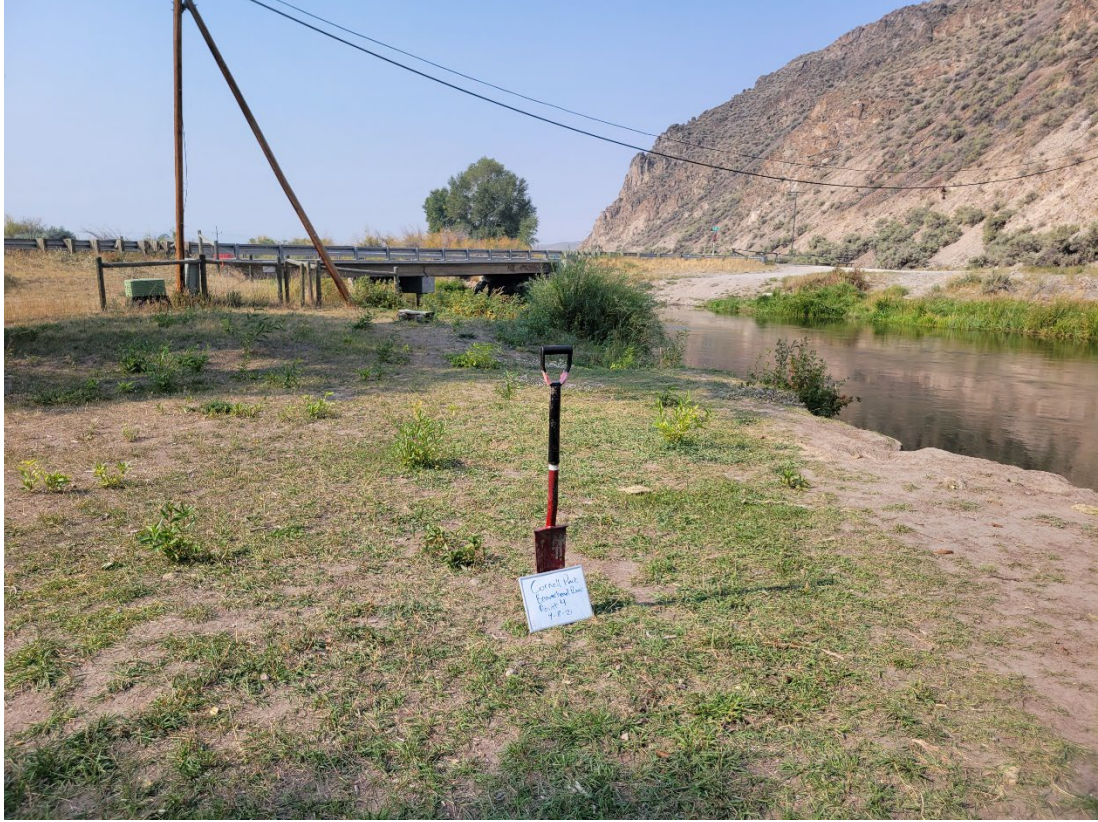
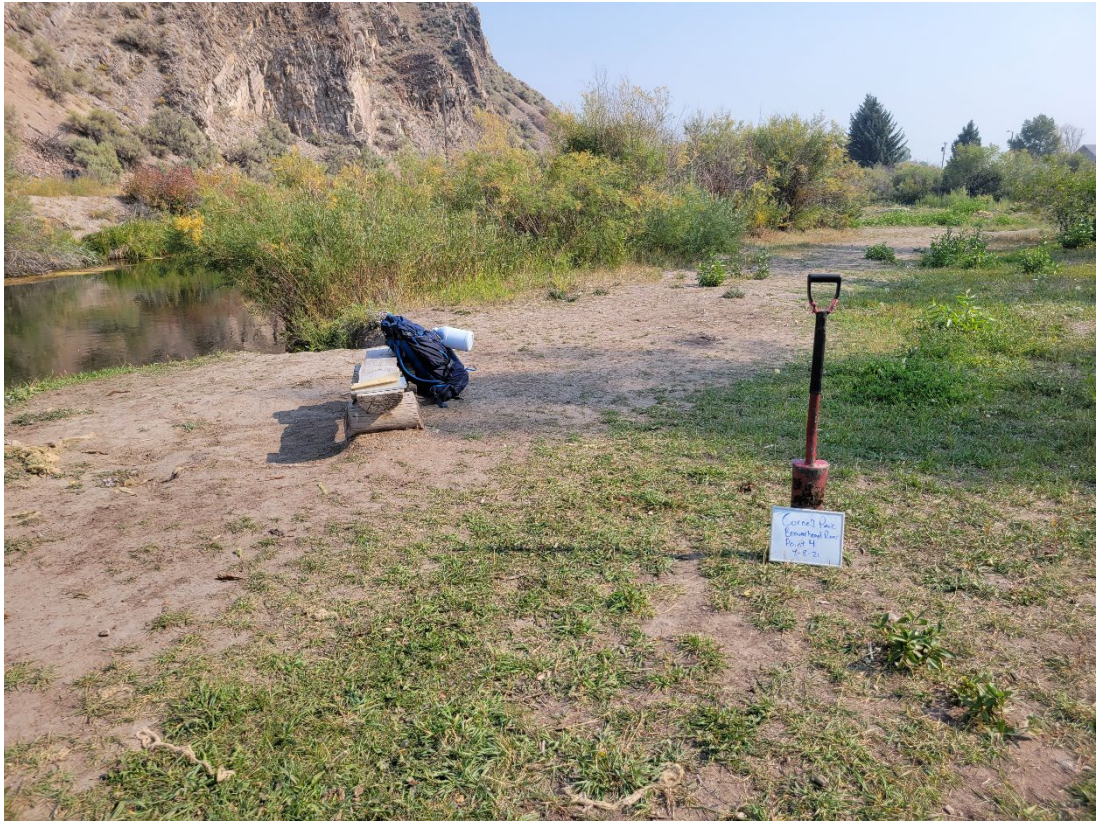
Remarks: *No wetland hydrology indicators present on site.*
