FUTURE FISHERIES IMPROVEMENT PROGRAM

BIENNIAL REPORT

Summary of program activities for the period November 1, 2016 to October 31, 2018

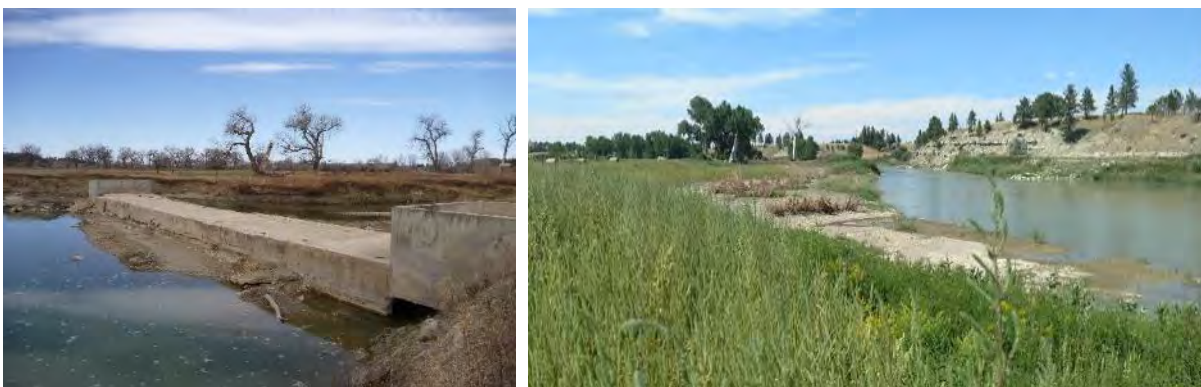
The Egge Diversion (Golden Valley County), on the Musselshell River, was in place for nearly 100 years. A 2011 flood flanked the diversion and led to severe erosion on the adjacent bank (Figure 32). This project maintained the recent connectivity in the Musselshell River by removing the fish barrier and allowing natural streamflow, opening a continuous 24-mile reach for passage and connecting the tributaries Big Coulee and Painted Robe Creeks, which contain species of concern northern redbelly dace, hybrid finescale dace, spiny softshell turtles, and many other native species. Fatmucket clams are also found in this area. The erosion on the adjacent bank was repaired using bioengineered soil lifts instead of rock riprap and was one of the first major bioengineering efforts in Eastern Montana.

FIGURE 32. PRE-PROJECT FLANKED DIVERSION (L) AND POST PROJECT RESTORATION (R) ON THE MUSSELSHELL RIVER.

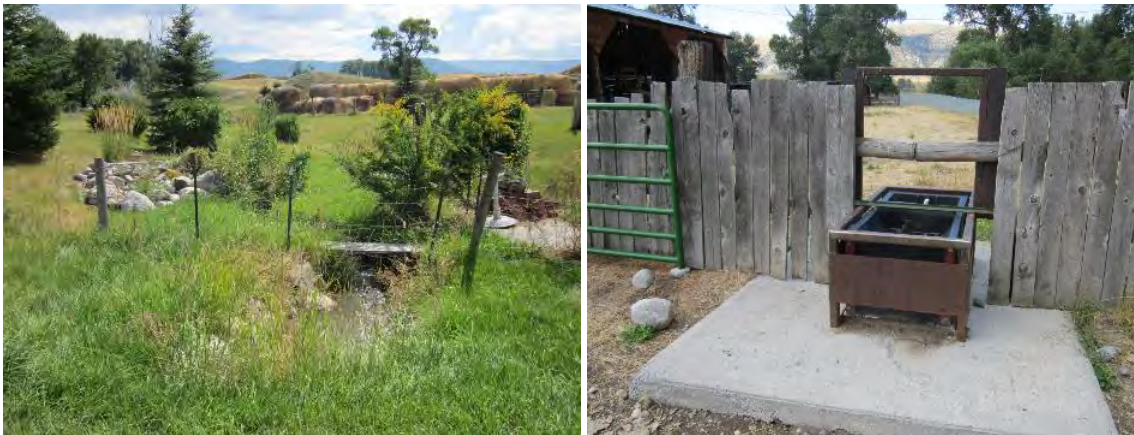
On August 16, 2017, Kyrsten Wolterstorff visited the project site to evaluate if the project was consistent with the FFIP application and to determine if the project had been beneficial to fish. Fencing had been installed, and cattle had no access to the creek. The riparian area was primarily a sedge community with little recruitment of riparian shrubs. Often, spring creeks do not provide suitable conditions for establishment of woody vegetation, so sparse woody vegetation was likely natural. The restored stream channel was relatively narrow and deep, consistent with a Rosgen E channel. The watering devices were in place; however, they were dry, as cattle were not currently occupying the corrals.

FIGURE 45. CURRENT VIEW OF THE RELOCATED SPRING CREEK (L) AND EXAMPLE OF AN OFF-STREAM WATER SOURCE FOR CORRALS INSTALLED AS PART OF THIS PROJECT (R).

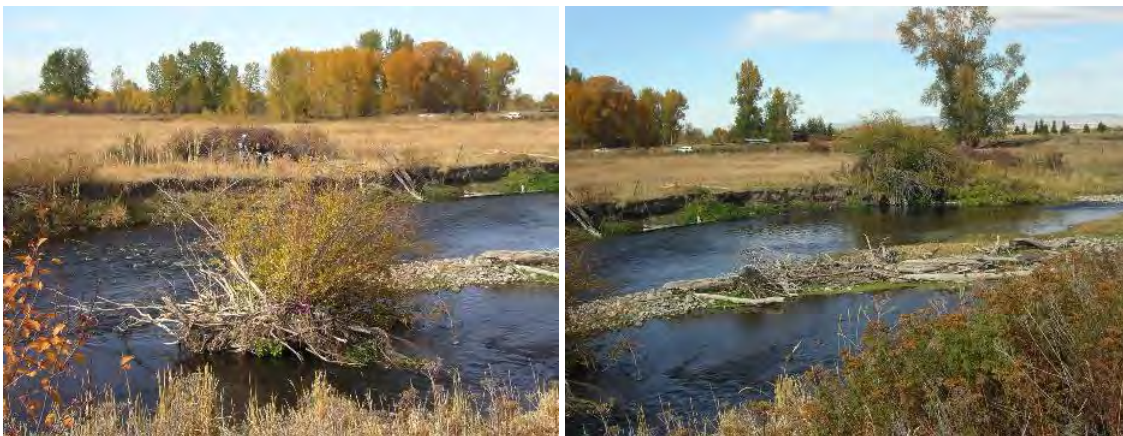
Patrick Byorth, now with Trout Unlimited, was the FWP biologist managing this project, and he provided photos and project background. The goal of this project was to provide a showcase for alternatives to bank armoring. The project occurred along three eroding banks on a single property. These vertical, eroding banks were retreating rapidly and threatening a bridge and buildings. The fluvial processes resulting in shear stress on banks varied among the banks. For banks 1 and 2, a mid-channel bar was diverting flood flows into these banks, in what was an otherwise straight reach (Figure 46). This mid-channel bar was recontoured with the intent of restoring riffle/pool periodicity and improving sediment transport.

FIGURE 46. MID-CHANNEL BAR THAT WAS EXERTING PRESSURE ON BANKS 1 AND 2 ON THE EAST GALLATIN RIVER.

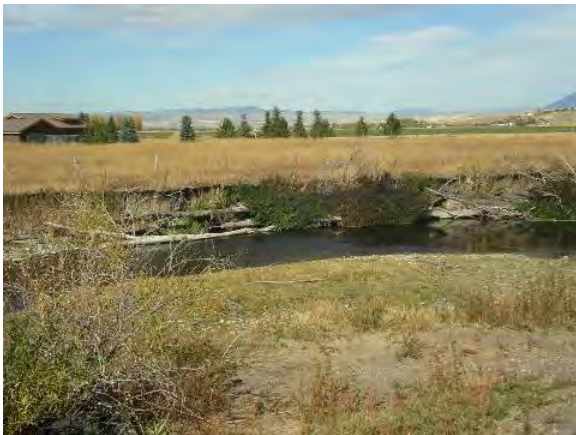
The third bank was on the outside of a meander bend and had vertical, eroding banks with slight protection afforded by woody debris and sparse shrubs. The cottonwoods were from an earlier attempt to stabilize this reach by anchoring large wood into the bank. Much of the large wood had been swept away, and the bank was laterally mobile.

FIGURE 47. BANK 3 ON THE EAST GALLATIN RIVER, SHOWING CABLED-IN COTTONWOODS THAT WERE PART OF AN EARLIER BANK STABILIZATION EFFORT.

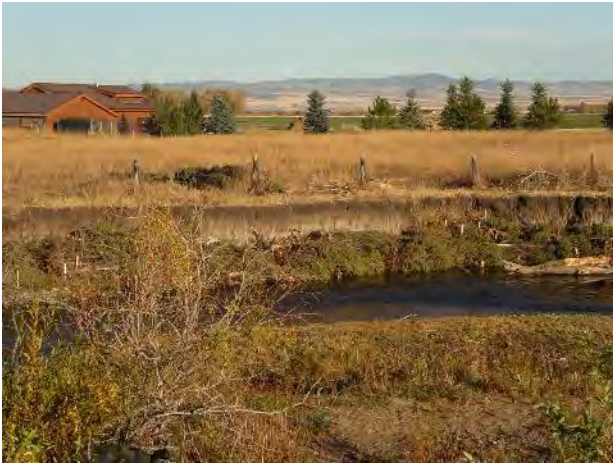
Earlier efforts to stabilize this bank entailed cabling large cottonwood trunks into the shoreline. Some cottonwoods were still in place and had slowed the bank erosion to a limited extent, but additional treatment was considered necessary to reduce flow velocities at the bank interface. The bank treatment entailed attaching juniper revetments to the existing cottonwood bank treatments. Revetments were commonly used in the 1990s and early 2000s. The conceptual approach was to provide bank protection and increase roughness, which would trap sediments, allowing banks to build on the installed features.

FIGURE 50. JUNIPER REVETMENTS CABLED INTO BANK 3.

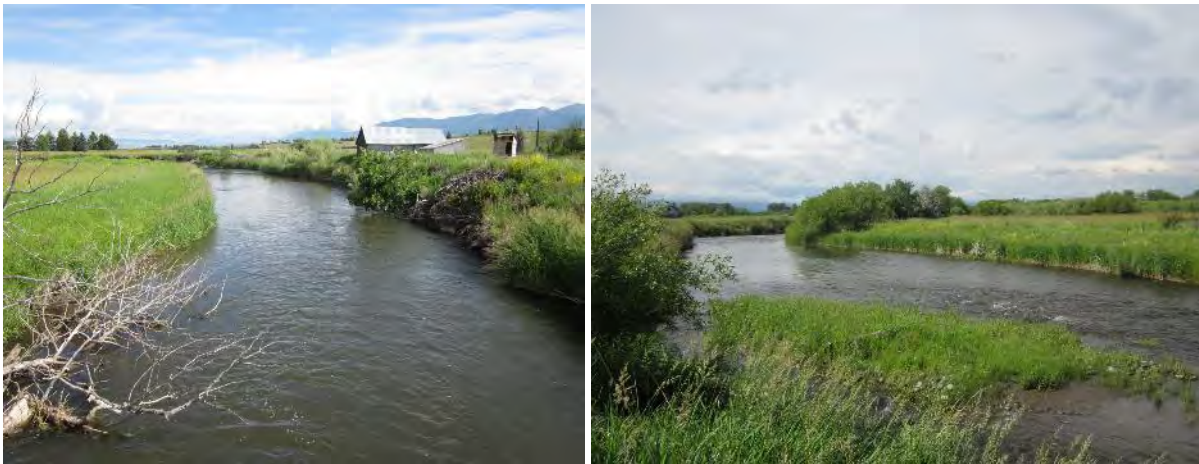
As described above, bank 1 was re-sloped, covered with erosion control fabric, revegetated, and stabilized at the toe with installation of rock modeled to be mobile at a 20-year recurrence interval event. This bank was stable with grasses and sedges providing most of the vegetative cover (Figure 52). The erosion control fabric was no longer visible and had likely decomposed with recovery of the bank vegetation, as is the intent when using this biodegradable material. The bank margin was vertical, with a 10-inch, 90° bank angle. The rock placed at the toe had been transported from under the bank, resulting in a stable undercut, which is an important habitat feature for fish. Fencing protected the bank from livestock over-use, and hoof shear or obvious types of disturbance from livestock were absent. A gravel bar had formed closed to the opposite bank; however, it was considerably smaller than the bar that had been excavated and was not apparently exerted erosive force on banks 1 and 2.

FIGURE 52. BANK 1 ON THE EAST GALLATIN RIVER BANK RESTORATION PROJECT, VIEWED FROM DOWNSTREAM (L) AND REESTABLISHED GRAVEL BAR NEAR BANK 1 (R).

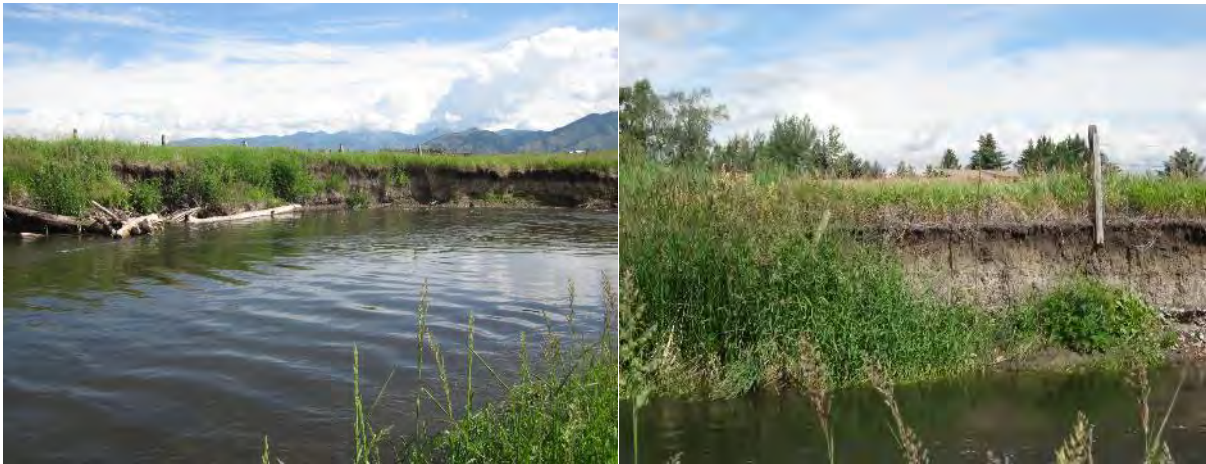
The third bank treatment entailing cabling juniper revetments to existing cottonwood logs was unsuccessful. Most of the cottonwood and junipers had washed away, the vertical, eroding banks were about 5-ft. high, and a hanging fence post were indicative substantial lateral adjustments (Figure 54). The juniper revetment treatment was unsuccessful in meeting project objectives.

FIGURE 54. BANK 3 ON THE EAST GALLATIN RIVER BANK RESTORATION PROJECT (L) AND VERTICAL EXPOSED STREAM BANK AND EVIDENCE OF LATERAL MOVEMENT, AS INDICATED BY THE HANGING FENCE POST (R).

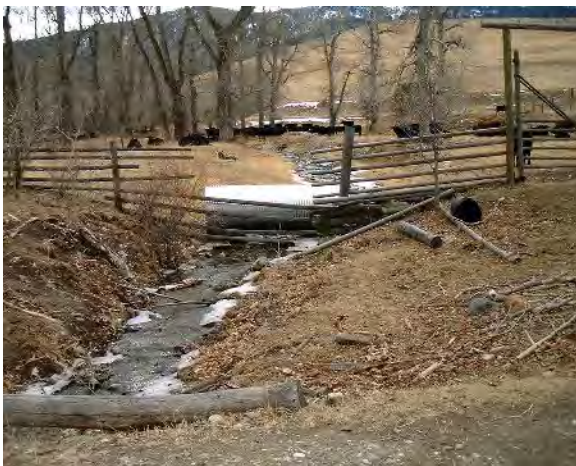
Pre-project photos a small, straightened spring creek that had experienced heavy, long-term disturbance by cattle. The stream was surrounded by bare ground, or closely cropped grasses (Figure 55). Hoof shear was present and contributed to loading of sediment into the stream. Concentrating livestock on this small stream resulted in accumulation of manure. The absence of a healthy riparian area meant the functional attributes of filtering sediment and nutrients, providing shade and fish cover, and maintaining channel form and function were entirely disrupted.

FIGURE 55. VIEW OF THE SPRING CREEK BEFORE PROJECT IMPLEMENTATION.

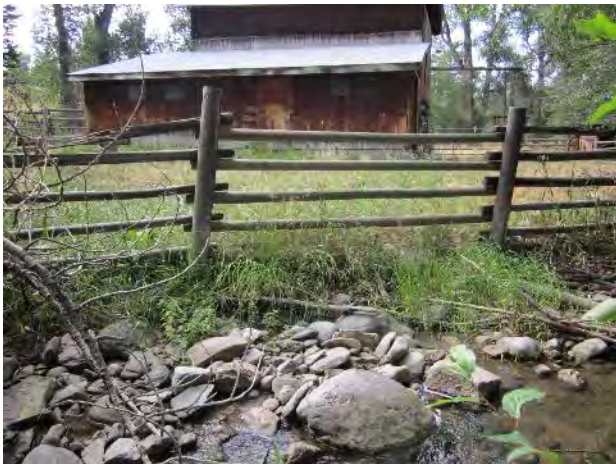
On August 16, 2017, Kyrsten Wolterstorff visited the Elk Spring Creek bypass project. She noted that fencing to protect Elk Creek had been installed, and although in slight disrepair, it was functioning to control livestock's access to the stream channel (Figure 56). The riparian area supported abundant shrubs, and all age classes of shrubs were present. This area appears to be the 50-ft. buffer between the corrals and Elk Creek mentioned in the application that was to filter runoff from the area of animal concentration.

FIGURE 56. RIPARIAN FENCING LIMITING LIVESTOCK ACCESS TO ELK CREEK AND THE BUFFER STRIP BETWEEN THE CORRALS AND SURFACE WATER.

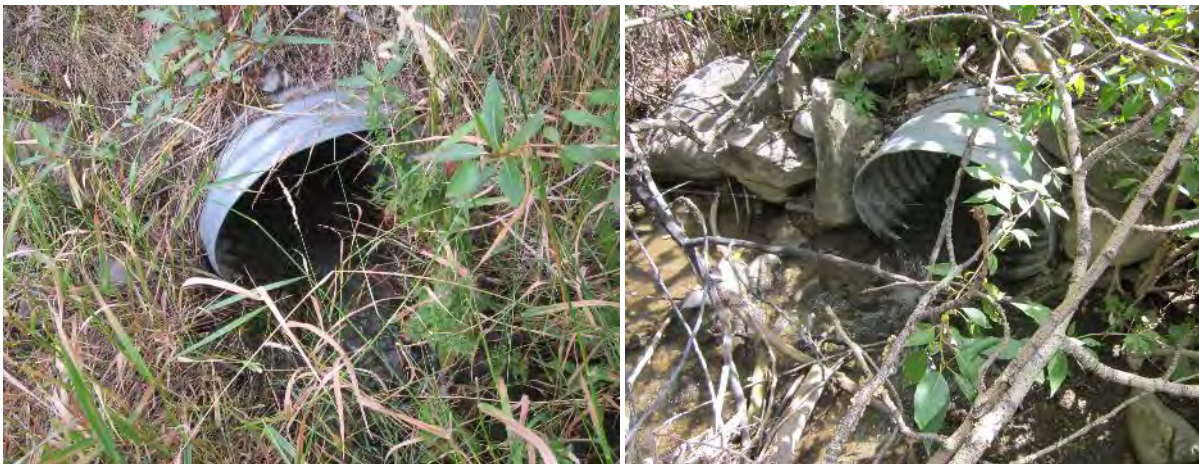
Kyrsten verified the stream had been piped under the corrals, and that alternative stock water had been provided. The inlet and outlet of the pipe were easily located (Figure 57). In addition, the stock water component of the project had been installed (Figure 58), and cattle no longer relied on surface water, which eliminated bank trampling and near-stream sources of sediment and nutrients. The operator reported the waterer occasionally clogged, but regular maintenance easily remedied this problem.

FIGURE 57. INLET OF PIPE THAT PASSES THE UNNAMED SPRING CREEK UNDER THE CORRALS ADJACENT TO ELK CREEK (L) AND OUTLET OF PIPE (R).

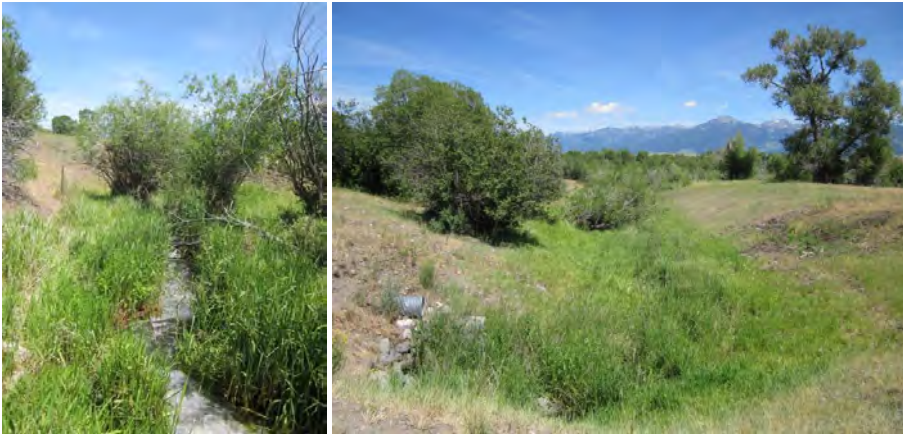
Kyrsten Wolterstorff visited the project site on June 30, 2017 and was accompanied by the landowner, who has had considerable interest in the success of this project. The step/pool sequence was still present and appeared unchanged since its post-construction condition (Figure 62). In addition, the siphon conveying North Fork Fridley Creek under the Park Branch Canal was still in place and remained at the constructed grade. Although not part of the FFIP grant, the landowner had installed a hotwire fence to exclude livestock. The riparian area was in excellent condition, with cottonwoods, alders, willows, and sedge-lined banks. The streambed was a mix of silt and gravels, although silt comprised most of the particles. On a subsequent visit on July 24, 2017, Krysten found three redds, and this timing coincided with the Yellowstone cutthroat trout spawning period.

FIGURE 62. NORTH FORK FRIDLEY CREEK DOWNSTREAM OF SIPHON UNDER PARK BRANCH CANAL (L) AND EMERGING FROM DOWNSTREAM END OF SIPHON UNDER PARK BRANCH CANAL (R).

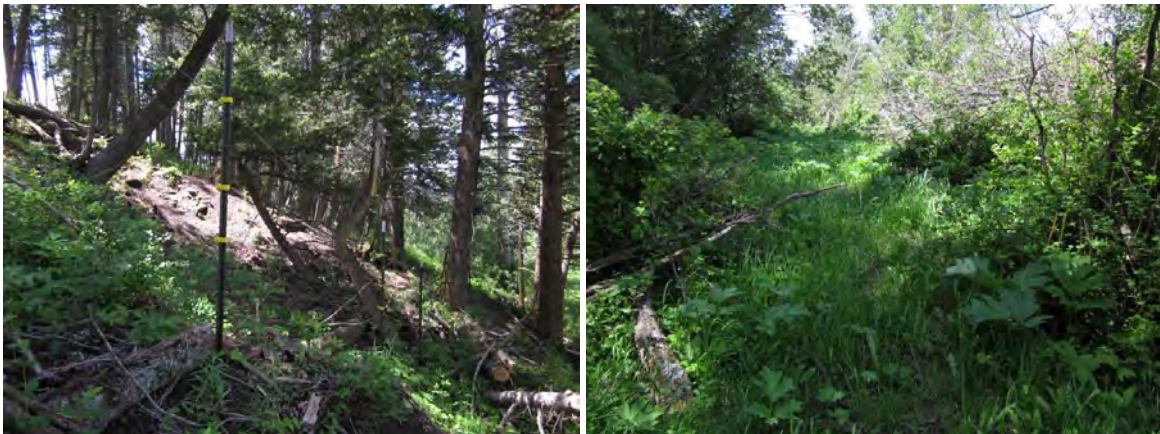
On June 22, 2017, Kyrsten Wolterstorff and Carol Endicott visited the property to determine if the fencing had been installed and evaluate the condition of the stream and riparian area. A robust fence had been constructed down-gradient from the bench and was an effective barrier to livestock (Figure 68). This hillslope showed no evidence of disturbance by livestock. This area had a dense, coniferous overstory, with a robust understory of herbaceous vegetation and mixed-aged shrub community.

FIGURE 68. NEW FENCE INSTALLED TO PREVENT LIVESTOCK FROM ACCESSING NORTH FORK HORSE CREEK FROM BENCH (L) AND TYPICAL VIEW OF THE FENCED OFF HILL SLOPE PROTECTED BY FENCING INSTALLED ALONG THE TOP OF THE BENCH (R).

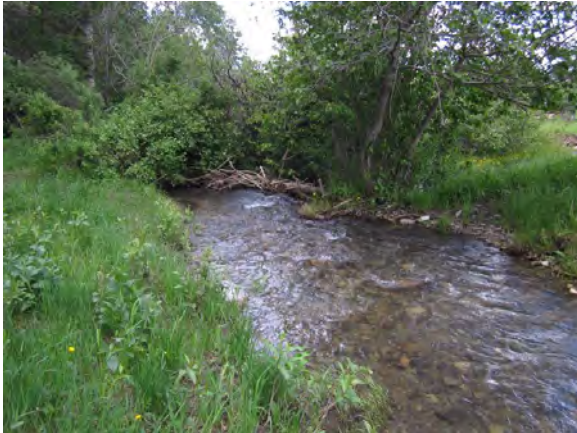
North Fork Horse Creek apparently benefited from reduced disturbance from livestock accessing the stream from the bench. The stream was a healthy foothills stream with a gravel streambed, stable banks, and a robust riparian area vegetated with sedges, forbs, and dense shrubs (Figure 69). The

opposite bank is under different ownership, and the residence is relatively close to the stream. This residential reach lacked a dense shrub community; however, herbaceous vegetation maintained bank stability, and the stream channel was stable. The conditions on the cross-stream neighbor's property had improved with implementation of the project.

FIGURE 69. TYPICAL VIEW OF NORTH FORK HORSE CREEK IN REACH PROTECTED BY FENCE INSTALLED ON THE BENCH.

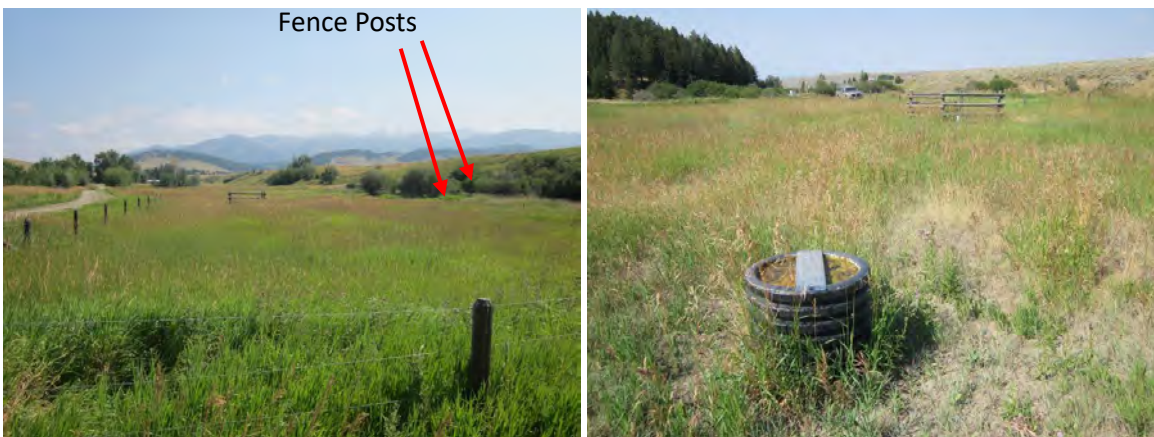
Fencing and installation of off-channel stock water had a positive effect on the riparian pasture at the downstream end of this property. Tall grasses within the pasture obscure much of the riparian fence; however, posts are visible at several locations (Figure 70). This photo replicates a pre-project photo. Indicators of improvement in the health of the riparian area include an apparent increase in density of willows, and the existing willows no longer have the umbrella-shaped morphology typical of grazed riparian areas. With exclusion of livestock from the riparian area, an alternative source of stock water was required. Kyrsten noted 2 automatic waterers within the fenced area. Combined, the fencing and off-stream water supply are complementary best management practices for sustainable livestock production adjacent to streams.

FIGURE 70. PASTURE AT DOWNSTREAM OF PROPERTY WITH RIPARIAN FENCING (L) AND OFF-STREAM STOCK WATERER (R).

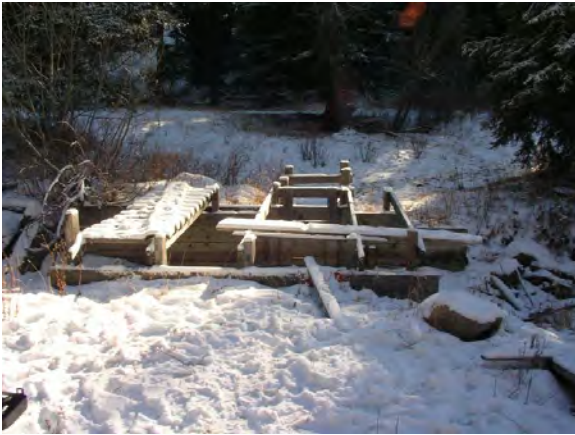
The goal of this project was to increase water use efficiency and prevent entrainment of nonhybridized Yellowstone cutthroat trout into an irrigation system on North Fork Horse Creek. The existing diversion was a wooden pin and plank structure that delivered water to an open ditch (Figure 71). Diversions that closed with check boards are notoriously leaky. Moreover, the ditch was an inefficient mode of delivering water, as it leaked and loss water to evaporation.

FIGURE 71. PIN AND PLANK IRRIGATION DIVERSION ON NORTH FORK HORSE CREEK.

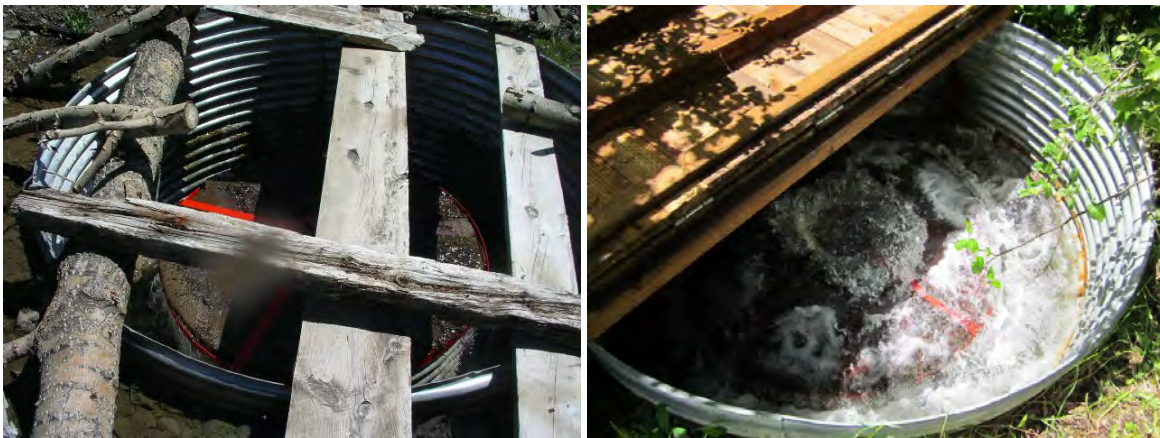
The fish screen on North Fork Fridley Creek has been visited several times. On August 11, 2010, Carol Endicott viewed the screen while it was not in use. Some detritus had settled on the face of the screen, but no fish were impinged. The detritus may have collected as the irrigation ceased for the season and flows decreased. The absence of dead fish on the screen suggested the turbulence was sufficient to flush fish off the screen. In addition, no dead fish were present in the tank surrounding the fountain, indicating the bypass pipe has sufficient draw to move fish back to the stream.

FIGURE 75. TURBULENT FOUNTAIN SCREEN WHEN NOT IN USE (L) AND IN USE (R) ON NORTH FORK HORSE CREEK.

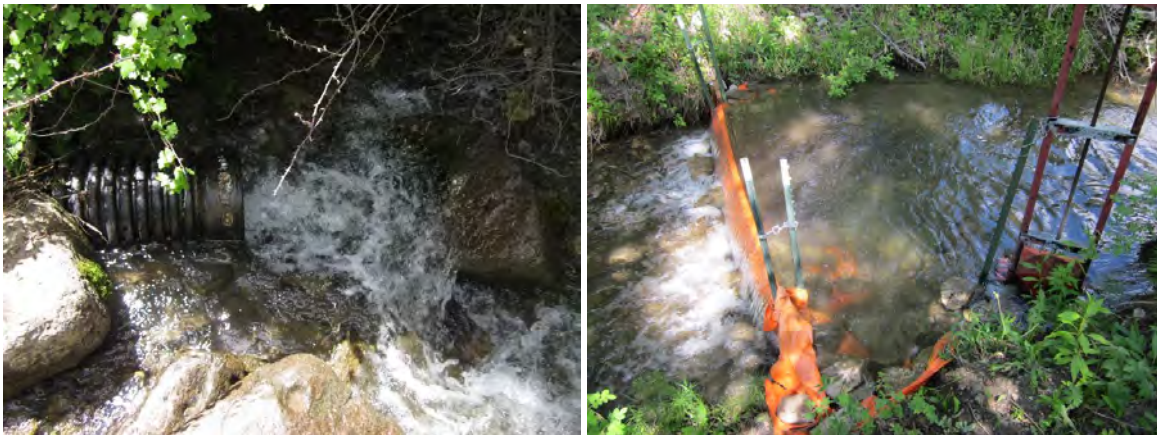
On June 22, 2017, Kyrsten Wolterstorff and Carol Endicott checked on the function of the screen. The turbulence was substantial and appeared to be sufficient to move detritus and fish off the screen. A substantial amount of water flowed through the bypass pipe (Figure 76). The check boards were in place and were likely a temporary barrier to fish movement.

FIGURE 76. BYPASS PIPE (L) AND CHECK BOARDS IMPOUNDING FLOWS TO DELIVER WATER TO THE HEAD GATE (R).

The potential for the check boards to block fish movement is another consideration. According to the FFIP application, the previous diversion had been a total barrier to fish movement. The difference with the current checking of water is that the duration of diversion was decreased by a month as a condition of funding. Instead of diverting from May 1 through July 15, the water user agreed to restrict use to May 1 through June 25, with a 10-day period of use after July 15. This timing coincides with the spawning period for Yellowstone cutthroat trout. However, flows may not be checked during much of the spawning period, as it coincides with spring runoff, when flows are elevated.

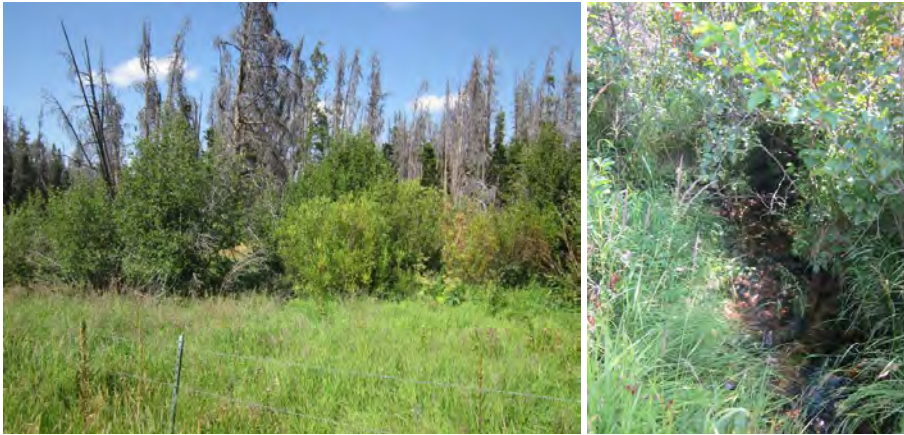
On August 3, 2017, Kyrsten Wolterstorff visited the restoration project on Richardson Creek. GPS data indicated she examined the entire length of the fenced area. The riparian exclosures were still in place, and a healthy riparian area and stable stream channel were present within the fenced area (Figure 79). A water gap between fenced areas showed indications of heavy use by livestock (Figure 80)

FIGURE 79. RIPARIAN FENCING (L) AND STREAM CHANNEL WITHIN THE RIPARIAN EXCLOSURE (R) ON RICHARDSON CREEK.

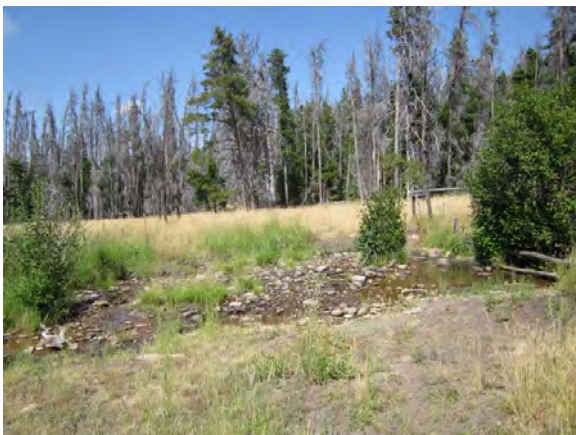
FIGURE 80. WATER GAP BETWEEN FENCED REACHES ON RICHARDSON CREEK.

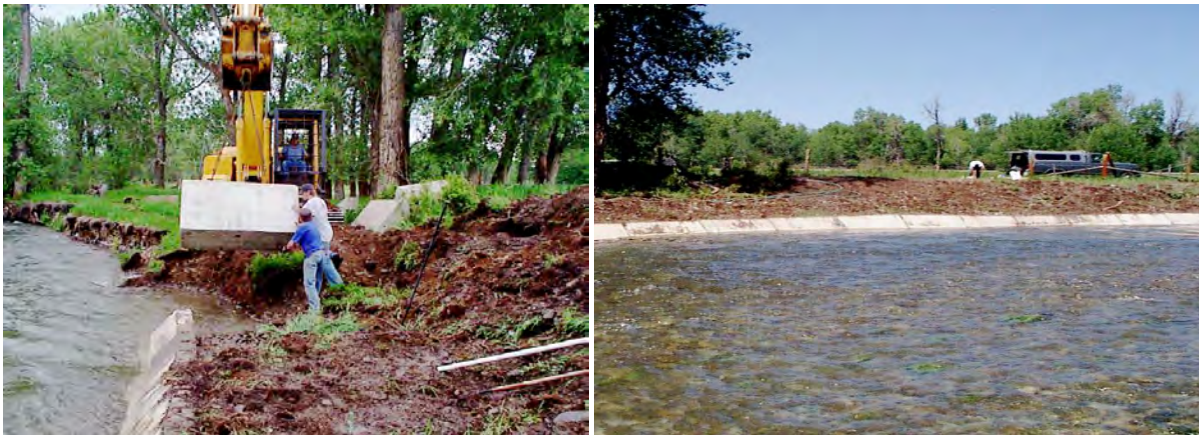
Photos from the construction show eroding banks, the constructed floodplain and the 2:1 slope to the terrace, along with installation of concrete blocks (Figure 82). The length of treated area was not reported; however, project photos indicated this bank was of considerable length.

FIGURE 82. PROJECT CONSTRUCTION PHOTO SHOWING EXISTING ERODING BANK (L) AND CONCRETE BLOCKS INSTALLED ALONG THE BANK LINE (R).

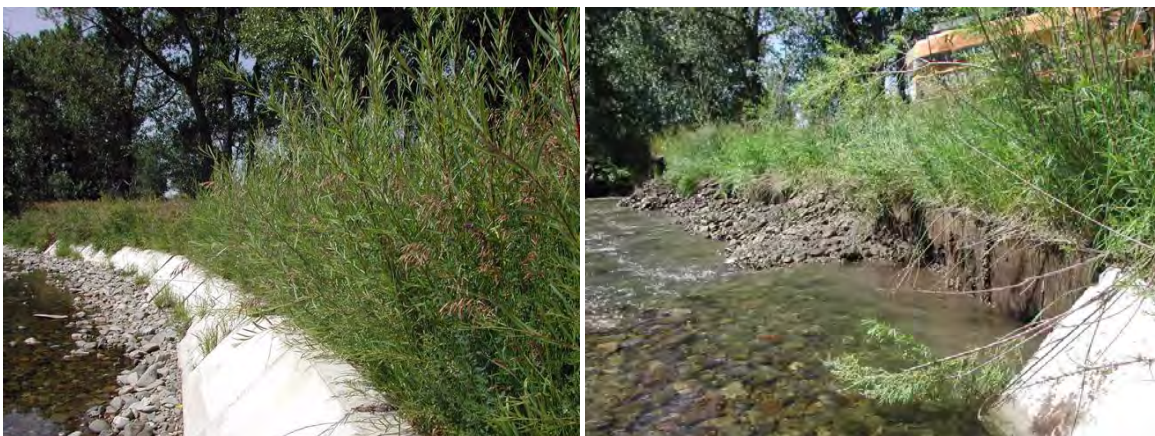
Post-construction photos show a dense mixed stand of nonnative grasses and sandbar willow adjacent to the concrete barriers (Figure 83). Apparently, a cobble toe was installed along the length of the bank treatment, as cobble extends onto the concrete and is at the toe of an eroding reach that was not covered with concrete blocks. The outer meander bend is an erosional area, not a depositional area, so it is unlikely that cobbles accumulated naturally. Neither the application nor post-project report mention installation of a cobble toe.

FIGURE 83. STABILIZED BANK ON THE SHIELDS RIVER (L) AND REMOVAL OF CONCRETE BLOCK AND INSTALLATION OF ROCK TOE (R).

Photos illustrating the removal of the concrete barriers show the barrier left a bare, vertical bank. The nonnative agricultural grasses did not provide the root mass typical of riparian species, which promote soil cohesion and resilience against erosion. A cobble toe was clearly installed as part of the project, although this action was not described in background materials or the project budget.

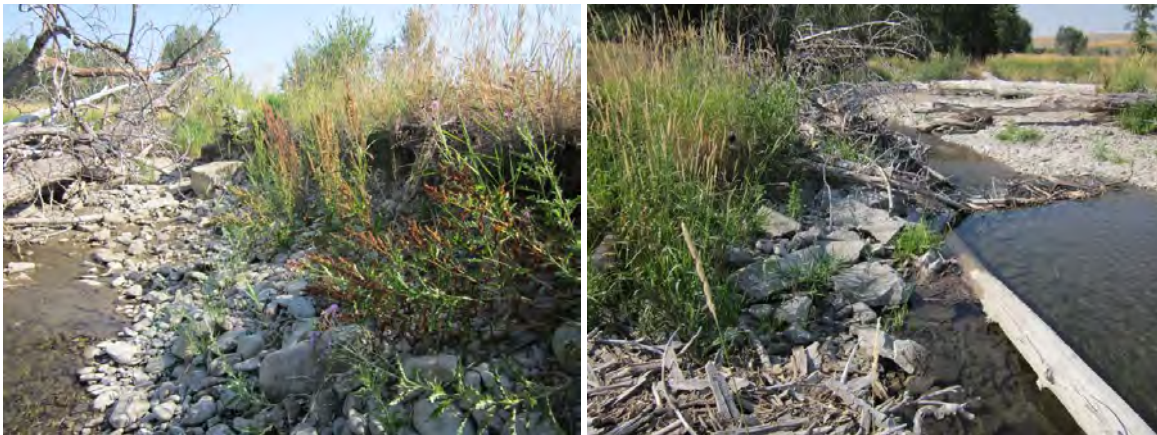
On August 22, 2017, Kyrsten Wolterstorff and Carol Endicott visited the project site. As noted, determining the bank that had been treated was problematic. A portion of the bank considered most likely to be the treated bank supported a community of nonnative grasses and Canada thistle (Figure 85). A cobble toe was present, as opposed to the raw dirt that was present before treatment. Nevertheless, the bank had receded several feet. Large woody debris had been deposited at the site and was providing bank protection. More aggressive efforts at bank stabilization were apparent with riprap being present at the downstream end of the bank.

FIGURE 85. STREAM BANK POTENTIALLY BEING THE RESTORED BANK (L) AND BANK ARMORING AND LARGE WOODY DEBRIS (R)

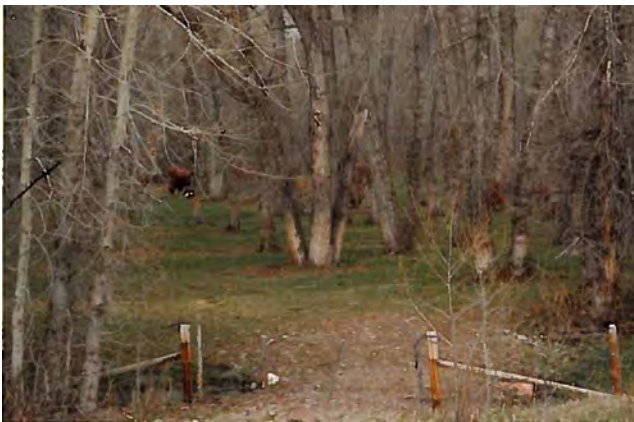
Across these properties, more than 800 cattle and other livestock grazed the riparian zones. Pre-project photos of the Shields River portion of the project are limited. One photo shows portion of a mature cottonwood gallery forest with closely cropped grasses and livestock within the riparian area (Figure 87). The second photo is an overview of the portion of the Shields River used as winter pasture. Determining the influence of livestock throughout the project area is not possible from these photos. The lack of an extensive photographic record of pre-project conditions is common with projects that predated common use of digital cameras and limits the ability to demonstrate recovery. Nevertheless, 800 cattle can exert considerable pressure on riparian areas, stream banks, and channel morphology, so substantial disturbance and degradation was likely.

FIGURE 87. PRE-PROJECT RIPARIAN AREA FOR IMPLEMENTATION OF BEST MANAGEMENT PRACTICES.

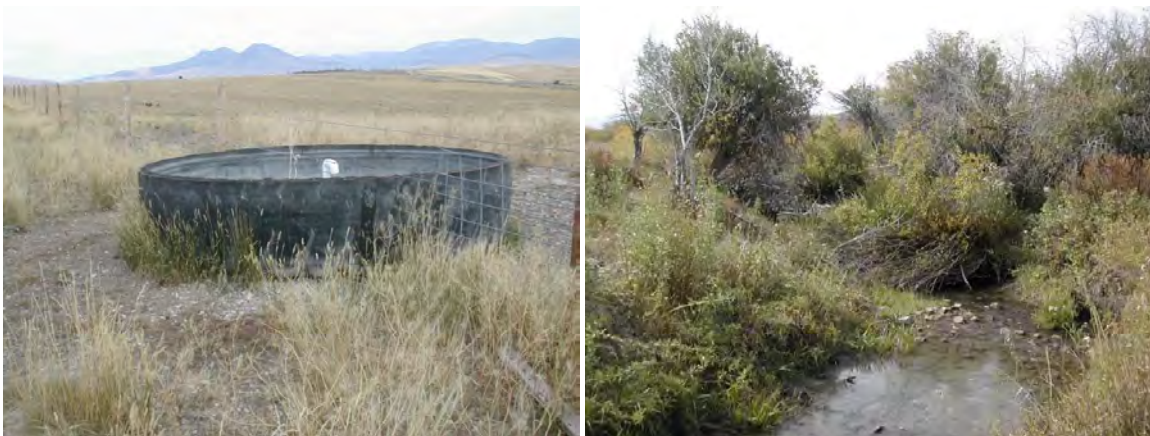
Other photos are dated 2000 and 2002, and document conditions soon after implementation of BMPs. Photos include documentation of a stock tank (Figure 89). Photos are that are likely from Elk Creek show variable conditions, with healthy reaches, areas where the channel was overly wide and devoid of riparian shrubs (Figure 90), and a reach with considerable down cutting and an exposed, highly erodible terrace. Historically, beavers likely had considerable influence on Elk Creek, and much of the stream was impounded by beaver dam complexes. Near extinction of beavers in the mid-1800s removed their influence on streams across the landscape of the West. These streams tend to be especially susceptible to channel down-cutting, as beaver dams trapped sediments for millennia, resulting in fine-grained banks that are susceptible to erosion and head-cutting.

FIGURE 89. STOCK TANK INSTALLED AS PART OF BMPs FOR THE SHIELDS RIVER AND ELK CREEK PROJECT (L) AND HEALTHY RIPARIAN AREA AND INTACT STREAM MORPHOLOGY ON ELK CREEK IN 2002 (R).

The failure of some of the stock tanks is of concern. It is unclear how water was delivered to the tanks and the reason for failure. Technical assistance through the NRCS is recommended for future projects to ensure stock tanks are using the latest technology and are unlikely to fail. Loss of calves to inoperable stock tanks is unacceptable.

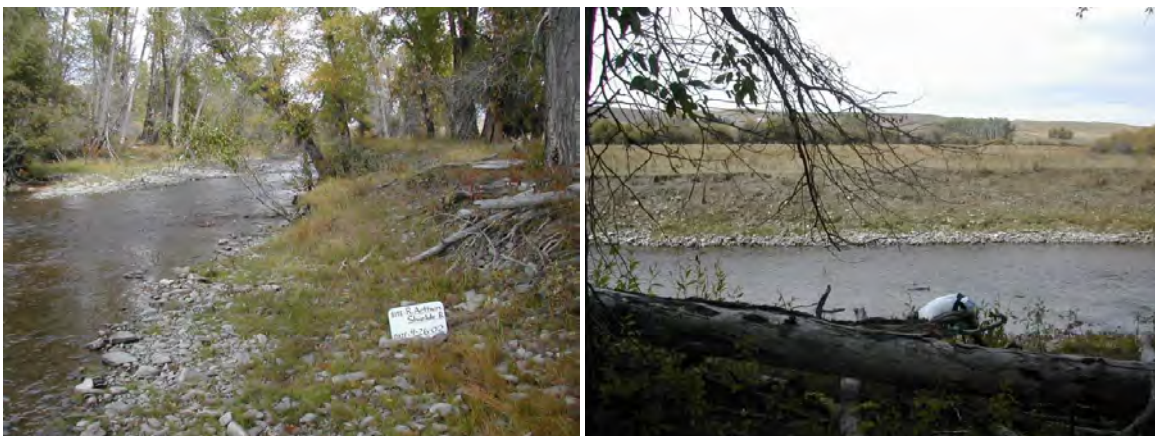
The Shields River is more resilient to disturbance than Elk Creek, as its cobble bed is not susceptible to vertical adjustments, and cobbles in the stream banks make them more resilient to trampling. Photos from 2002 show a mature cottonwood gallery forest, but little recruitment of cottonwoods from suckering and a lack of riparian shrubs (Figure 91). Another photo from 2002 shows a bank devoid of riparian vegetation, vegetated with closely cropped grasses, which suggests continued, heavy use by livestock.

FIGURE 91. FENCED REACH OF THE SHIELDS RIVER IN 2002.

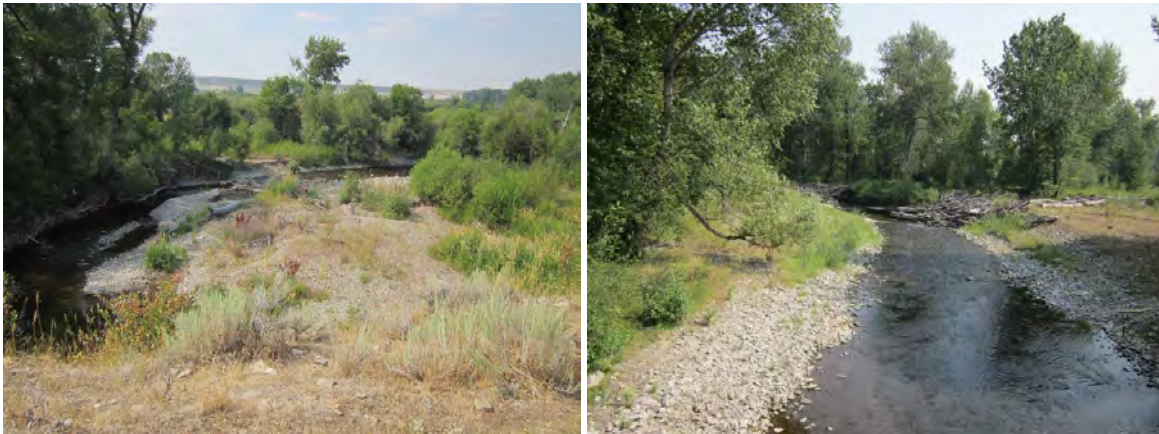
The fence was in good condition, and grazing pressure within the riparian area was light. Much of the riparian area was within a mature cottonwood gallery forest; however, shrubs and cottonwoods were recruiting on point bars (Figure 93). Owing to the substantial bed load supply, the channel was braided in some areas, but occupied a single thread in others. Dense riparian understory was present and afforded high quality habitat for wildlife (Figure 94). A hay field encroached on the stream bank on the

west side of the river, and banks were calving due to lack of root protection, the cobble toe provided some protection against erosion.

FIGURE 93. VIEW OF FENCED SECTION OF THE SHIELDS RIVER SHOWING RECRUITMENT OF WOODY VEGETATION ON POINT BARS (L) AND ON THE SHIELDS RIVER PROPERTY 1.

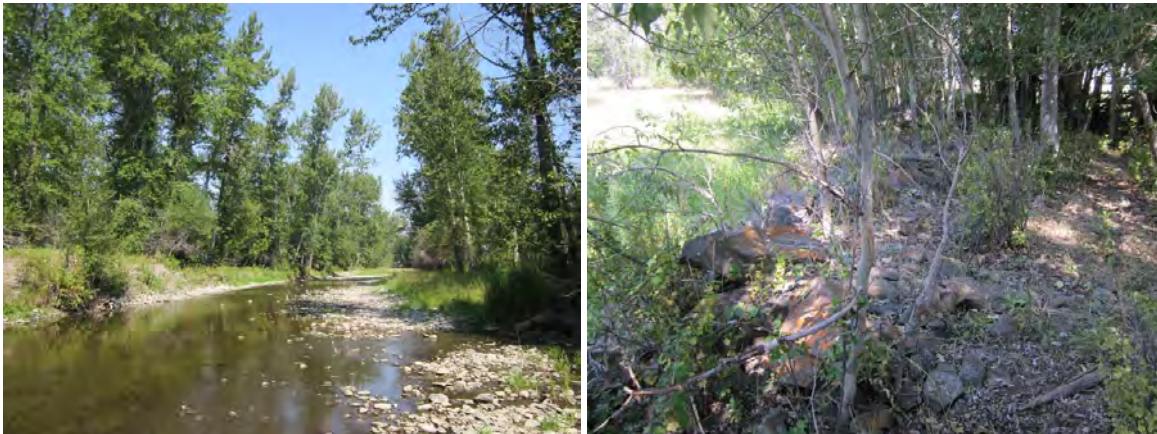
The Shields River flows through a cottonwood gallery forest and is single thread throughout the property (Figure 96). An old attempt at bank stabilization using riprap was only partially protecting the stream, as the channel had moved away from a considerable length of the applied rock. Although not locally derived, the streambed was heavily silted throughout the reach (Figure 97). The Shields River is

FIGURE 96. TYPICAL VIEW OF PROPERTY 2 (L) AND OLD RIPRAP THAT WAS NO LONGER NEAR THE CHANNEL.

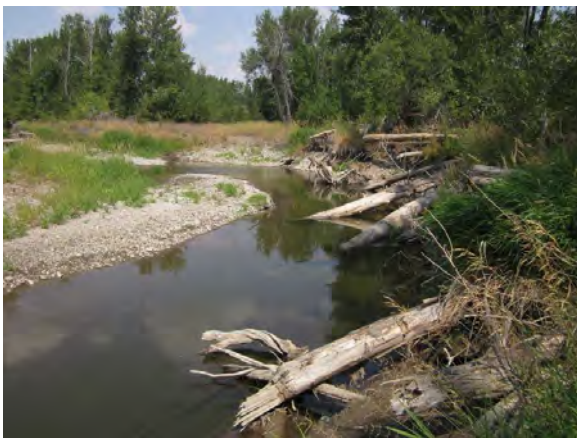
Although fencing and development off-stream stock water benefited the length of the Shields River treated in this project (Figure 95), Kyrsten observed this reach to have the best habitat of all the reaches (Figure 98 and Figure 99). The channel was stable, had high quality pools with large woody debris. Some light browse was present, but no signs that cattle accessed the stream. The landowner does not produce livestock but does grow irrigated hay. Localized infestation of reed canary grass was the only feature that detracted from the functions and values of the riparian area. Similarly, the streambed was heavily silted; however, the fine sediment was likely contributed from upstream sources.

FIGURE 98. HIGH QUALITY POOL, WITH LARGE WOODY DEBRIS AND RECRUITMENT OF WOODY VEGETATION ON RECENT ALLUVIAL BARS.

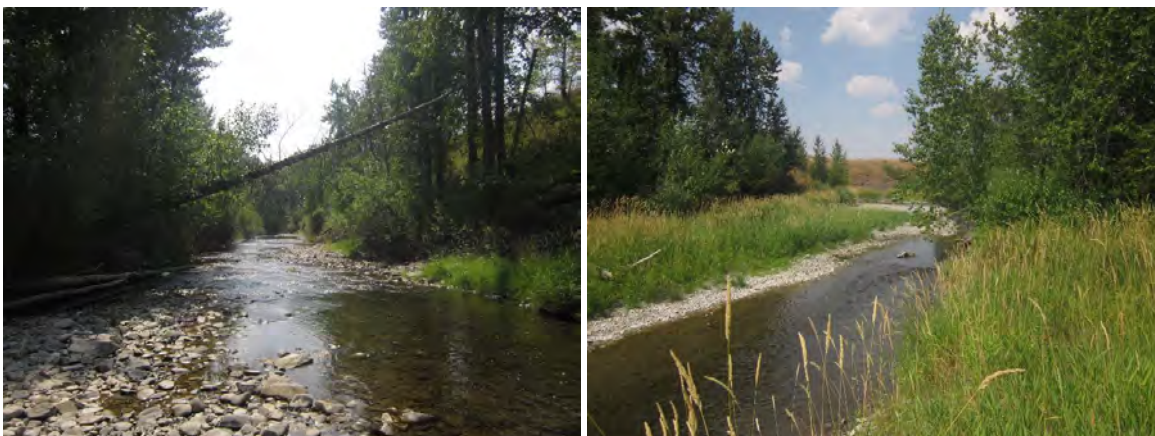
FIGURE 99. SHIELDS RIVER WITH MIXED CONIFER AND COTTONWOOD OVERSTORY (L) AND INFESTATION OF REED CANARY GRASS (R) ON PROPERTY 3.

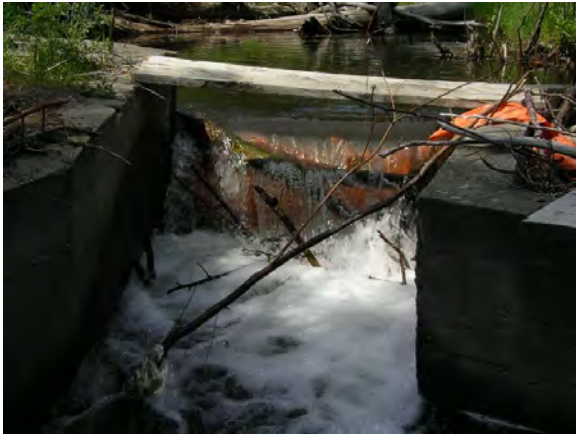
South Fork Fridley Creek is a tributary of the Yellowstone River located upstream of Emigrant in Paradise Valley. An irrigation diversion that used check boards to divert its flows into an irrigation canal was a barrier to upstream movement of fluvial spawners (Figure 100). The solution was to replace the existing diversion with a similar diversion equipped with a Denil fish ladder, constructed in 2008. The ladder was constructed with cast concrete, with wooden baffles installed at 45° angles.

FIGURE 100. IRRIGATION DIVERSION ON SOUTH FORK FRIDLEY CREEK.

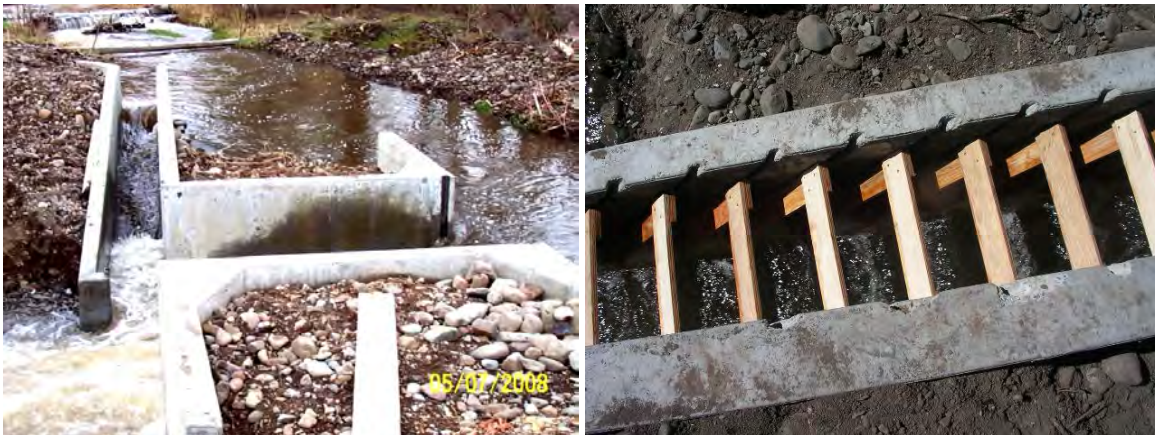
FIGURE 101. NEWLY CONSTRUCTED FISH LADDER (L) AND WOODEN BAFFLES (R) ON SOUTH FORK FRIDLEY CREEK

Soon after construction was completed, South Fork Fridley Creek experienced a flood of significant magnitude. Emergency riprap was installed to keep the stream from cutting around the new structure. This flood also embedded the baffles with cobble, making them impossible to remove without mechanical assistance.

Recommendations include clearing the cobble and removing the baffles to check their condition. Another set can be installed if they are damaged. In addition, personnel with expertise in fish passage should evaluate if the ladder is passable in its current condition.

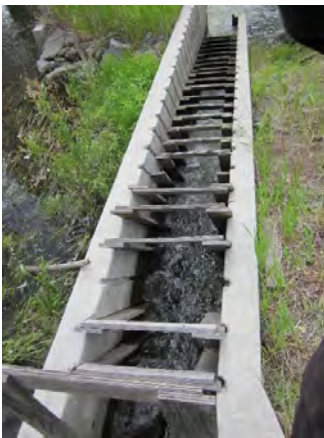
the fish ladder. The Denil fish ladder was designed according to the established standard, with closely spaced baffles that create turbulence that dissipates energy. Visual inspection of the ladder found highly turbulent water; nevertheless, the velocity appeared to be substantial in the ladder and may exceed the burst swimming ability of fish. Other observations were that cobbles had embedded the baffles, which are now immobile. In addition, the baffles are wooden and have swollen. Digging out the cobbles or using a mechanical winch may be advisable to reset the baffles. A second set of baffles is stored at the Livingston Fisheries Office; however, metal baffles may be an improvement, as they would not swell, and may be easier to extract in cleaning the ladder, despite their greater weight.

FIGURE 102. DENIL FISH LADDER ON SOUTH FORK FRIDLEY CREEK.

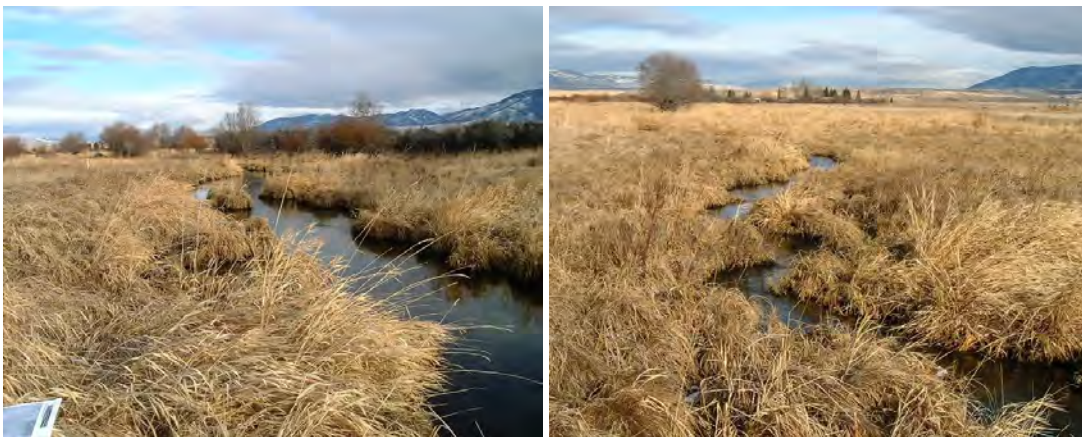
Photos presumably of the unnamed tributary show sedge covered stream banks and variability in channel width (Figure 104). Willows were rare to absent along the channel. Formation of a sedge covered, mid-channel bar suggested insufficient energy to maintain a narrow, deep E channel that is typical of spring creeks.

FIGURE 104. UNLABELED PHOTO POTENTIALLY SHOWING UNNAMED TRIBUTARY.

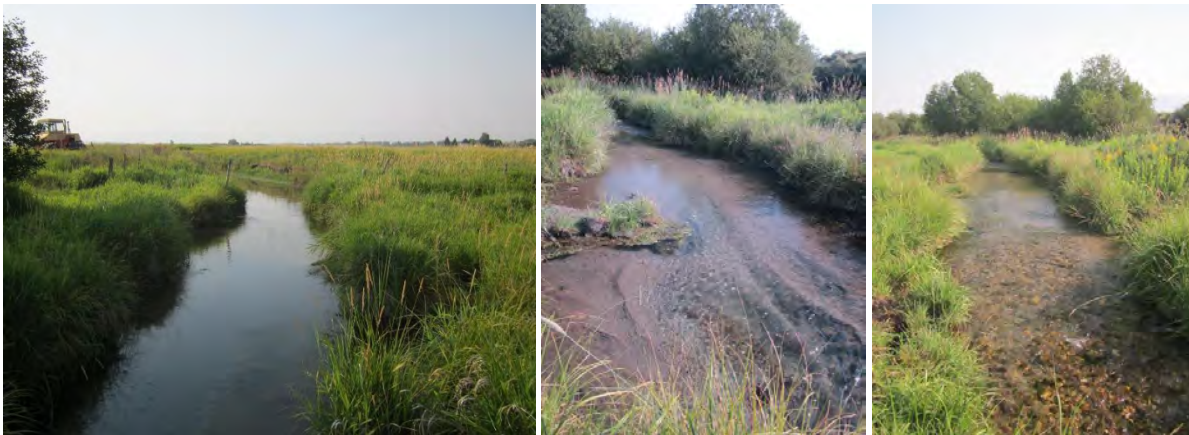
On August 4, 2017, Kyrsten Wolterstorff visited the South Fork Ross Creek project site, accompanied by the landowner. The channel had reverted to its overly wide configuration, and accumulation of fine sediment was again substantial (Figure 105). A robust stand of undisturbed sedges occupied the bank line, so lateral adjustments were not the result of bank erosion. Fine sediment did not fill in the entire channel, as a discrete reach maintained clean gravel (Figure 105).

FIGURE 105. OVERLY WIDE CHANNEL (L), ACCUMULATION OF FINE SEDIMENT (C), AND EXPOSED GRAVEL (R) ON RESTORED PORTION OF SOUTH FORK ROSS CREEK.

The landowner reported that in a few years after restoration, he witnessed considerable use of South Fork Ross Creek by spawning fish. The stream morphology reverted to pretreatment conditions within a few years. Despite the failure of this project to secure high quality spawning and holding habitat for fish, wildlife benefited, especially waterfowl.

As the FFIP and other funding sources have contributed substantially to spring creek restoration, and these streams have high ecological and conservation value, approaches to spring creek restoration need thorough review, application of an adaptive approach, where stream restoration practitioners learn from successes and failures.

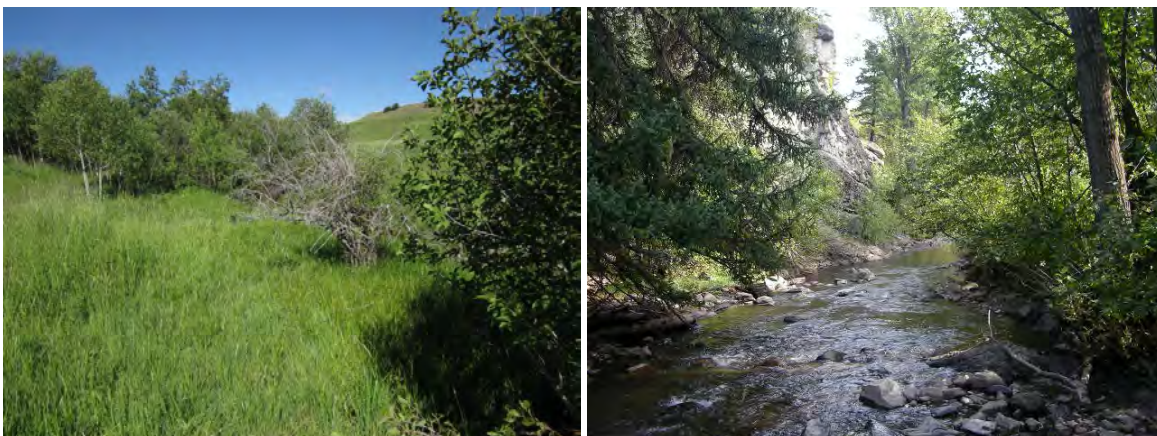
Subsequent electrofishing efforts indicated Yellowstone cutthroat trout did not stay in Thiel Creek. Thiel Creek is a small, gravel-bed stream flowing through rangeland (Figure 107), and Lower Deer Creek is a montane stream with a predominantly cobble substrate (Figure 107). As the habitat in Thiel Creek was considerably different than Lower Deer Creek, the Yellowstone cutthroat trout likely left. Efforts to establish or reestablish Yellowstone cutthroat trout since this project has used egg boxes or remote site incubators, so fry become imprinted on the new stream.

FIGURE 107. TYPICAL VIEW OF THIEL CREEK UPSTREAM FROM THE CONSTRUCTED BARRIER (L) AND OF LOWER DEER CREEK (R).

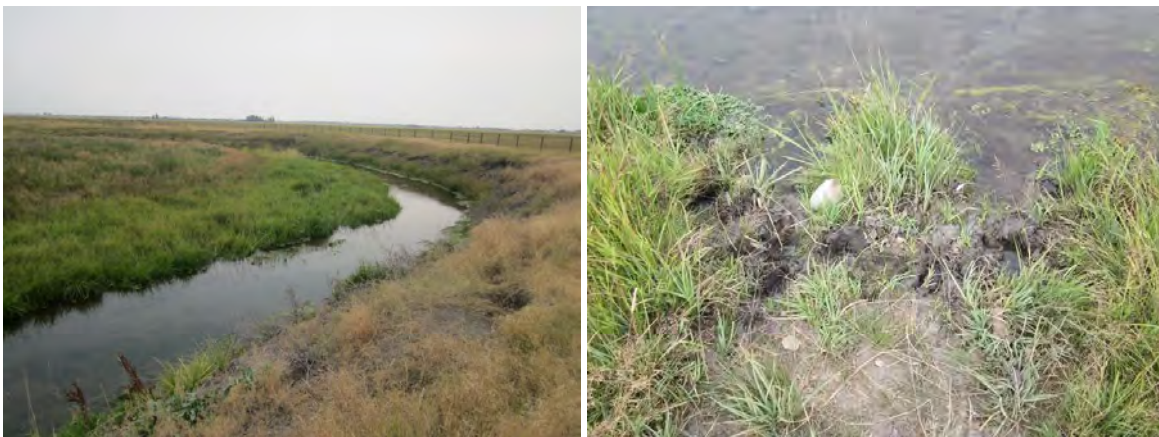
Kyrsten Wolterstorff visited the Thompson Creek project on August 8, 2017. The riparian area was fenced (Figure 110), although not according to the FFIP application. Some hoof shear and manure were present, but grazing pressure was otherwise light.

FIGURE 110. RIPARIAN FENCING (L) AND SLIGHT TRAMPLING BY LIVESTOCK (R) ON THOMPSON CREEK.
