FUTURE FISHERIES IMPROVEMENT PROGRAM

BIENNIAL REPORT

Summary of program activities for the period November 1, 2016 to October 31, 2018

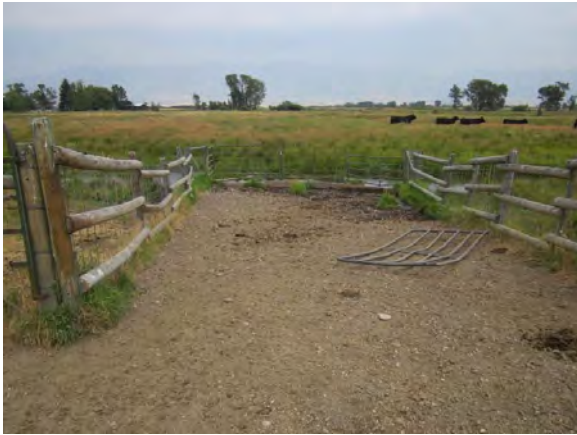
Armored water gaps had been installed as described in the FFIP application (Figure 111). Although it was unclear if the grazing followed a developed grazing management plan, the combination of fencing, water gaps, and limited use of the riparian area resulted in dense herbaceous vegetation within the riparian area. Shrubs were sparse to absent; however, many spring creeks do not provide habitat suitable for establishment of riparian shrubs.

FIGURE 111. ARMORED WATER GAP ON THOMPSON CREEK.

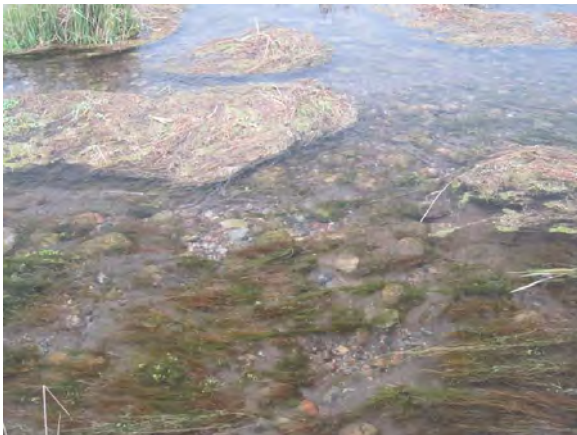
The amount of fine sediment choking the streambed was a factor limiting the ability of Thompson Spring Creek to meet project goals of providing spawning habitat for fish migrating from the East Gallatin River (Figure 110 and Figure 112). The channel was relatively shallow and wide. Combined with the buffered flows typical of spring creeks, the stream lacks the energy to transport fine sediment from its bed.

FIGURE 112. THOMPSON CREEK'S STREAMBED, SHOWING HIGH LEVELS OF FINE SEDIMENT AND SPARSE GRAVEL.

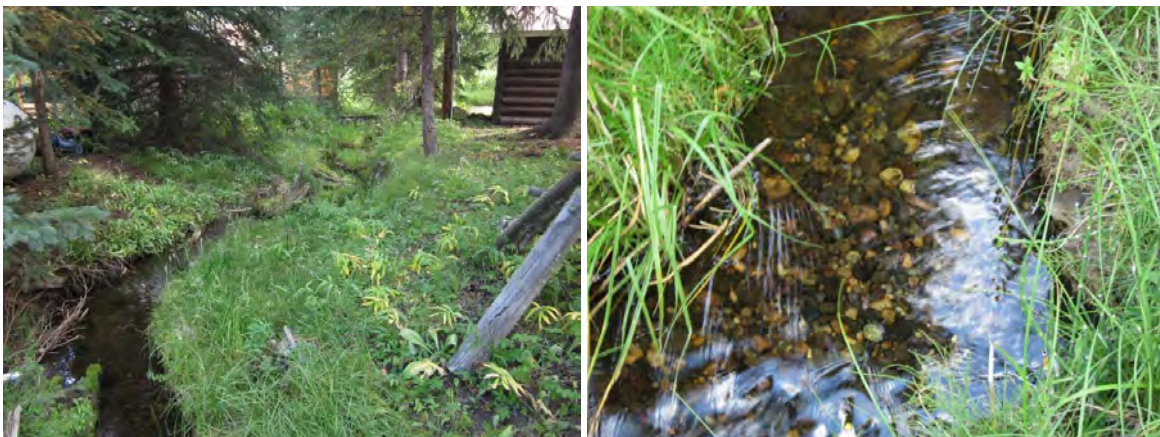
FIGURE 117. TYPICAL REACH OF WILLOW CREEK, RETAINING ITS CROSS-SECTIONAL DIMENSIONS (L) AND GRAVEL SUBSTRATE (R).

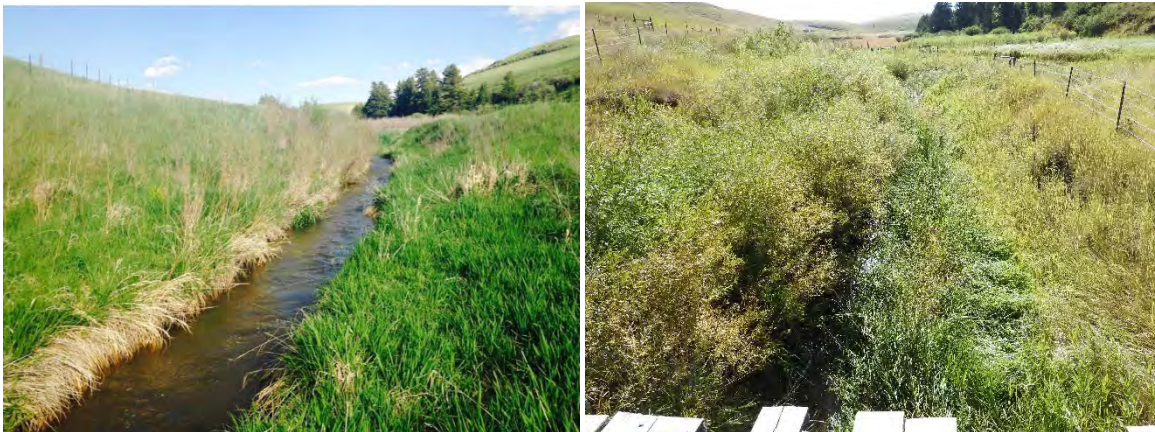
In 2018, this project location was visited while monitoring an adjacent project (018-2017). The fence and riparian areas were in good condition. Some weeds were present, but riparian areas have not been grazed. The landowner reported that the project has been successful and is working as intended.

The area has recovered significantly. Soil was added the bridge to encourage cattle to cross, which has been successful.

FIGURE 118. BIG OTTER CREEK RIPARIAN RESTORATION BEFORE (L) AND AFTER (R) RESTORATION.

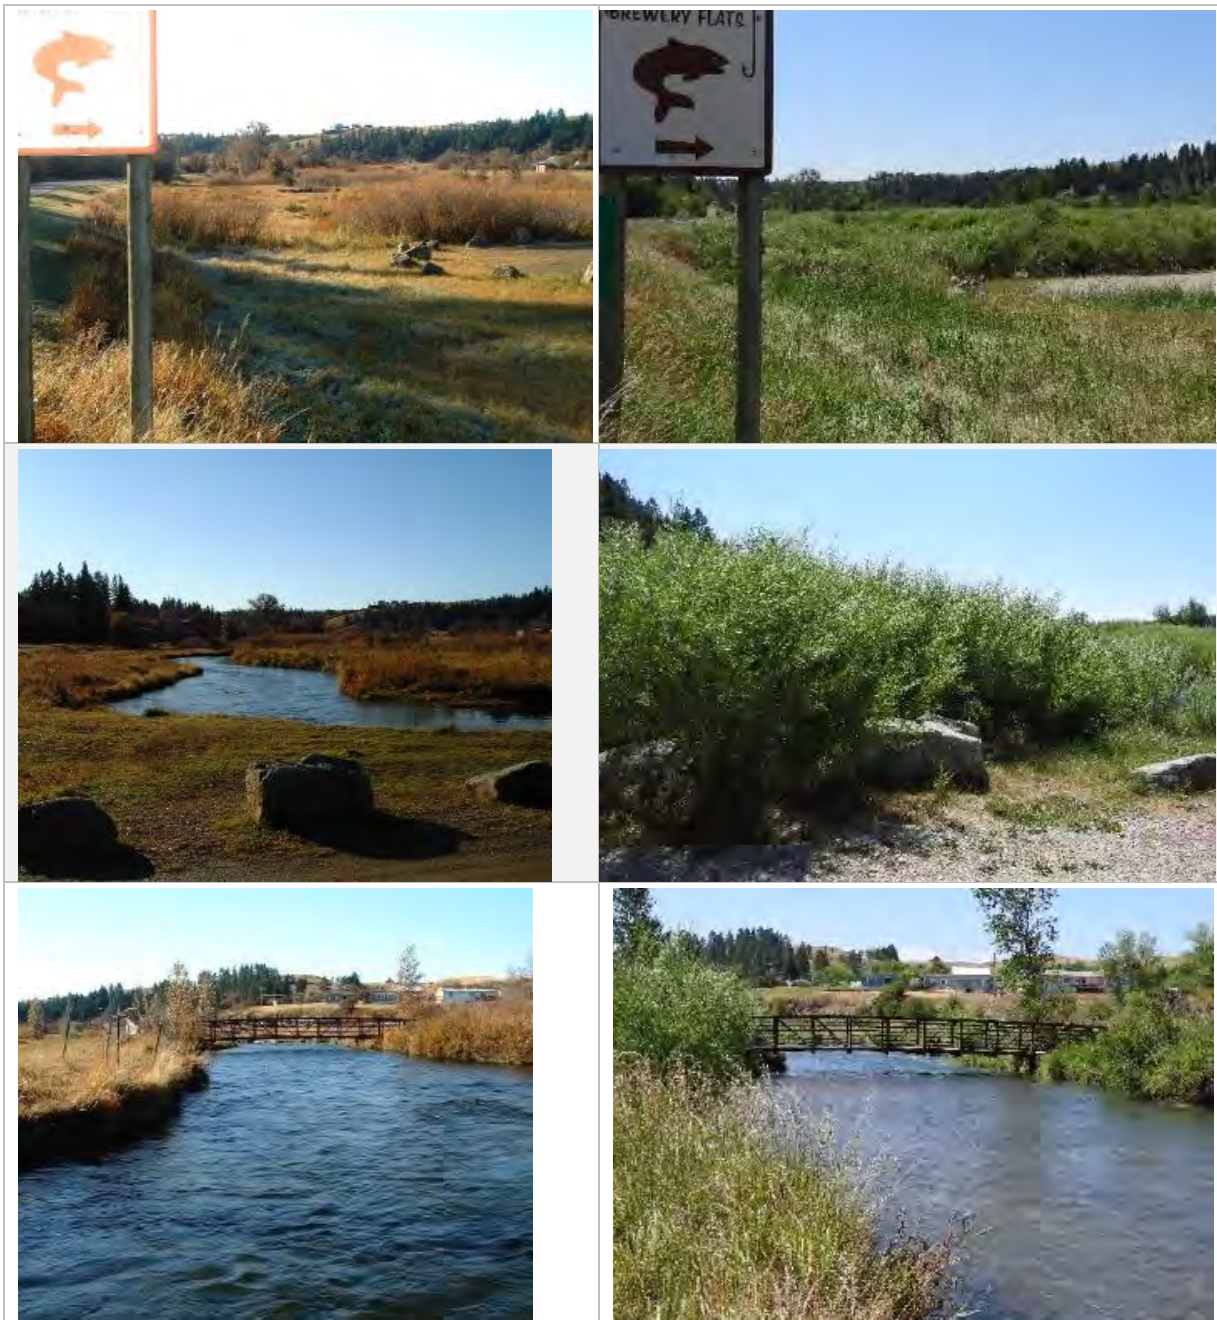
Monitoring in 2017 showed considerable willow growth (Figure 119). Some riparian enclosures were in place, but natural recruitment is having the highest success rate. The stream had only minor adjustments after 17 years. Some lateral erosion was present near a walking trail bench, but minimal overall. The project has been very successful in its goal to reconstruct the stream to its natural channel and establish natural riparian vegetation. This project site is public and used for walking, bicycling, bird watching, and angling. It is the ideal project for the FFIP: angling opportunities and fisheries habitat have increased substantially.

FIGURE 119. EFFECTIVENESS MONITORING PHOTOS AT BREWERY FLATS. AFTER CONSTRUCTION (2009, L) AND CURRENT (2017, R).

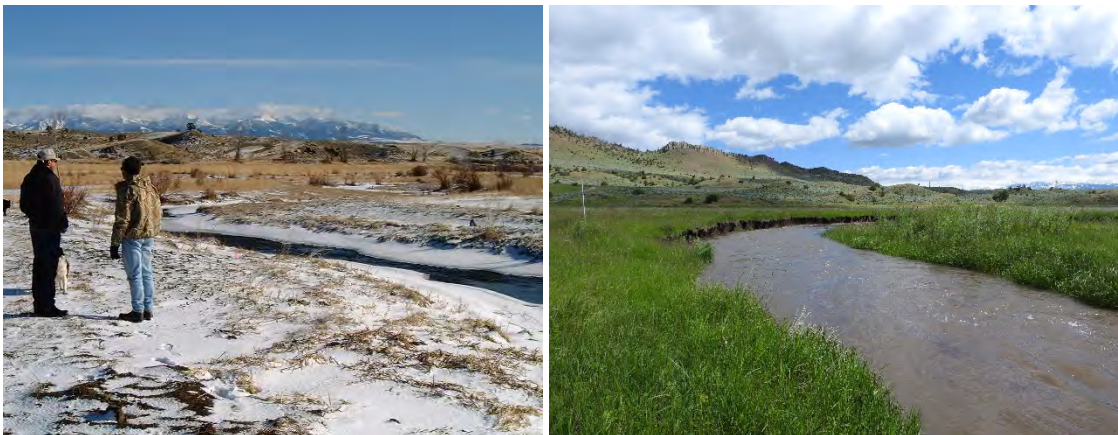
This site was visited as part of a FFIP project tour, led by Yellowstone Cutthroat Trout Restoration Biologist Carol Endicott, where current Panel members gained on-the-ground experience with historical projects. The stream was wider than expected and some erosion remained, but the channel form has generally been maintained. It is functioning as intended and is considered a successful project. The areas of erosion could potentially be improved with the addition of woody vegetation. Willows were not dominant throughout much of the project site.

FIGURE 120. BRACKETT CREEK AFTER PROJECT CONSTRUCTION (L) AND IN 2017 (R).

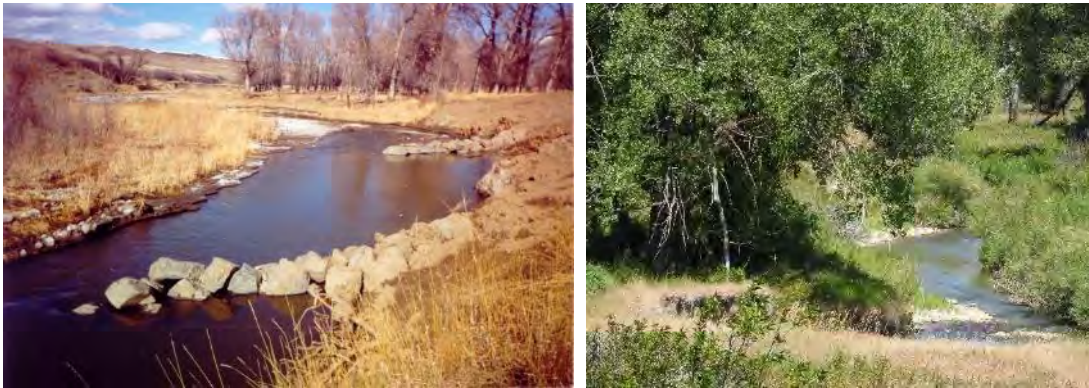
In 2017, the stream was observed downstream of the project site as the landowners could not be reached. Aerial photography was used to compare channel form over the years at the project site. It was evident that the project was successful in taking pressure off the bank. Fencing appears to be in

good condition and riparian area looks healthy. This project appears to have been successful in repairing the riparian area.

FIGURE 121. COTTONWOOD CREEK IN 1999 (AFTER COMPLETION; L) AND IN 2017 (SLIGHTLY DOWNSTREAM OF PROJECT SITE, R)

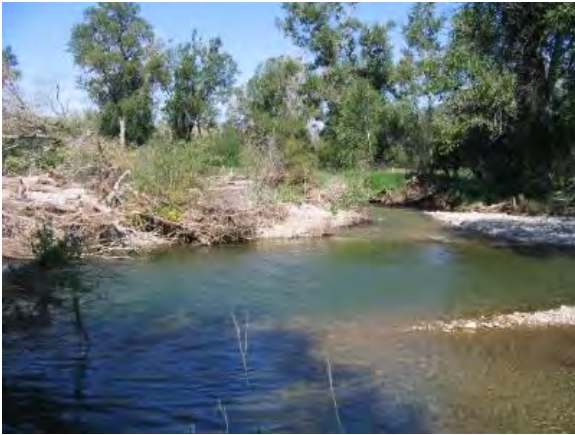
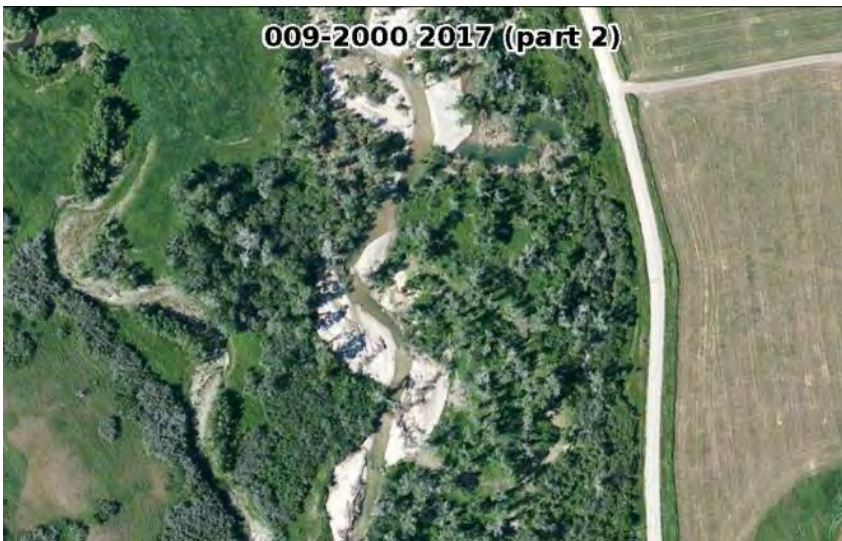
In 2017, the FFIPC met with the landowner, who was confused about the exact project location. Nonetheless, the landowner indicated that there have been dying cottonwood trees, meaning that the floodplain connection may be limited. Conditions upstream and downstream of the site showed erosion and some bank stabilization problems. Aerial photography showed topography in 2017 similar to 2011 conditions, when the channel straightened during a high flood event. At that time, riparian condition was considered good. This project may have improved erosion to some degree, but after a discussion with the local fisheries biologist, it appears the problems are much bigger in scope. Any additional improvements would need to consider the watershed. The project is considered minorly successful, and probably had most of the benefit before the 2011 channel adjustment. Lessons learned from this project include evaluation of the watershed and other limitations in project development.

FIGURE 122. PROJECT SITE IN 2011 (10 YEARS POST-CONSTRUCTION)

FIGURE 123. AERIAL VIEW OF SITE, 2017 (16 YEARS POST-CONSTRUCTION).

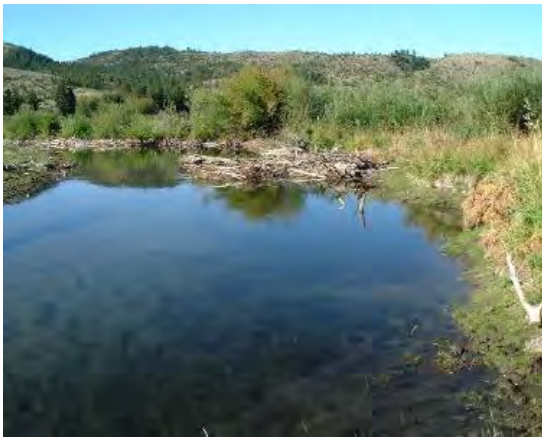
FIGURE 124. DEEP CREEK PROJECT SITE, COMPLETED IN 2004.

In 2017 the FFIPC visited the site with the fisheries biologist, Ron Spoon. Mr. Spoon noted that the use of juniper revetments had limited success and were washed out in most cases, but believed they contributed to downstream woody debris jams/habitat. Some banks appeared stabilized in the locations where vegetation developed, but the areas most prone to failure were outside bends where

scour tends to be highest. Overall, the project appears to have been partially successful. However, the use of juniper revetments is no longer common practice due to its rate of failure. Additionally, rock toe was not part of project and that may have kept banks in place for a longer period.

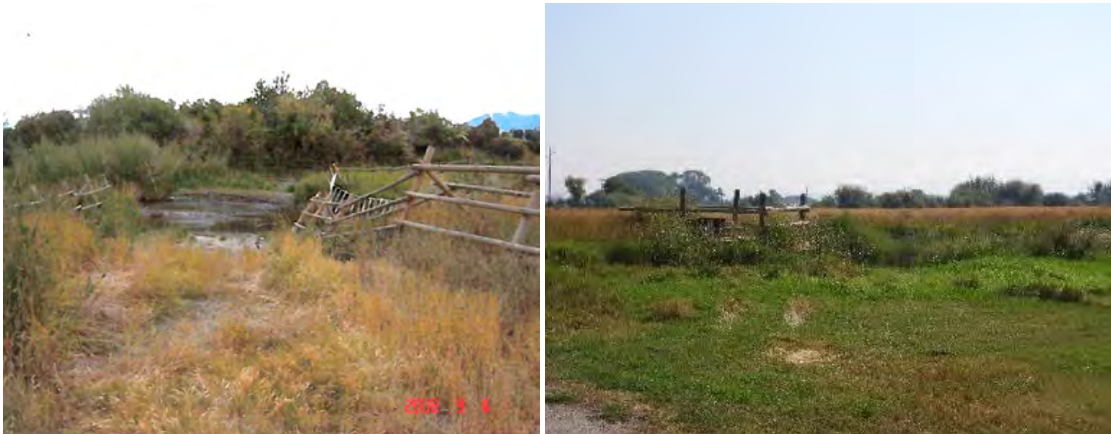
In 2017, the FFIPC and fisheries biologist Ron Spoon visited the site. Mr. Spoon noted that the project area was particularly useful in the winter and had a significantly positive impact on the riparian area.

It has been very successful in reducing the impact from livestock. This project is part of a larger watershed effort to improve Deep Creek.

FIGURE 125. DEEP CREEK PROJECT SITE IN 2008 (PROJECT COMPLETION, L) AND 2017 (9 YEARS POST PROJECT, R). WATERGAP AND OFF STREAM WATER.

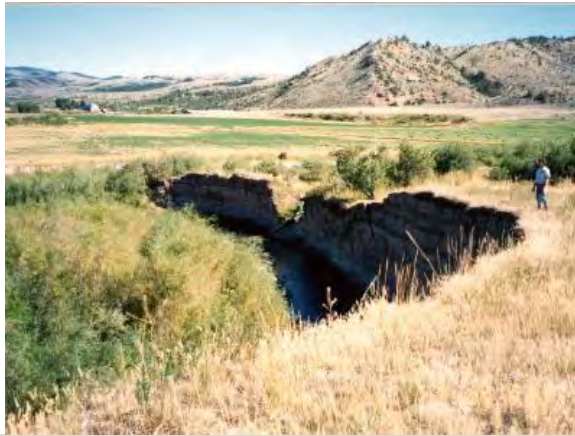
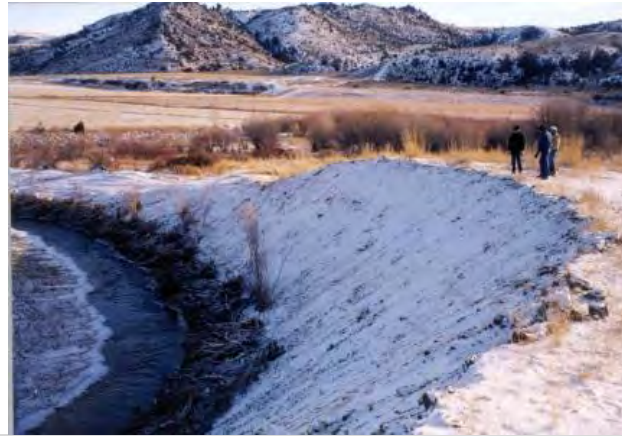
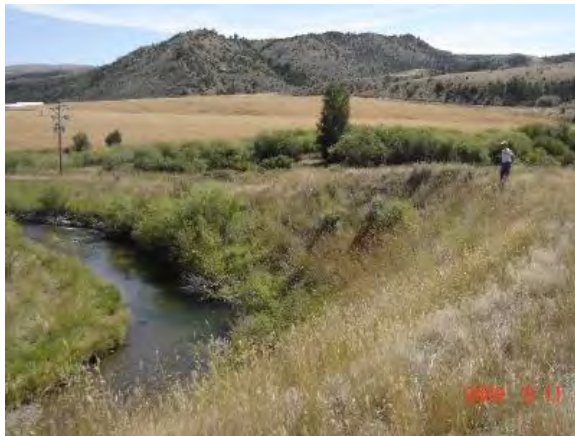
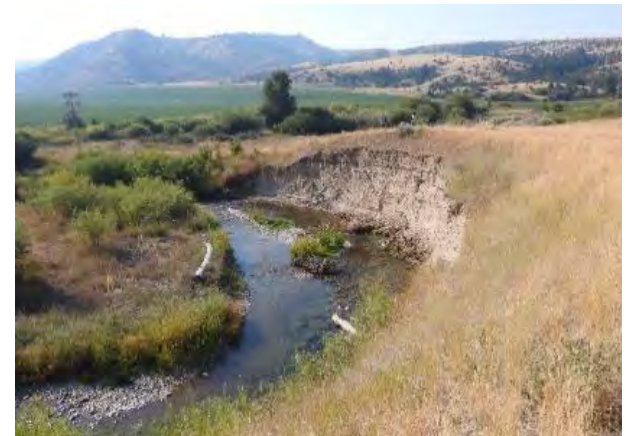
FIGURE 126. DEEP CREEK PROJECT SITE FROM 1996 TO 2017.

In 2009, the riparian condition was excellent with no observed livestock use. Stabilized banks were mostly retained, and willow recovery was considered good. There was one observed bank slump and it was noted that there could be some future erosion in the area. By 2017, the specific site had experienced extensive erosion and a vertical bank was again present (Figure 124). The primary method of bank stabilization used in this project was juniper revetments, which have washed out in most places that they were installed, especially in high risk areas such as meander bends.

This project had high success for at least 10 years, but by 20 had reverted to an erosive bank. The degree of success is hard to determine based on the duration of this project. It is considered moderately successful because it created a benefit for over 10 years. However, the lessons learned concern the use of juniper revetments for long-term bank stabilization. That specific treatment has largely been replaced with more effective methods. This project also shows how a small area of maintenance can unravel a project without intervention or repair. Had the small area of erosion been repaired, much of the bank treatment may have stayed in place.

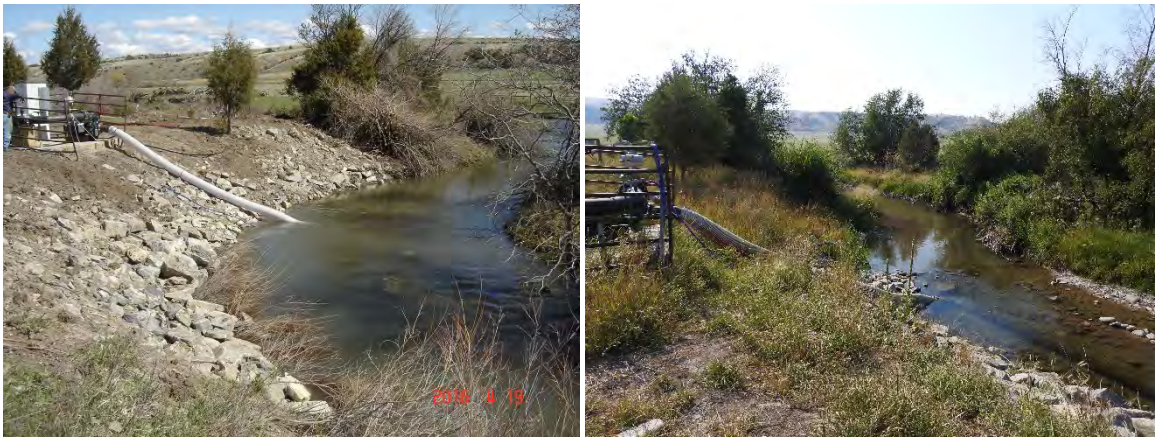
velocity on adjacent streambanks. The willow did not take and was reportedly not installed well. Overall the project was successful in water conservation but could have benefited from improved techniques or better construction oversight of the to riprap installation.

FIGURE 127. DEEP CREEK PUMP SITE AT COMPLETION (L) AND IN 2017 (R).

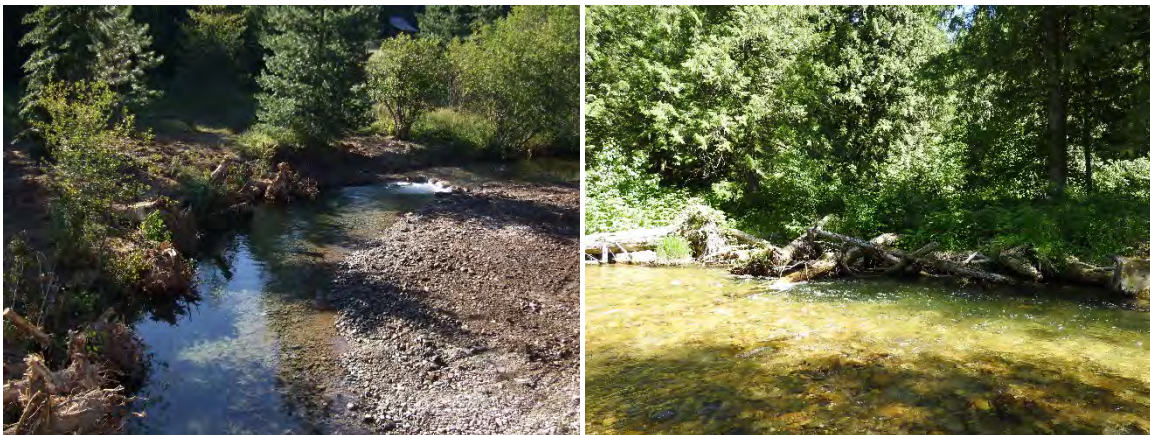
When the project site was visited in 2018, it was largely intact and functional. Much of the wood in the banks and as grade controls were retained, which is notable for a 10-year-old project in a high energy stream system. This project is considered highly successful in meeting its objectives of moving the stream away from a slide and incorporating stability and habitat complexity.

FIGURE 128. EAST FORK BULL RIVER CHANNEL STABILIZATION AFTER CONSTRUCTION (L) AND IN 2017 (R).

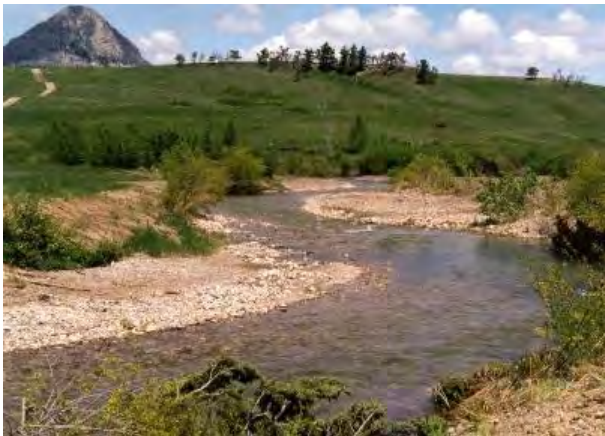
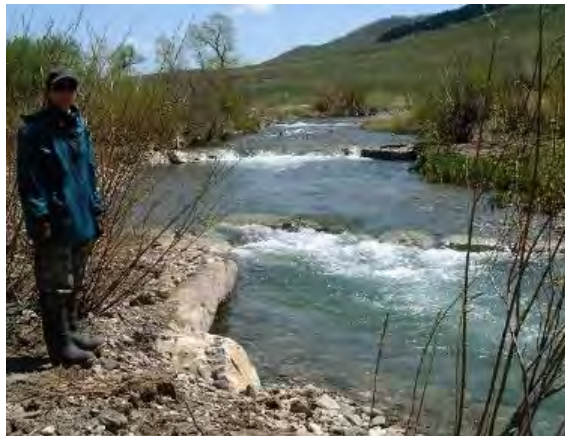
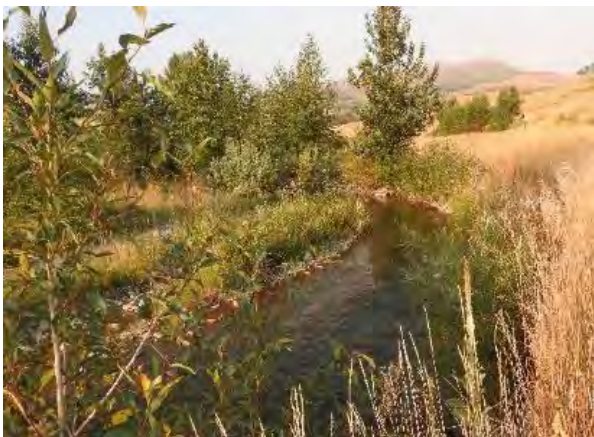
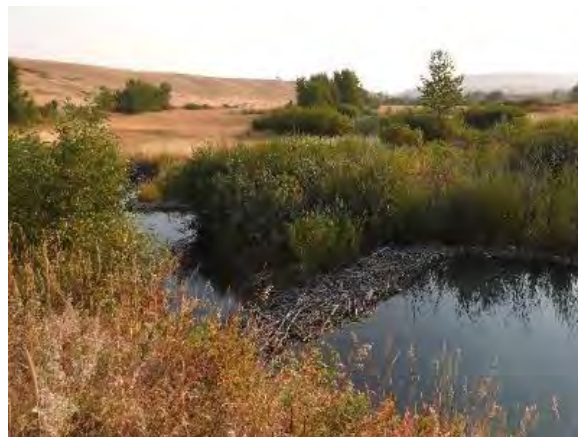
FIGURE 129. ELK CREEK RESTORATION PROJECT, 2000-2017.

In 2001, fencing was installed. The goal was to improve water quality, reduce sedimentation, and improve the riparian corridor. In 2017, the project was in great condition with a healthy riparian area and little to no browsing by livestock. Past erosive areas were showing evidence of healing. This project is considered successful from both the landowner and from the FFIP. It is being managed as intended with healthy riparian and stream areas.

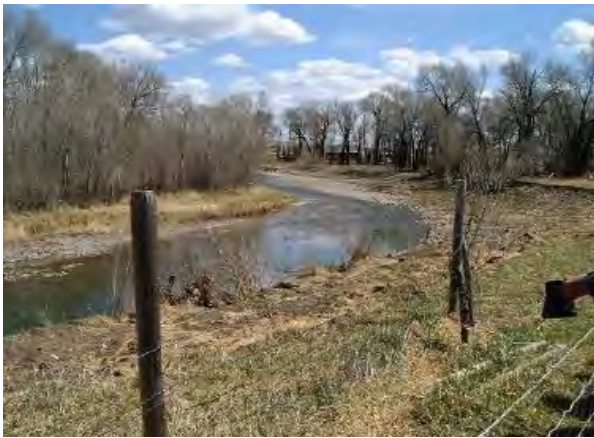
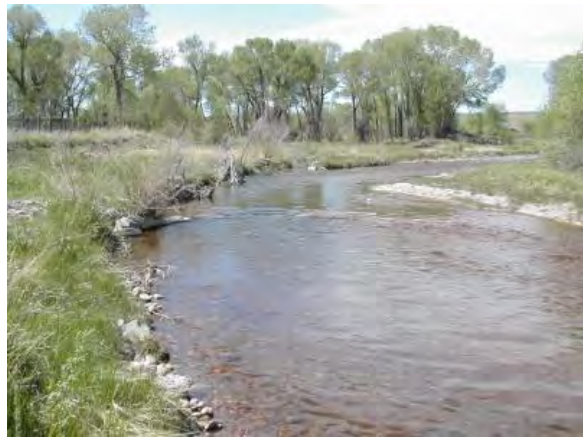
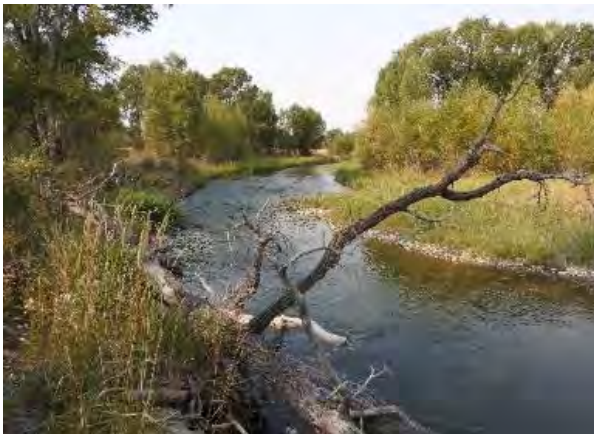
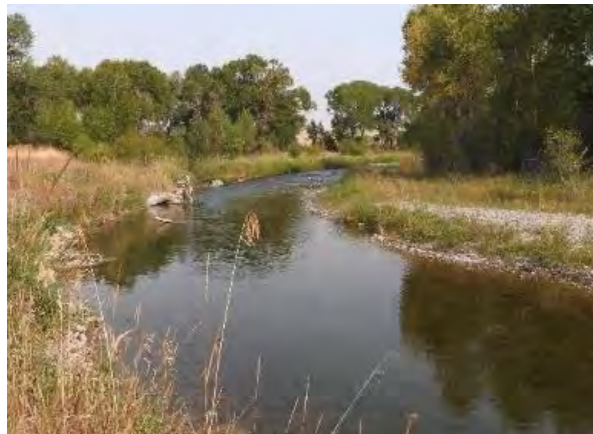
FIGURE 130. ELK CREEK CHANNEL RESTORATION, 2000-2017.

When it was monitored in 2017, the past project was evident. There has been some erosion, but the project has been maintained to meet its original goals. Even though there was no grazing plan recorded, fencing is in good condition and browsing is minimal. The channel appears to be functional and transporting sediment. Some erosive areas were present, but they were not abundant. Weeds

were prevalent throughout the observed reach. The landowner was not present, so it is unclear how the project area is managed. Overall, this project is considered successful in meeting its original goals and objectives. Weed management could improve its efficacy.

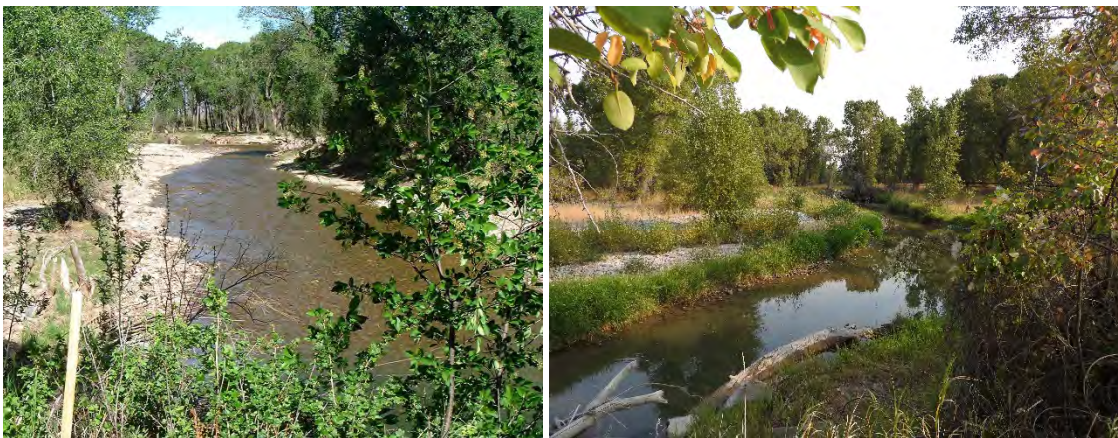
A 2017 site visit indicated that the current landowner was not familiar with project, but her son gave some input on location. When walking the site, it was noted that the riparian area was in good condition, with plenty of vegetation present. Some weeds were noted in the area. Condition of the riparian vegetation had improved since construction, point bars have developed, and stream has an obvious floodplain. Overall, the project continues to meet its goal of preventing a meander cutoff and retains a vegetated riparian area.

FIGURE 131. ELK CREEK CHANNEL RESTORATION, AFTER COMPLETION (L) AND IN 2017 (R).

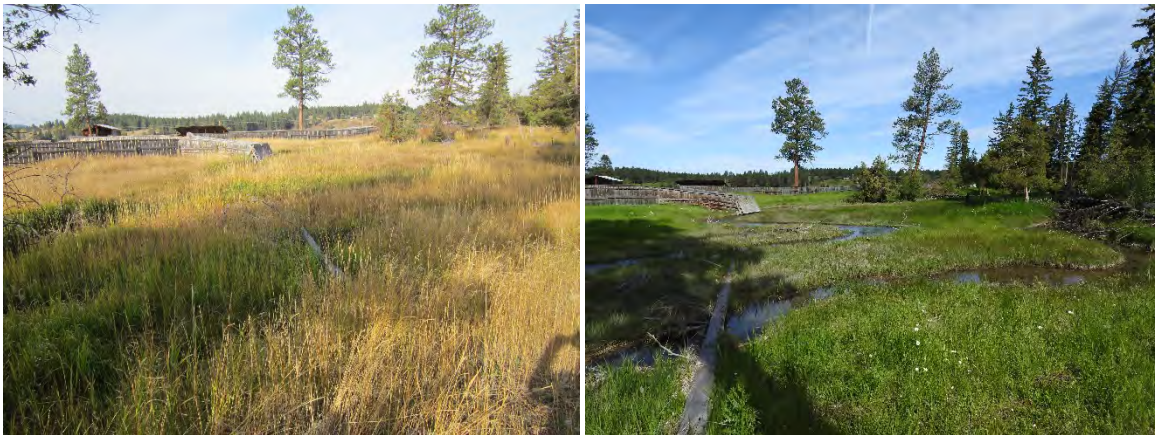
In 2018, this site was visited as part of a FFIP project tour. The stream was in great shape and looked very similar to its 2011 photos. This is significant, considering that it is a spring creek and these types of projects tend to become over-wide or not scour enough to retain clean spawning gravels. This stream has mostly retained its form and clean gravel 10 years later. Ryen Neudecker (Big Blackfoot Chapter of Trout Unlimited) was unsure of fishery response, but a spawning redd was visible during the site visit. Although the fish weren't present, the species was likely rainbow trout or westslope cutthroat trout. Overall, this project is considered successful and is one of the best examples of spring creek restoration observed by the FFIPC.

FIGURE 132. ENDERS SPRING CREEK AFTER CONSTRUCTION (2011; L) AND 2018 (R).

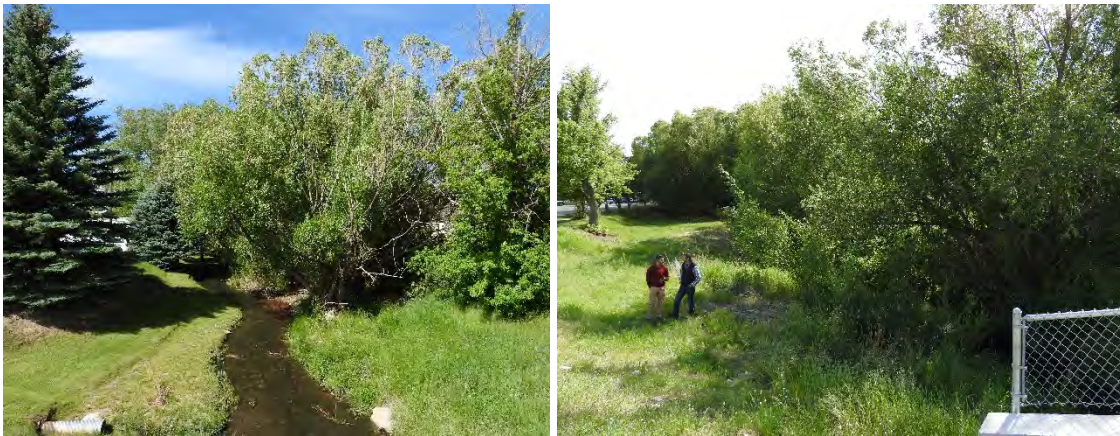
Several site locations were visited in 2017 as part of a FFIP project tour. The project appeared to be generally successful but because it is in the town of Livingston, there have been a few issues including erosion and mowing grass too close to the stream (Figure 134). Overall, this project has been successful in mitigating flood-related impacts and reducing water quality degradation from the city of Livingston. Although there are minor issues, they are generally related to the location of the project in an urban area.

FIGURE 134. FLESHMAN CREEK IN 2017. MOWING ADJACENT TO THE STREAM (L) AND ABUNDANT RIPARIAN DEVELOPMENT (R).

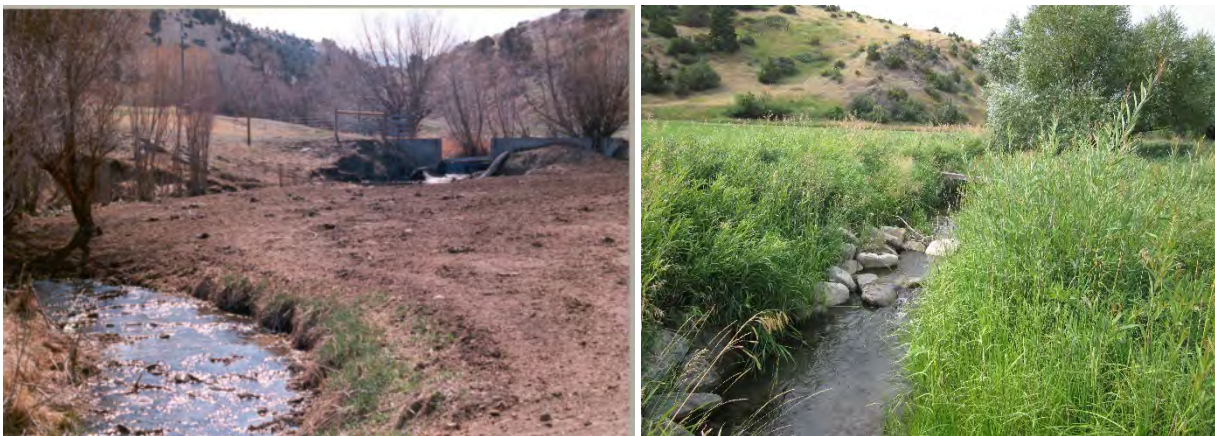
There were a few concerns about the site, including the observation that the railroad culvert could now be a barrier. Additionally, the apron on the diversion that was converted into a barrier appears to be slightly collapsing. It was also noted that the stream channel downstream of interstate was silty, but with a lot of willow cover. The area upstream of interstate had sparse shrub cover and may be contributing sediment.

Overall, the project appears to be successful in creating fish passage at the diversion structures. However, spawning habitat has not been improved and a new passage barrier may be present. Additional investigation into the sediment contributions, fish passage, and the success of Locke Creek as a spawning tributary.

FIGURE 135. LOCKE CREEK BEFORE (2001; L) AND AFTER (2017; R).

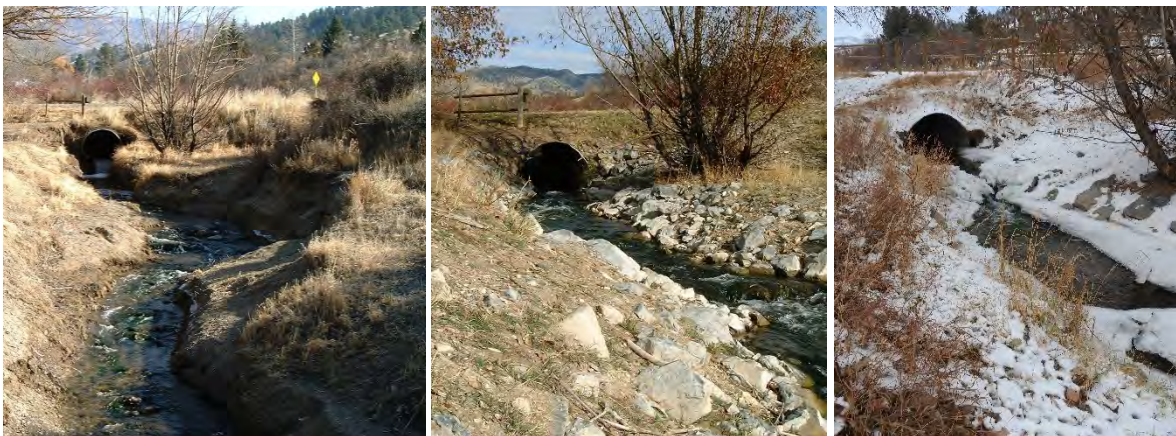
Magpie Creek (Lewis & Clark County) supports a spawning run of rainbow trout from Canyon Ferry Reservoir. A perched culvert at a county road crossing and a short distance upstream from the mouth, was a barrier to fish movement. This project installed a series of rock drop structures below the culvert that brought the level of the stream up allowed fish to pass through the culvert (Figure 138).

This project was monitored in 2017 and stream flow was sufficient for fish passage, but because the culvert was not embedded, there was concern that the culvert may impede passage at certain times of the year—particularly with high flow and limited resting spaces for fish. Fisheries biologist Eric Roberts noted that the rock ramp is functioning as intended. Overall, this project has been successful in meeting its goal of installation and maintenance of a rock ramp to encourage fish passage.

FIGURE 138. MAGPIE CREEK BEFORE (L; 2000), IN 2001 (C), AND IN 2017 (R).

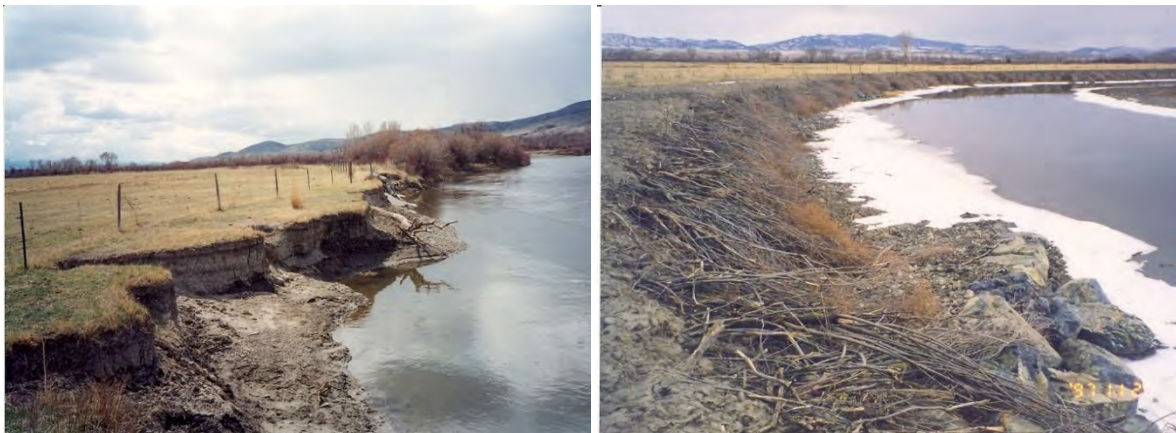
A side channel of the Missouri River near Townsend was heavily used for spawning by brown and rainbow trout from Canyon Ferry Reservoir. Portions of the side channel were experiencing severe erosion due to past grazing practices. This project involved riparian fencing, back-sloping the banks, keying the toe of the slope with rock, and re-vegetation with sod and willows (Figure 139). Approximately 700 feet of bank was treated.

FIGURE 139. MISSOURI RIVER SIDE CHANNEL BEFORE CONSTRUCTION (L, 1996) AND AFTER CONSTRUCTION (1997, R).

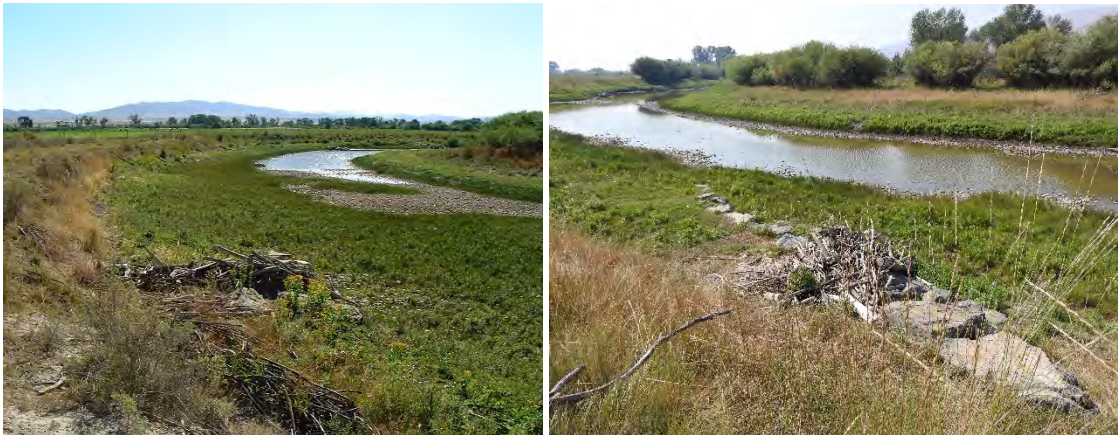
In 2017, the site was visited with Ron Spoon, fisheries biologist. The side channel was essentially disconnected from river, which has been the case since the early 2000s (Figure 140). It is likely that significant flow reaches site only in high water events. Aside from the wetland value, this project has no fishery benefit. The installed structures remain in place but are now vegetated and unused. Grazing still occurs, although it likely has minimal impact to fishery at that location. The project was unsuccessful because the side channel was abandoned. Future projects should consider likelihood of channel movement, if possible. This project is now expired, having reached its 20-year life.

FIGURE 140. MISSOURI RIVER SIDE CHANNEL IN 2004 (L) AND 2017 (R).

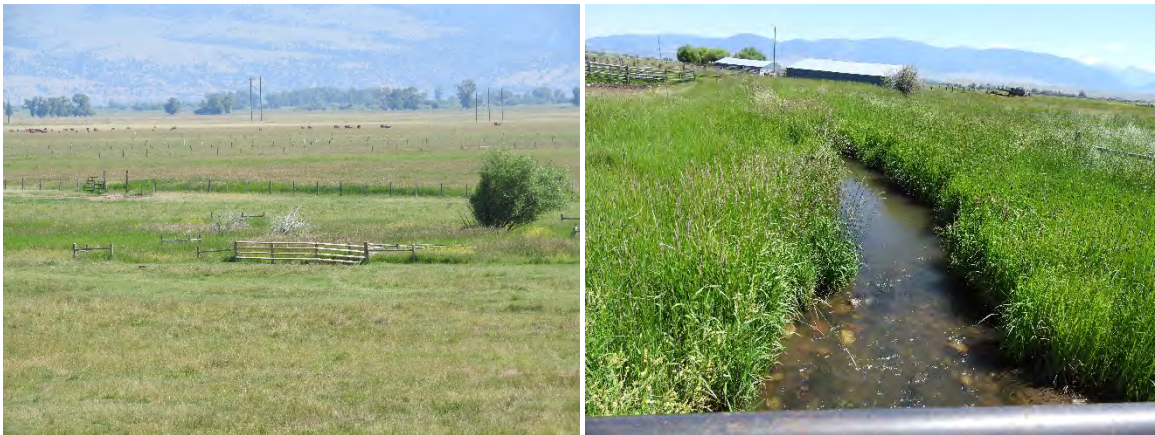
In 2018, the site was visited with Sunni Heikes-Knapton, Madison Conservation District Administrator (Figure 141). The entire project was viewed from hospital parking lot and in-depth at the Goggins Ranch. Since completion, vegetation has been established and the ranch continues to operate as needed. Overall, the project has been successful in maintaining a vegetated channel with protection from livestock, while also meeting the needs of the ranch.

FIGURE 141. MOORES CREEK ON THE GOGGINS RANCH, 2018.

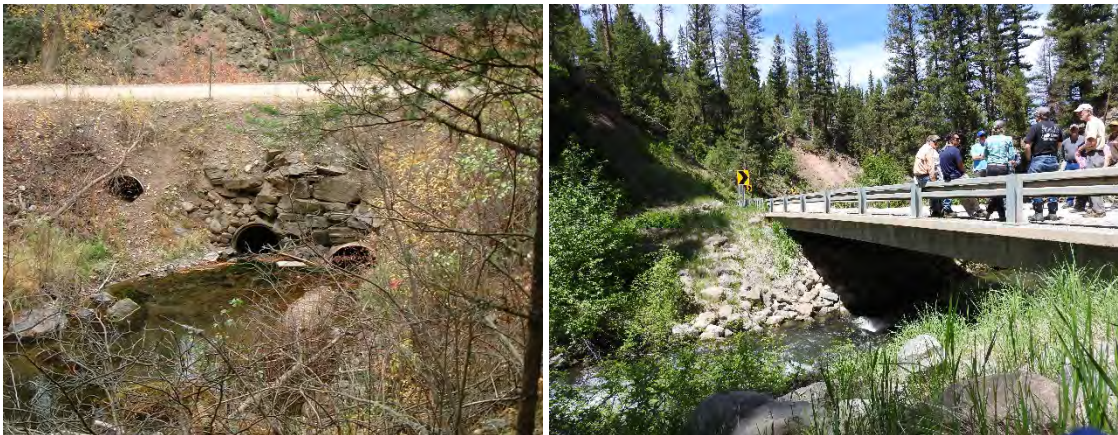
In 2018, this site was visited as part of Future Fisheries tour. The bridge is easily accessible, in good condition, and appears to have been very successful in improving migratory corridors.

FIGURE 143. POORMAN CREEK CULVERT (2002; L) TO BRIDGE (2018; R).

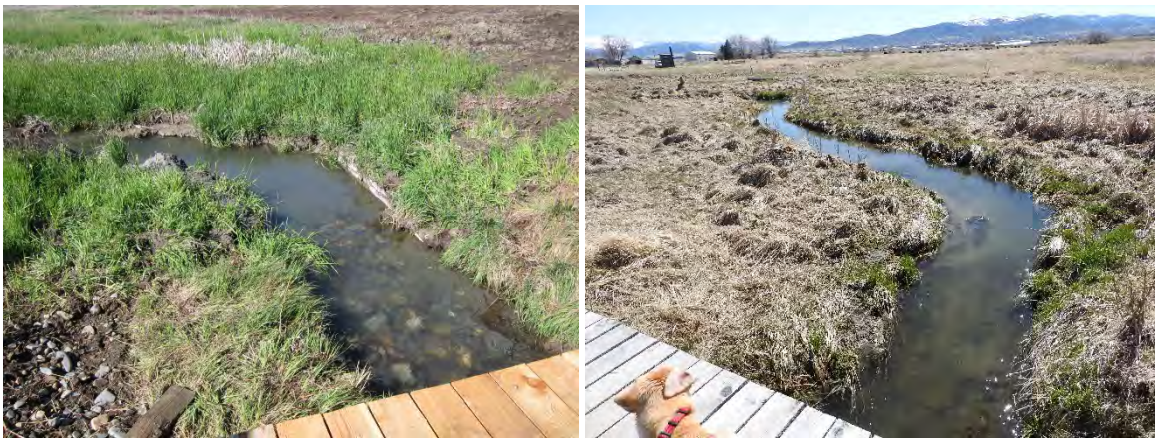
The site was visited in 2018, and the project appeared to be functional in several places with vegetation growing and becoming established. However, erosion occurs in several places of Prickly Pear Creek. The stream may be making adjustments and it may need to be monitored again in the coming years. The Spring Creek portion looks good with exposed gravels. The project has been a success.

FIGURE 144. UNNAMED TRIBUTARY TO PRICKLY PEAR CREEK AFTER CONSTRUCTION (2015; L) AND IN 2018 (R).

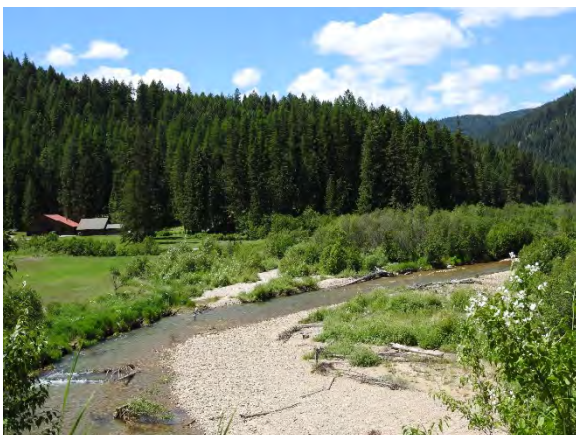
Prospect Creek is a dynamic system dominated by cobble (Figure 146). Erosion is unlikely to be a large issue in terms of sediment input and is more likely a concern for landowners in the floodplain. The stream appears to be moving fairly actively within its floodplain and is likely significantly affected by downed trees and other debris in the floodplain. The riparian area is overall highly vegetated, and livestock does not appear to be an issue. The project was not successful in its original design, but the stream appears to be mostly functional within its floodplain. The lesson learned is to avoid stabilization techniques in areas with significant channel movement within a floodplain.

FIGURE 146. AN EXAMPLE OF PROSPECT CREEK, WITHIN THE PROJECT AREA (2018).

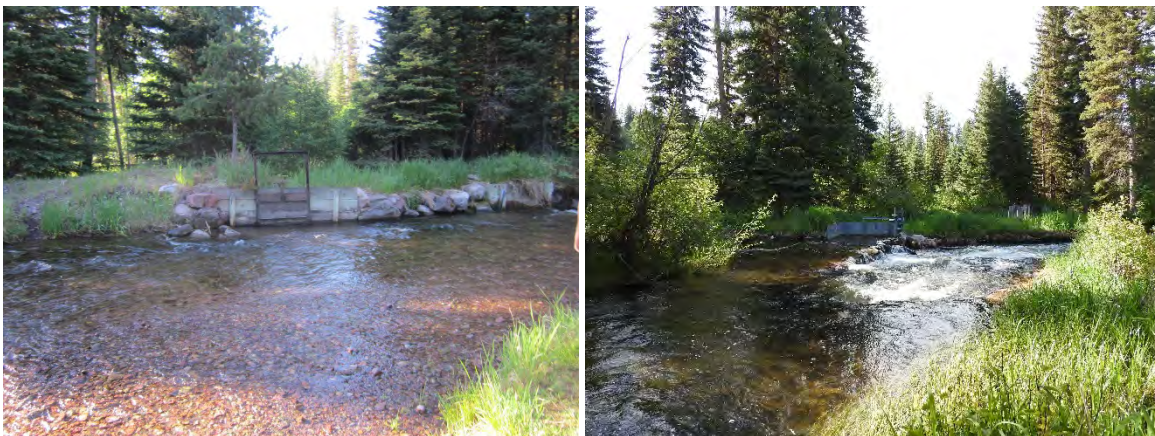
In 2018, as part of a FFIP project tour, the site was visited, and the project appears to be in place and functional. The project has been successful and was largely intact after a high flow year in 2018.

FIGURE 148. TRAIL CREEK BEFORE (L) AND AFTER (2018; R) CONSTRUCTION.

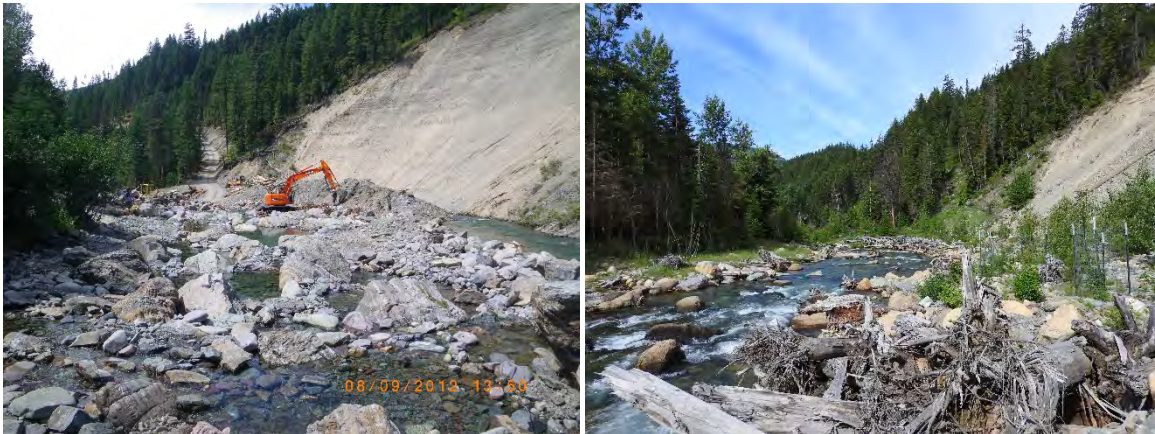
sediment and stabilize the slide. It appears to have been beneficial to bull trout as well. This project is a great example of a location where hardened stabilization has been successful.

FIGURE 149. VERMILLION RIVER CHAPEL SLIDE STABILIZATION BEFORE (L) AND AFTER (2018; R).

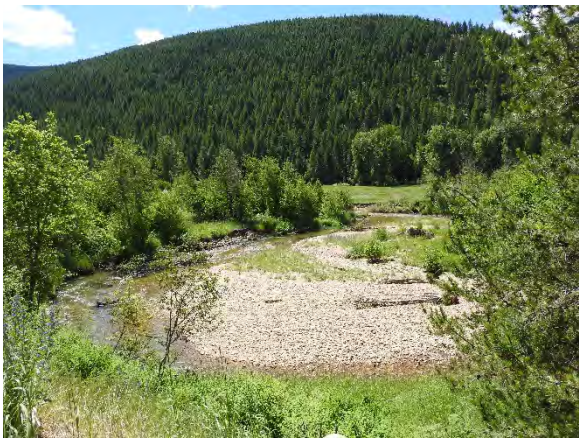
The site was visited in 2018 and it was evident that the channel had been actively shifting in places (Figure 150; Figure 151). The landowners have been frustrated with the dynamic system so close to their homes. Although it is considered an unsuccessful project, the lessons learned are that bank stabilization isn't successful in highly mobile systems that experience constant fluctuations. A consideration of this program should be placed on allowing a stream to move within its floodplain. Roads were highly armored in places, as the stream is actively putting pressure on some areas. Fine sediment is not likely to be a significant issue in this stream.

FIGURE 150. WHITE PINE CREEK (2018), A HIGHLY MOBILE SYSTEM.

Ultimately, projects installing hard structures into dynamic streams should be avoided. Enhancements to these highly-mobile systems should consider the constant movement of the channel.

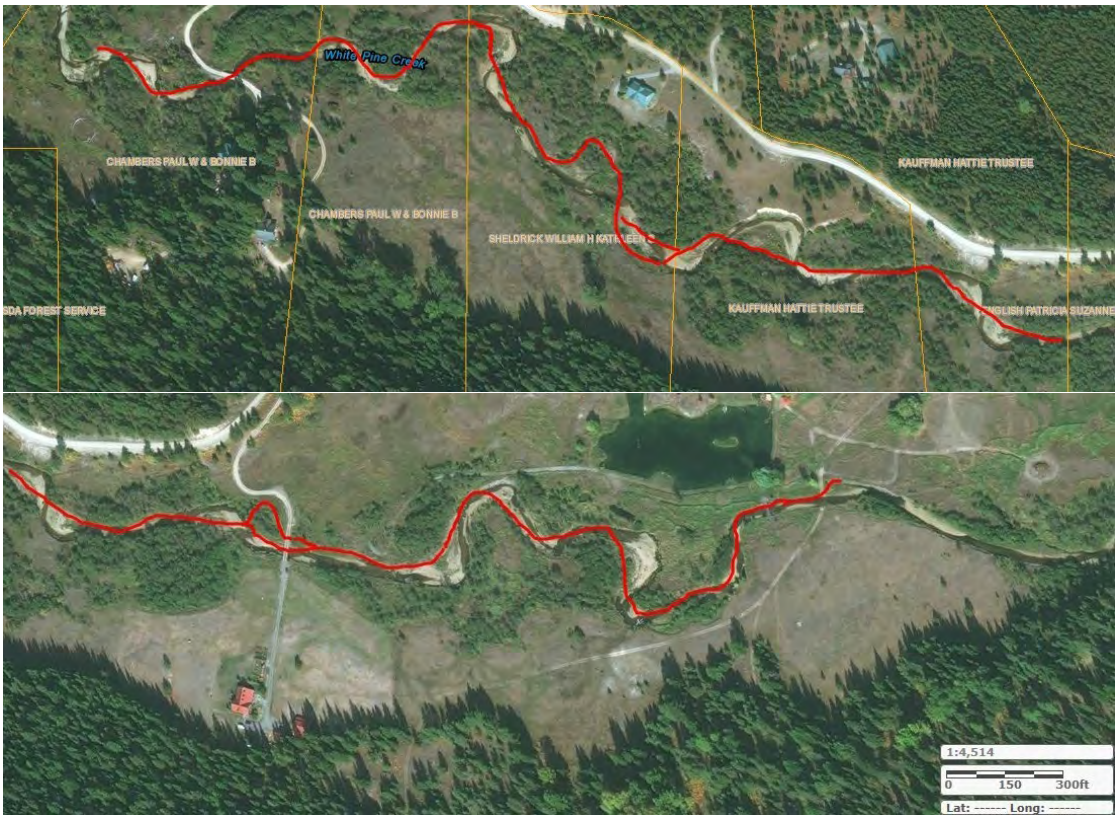
FIGURE 151. WHITE PINE CREEK MOVEMENT, FROM 2005 (RED LINE) TO 2017 (AERIAL BACKGROUND) AT TWO LOCATIONS WITHIN THE PROJECT AREA.
