LONG CREEK INCISED CHANNEL RESTORATION PROJECT DESIGN REPORT AND COST ESTIMATE

November 20, 2015

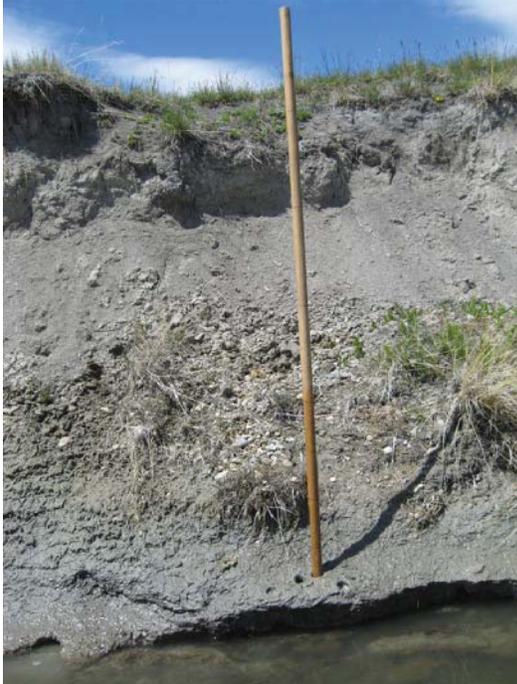
Figure 3. High bank on Long Creek showing clay in bank toe and mid-bank gravels

Figure 1	Project area location map.....	5
Figure 2.	Geologic map of central Centennial Valley with lower Long Creek circled.....	8
Figure 3.	High bank on Long Creek showing clay in bank toe and mid-bank gravels.....	9
Figure 4.	Long Creek bed material (D50 approx. 0.75 inches).....	9

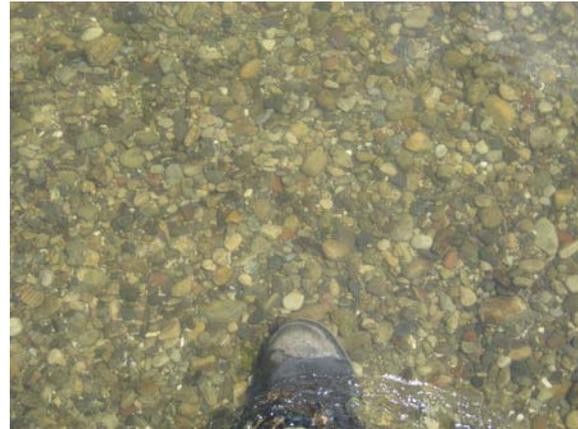
Figure 4. Long Creek bed material (D50 approx. 0.75 inches).

Long Creek is a tributary to the Red Rock River, and its confluence is located approximately 3.5 miles upstream of the upper end of Lima Reservoir in the Centennial Valley of Montana. Lower Long Creek flows southward through the southern portions of the Snowcrest Range and Gravelly Range into the east-west trending Centennial Valley. The Centennial valley is unglaciated, however glacial tills are found on the Centennial Mountains to the south. In the valley itself, large lakes appear to have at least intermittently filled the basin during the Pleistocene (Albanese, et al, 1995). As Long Creek flows into the Centennial Valley, it flows through alluvial fan deposits and into lake and windblown (eolian) deposits on the valley floor (Figure 2). As such, the project area transitions from alluvial fan sediments which range from coarse cobbles to fine silts, to extremely fine silt/clay lake deposits. These units interfinger on lower Long Creek, creating variable conditions in the stream bed and banks. In general, however, this portion of lowermost Long Creek is fine grained, with localized exposures of gravels in the bank (Figure 3). Sediment loading from the upper watershed is relatively coarse, however, with gravels commonly comprising the bed and point bars (Figure 4 and Figure 5).

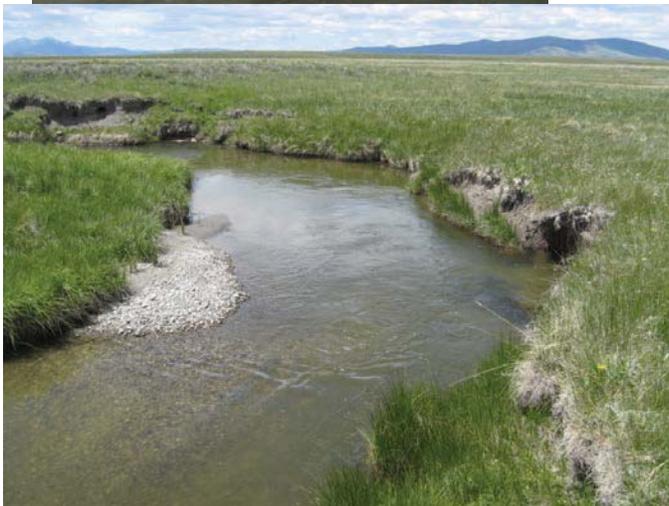
Figure 5. Long Creek point bar showing gravel bedload.

Figure 5. Long Creek point bar showing gravel bedload. 9

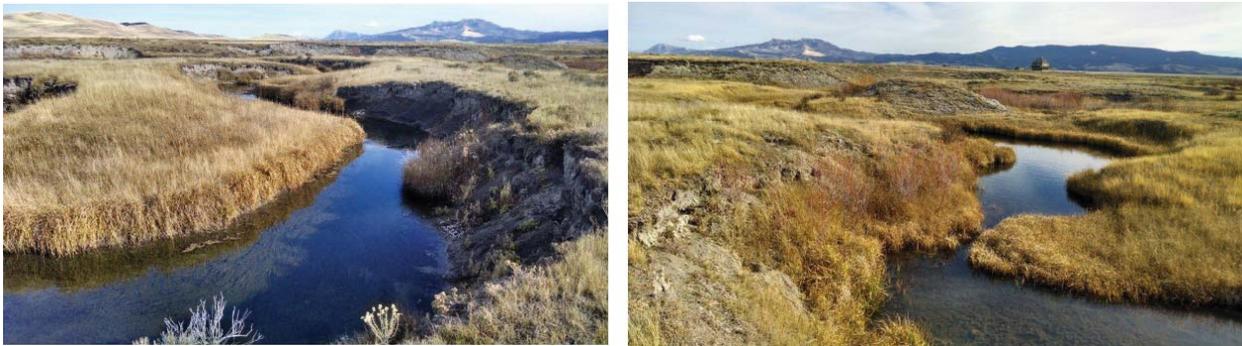
Figure 8. Typical channel conditions in project area. Note only intermittent willow regeneration and lack of riparian canopy.

Figure 8. Typical channel conditions in project area. Note only intermittent willow regeneration and lack of riparian canopy..... 12

The channel in the project reach is highly sinuous (2.68) and entrenched (Figure 8). In the Rosgen classification the channel is largely an E_G (sinuous and entrenched). The average width is 18.6 feet and depth of 3.7 (W:D = 5.1; measured from top of banks), though there is variability including significantly overwide outside bends with widths of up to 30 feet. The average “bankfull” cross-section area is 66 sf. The majority of outside bend banks are erosive.
