# FUTURE FISHERIES IMPROVEMENT PROGRAM

REPORT TO THE 2011 LEGISLATURE  
AND  
FISH, WILDLIFE AND PARKS COMMISSION

Prepared by: Habitat Section, Fisheries Bureau

DECEMBER 2010

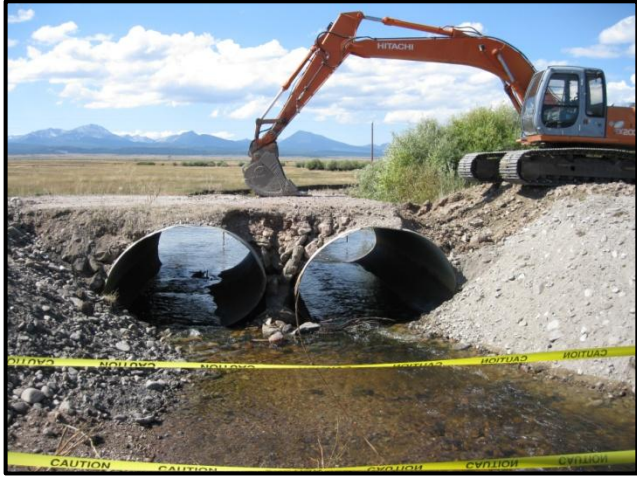
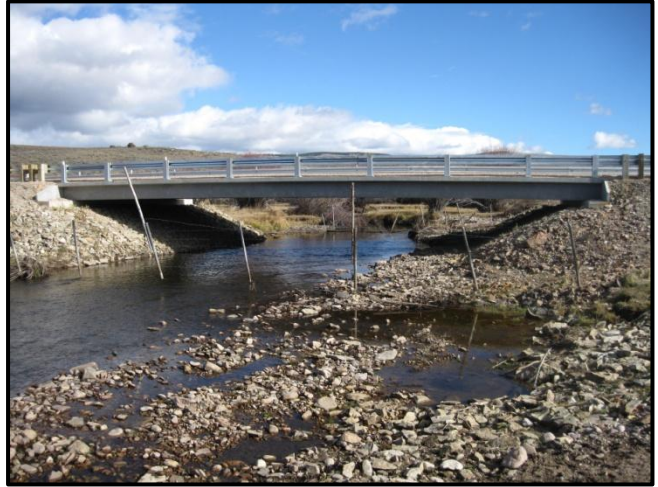
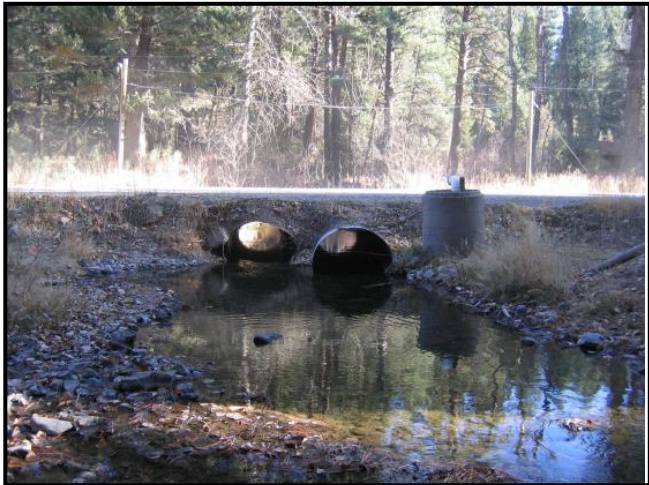
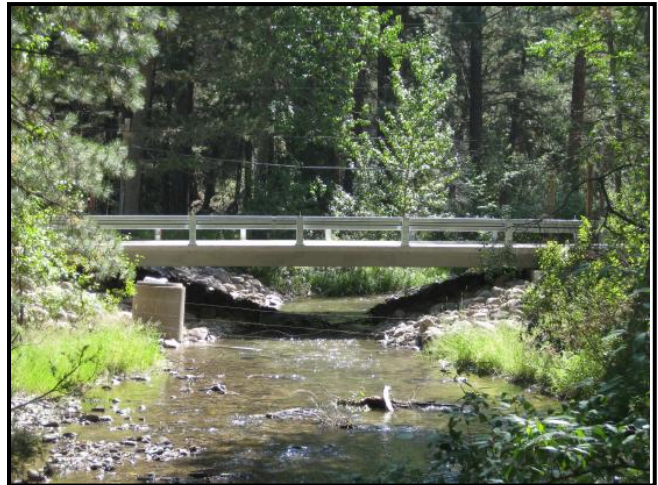
**Photo Illustration 1.** The upper two photographs display a fish passage enhancement project located on Governor Creek, a tributary to the Big Hole River near the community of Jackson. The project replaced double 6-foot in diameter culverts (upper left photo) with a 64-foot concrete bridge (upper right photo) to the benefit of fluvial arctic grayling, rainbow trout, brown trout, burbot and mountain whitefish. The lower two photographs show a fish passage enhancement project on Poorman Creek, a tributary to the Blackfoot River located near the town of Lincoln. The project replaced a double culvert (lower left photo) with a free span bridge (lower right photo) to enhance fish passage for bull trout, westslope cutthroat trout and brown trout. Upper two photos are courtesy of Jeff Everett, USFWS. Lower two photos are courtesy of Ryan Aasheim, Big Blackfoot Chapter Trout Unlimited.

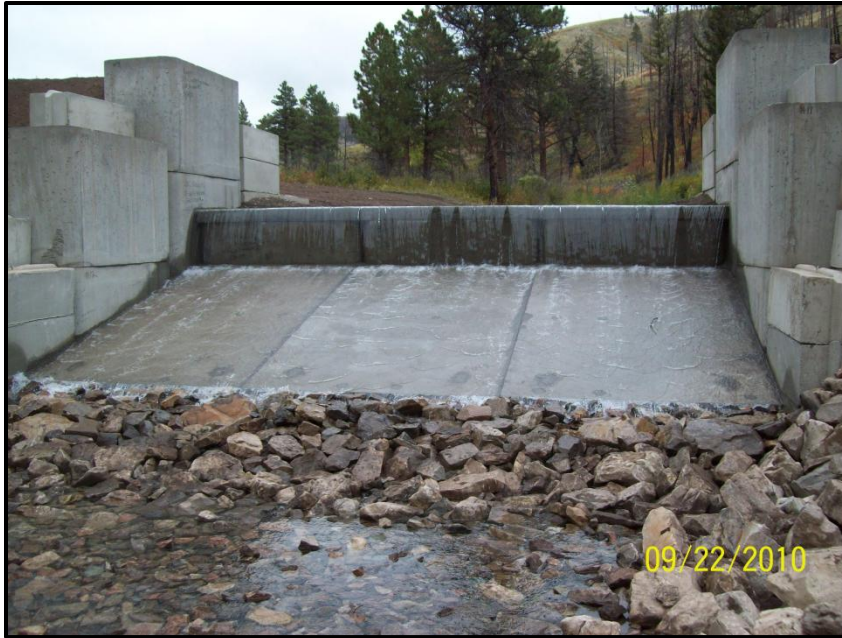
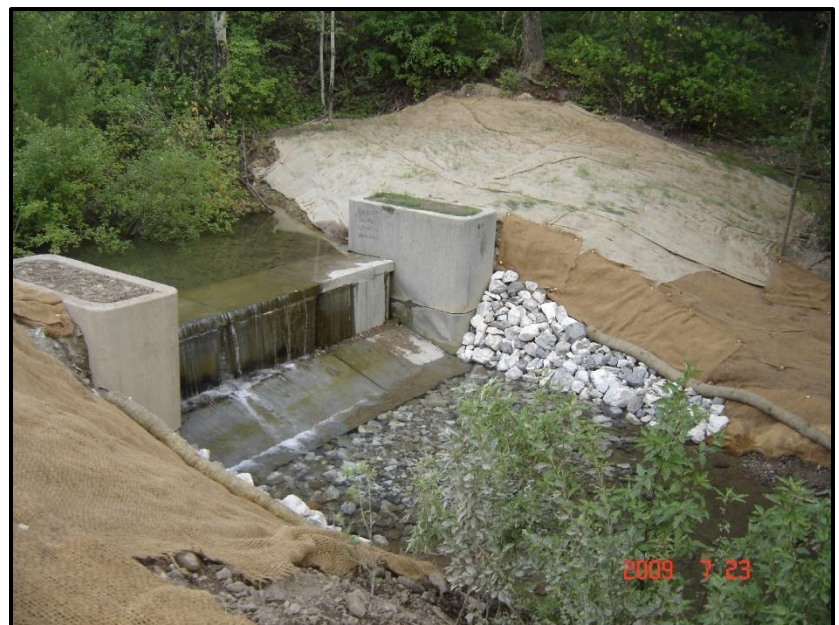
**Photo Illustration 2.** Fish passage barrier projects constructed on Cottonwood Creek and White Gulch for the purpose of protecting genetically pure westslope cutthroat trout from invasion by non-native fish, including rainbow trout, brown trout and brook trout. The upper photo shows the new fish passage barrier constructed on Cottonwood Creek, a tributary to Holter Reservoir located on FWP’s Beartooth Game Range. The lower photo shows a new fish passage barrier constructed on White Gulch, a tributary to Canyon Ferry Reservoir. The upper photo is courtesy of Allied Engineering. The lower photo is courtesy of Ron Spoon, FWP.

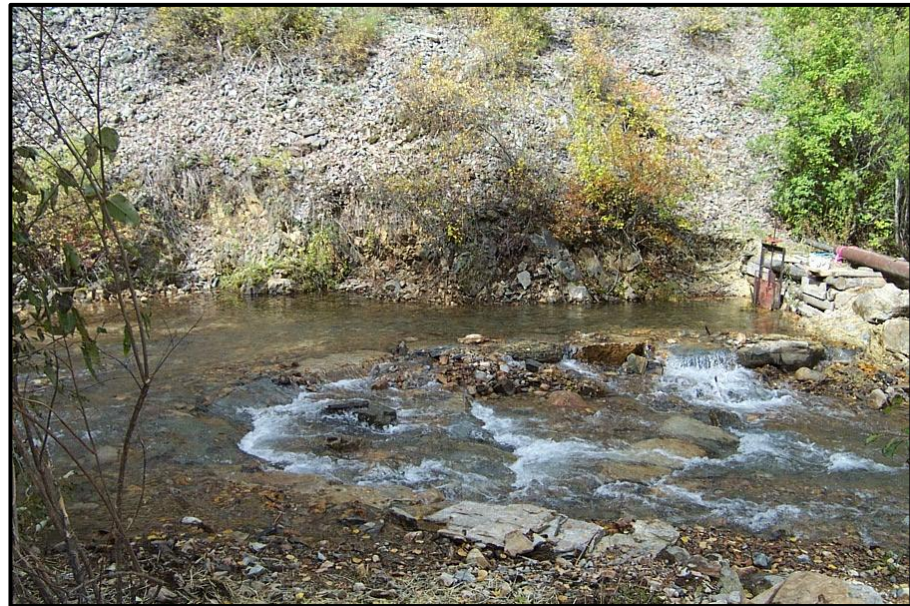
**Photo Illustration 3.** Upstream fish passage for bull trout, westslope cutthroat trout and sculpins was enhanced on Dry Creek, a tributary to the Clark Fork River located near the town of Superior, to improve access to important spawning and rearing habitat. The upper photograph shows the old wood crib diversion dam creating a hindrance to upstream fish passage. The lower photograph shows the new diversion consisting of three vortex rock weirs that create a series of rock steps, providing ample upstream passage opportunity for fish while continuing to provide the water user their irrigation diversion needs. Photos courtesy of Ladd Knotek, FWP.

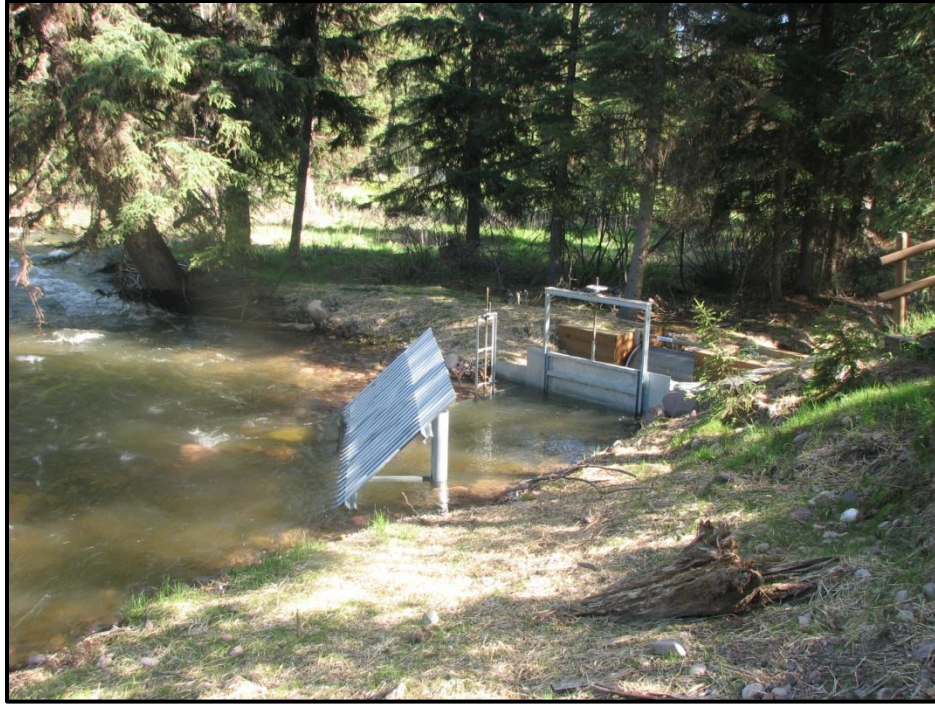
**Photo Illustration 4.** Fish screens installed on irrigation diversions located on Morrell Creek and Ninemile creeks. Morrell Creek, a tributary to the Clearwater River located near the town of Seeley Lake, supports an important fluvial bull trout population. The Morrell Creek project (upper photograph) involved reducing entrainment into two irrigation canals by installing fish screens, improving upstream fish passage, reducing periodic channel disturbance and enhancing instream flow while continuing to meet the needs of the water user. Ninemile Creek is a tributary to the Clark Fork River located near the community of Ninemile that supports westslope cutthroat trout, rainbow trout, brown trout and mountain whitefish. The Ninemile Creek project involved installation of a coanda style fish screen to prevent entrainment into the irrigation canal and installation of a vortex rock weir to enhance upstream fish passage while meeting the needs of the water user. The lower left photograph shows the Ninemile Creek diversion before project completion. The lower right photograph shows the installed coanda fish screen and vortex rock weir. All photos courtesy of Ladd Knotek, FWP.

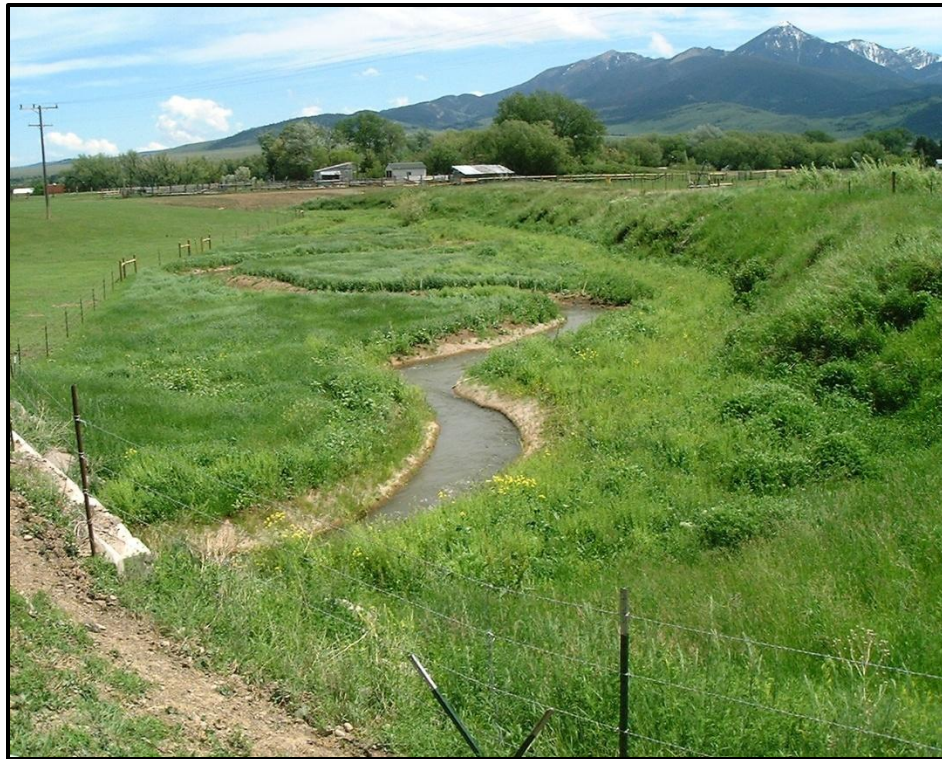
**Photo Illustration 5.** Channel restoration on Fleshman Creek, a tributary to the Yellowstone River near the town of Livingston. This reach of Fleshman Creek had historically been subjected to channelization and heavy livestock use. This project restored the morphology of 2,400 feet of stream channel and greatly enhanced the floodplain and riparian vegetation while continuing to maintain the agricultural viability of the ranch. The project has benefitted a mixed assemblage of fish including rainbow trout, brown trout, brook trout and Yellowstone cutthroat trout. The upper left photo shows the stream channel prior to restoration. The upper right photo shows the stream channel during construction, including the coir fabric used to form the newly created stream banks. The lower photo shows the restored channel following one growing season with the exclusion of all livestock.

**4. Fleshman Creek Channel Restoration.** Fleshman Creek (Park County), a tributary to the Yellowstone River near Livingston, supports a mixed salmonid assemblage. Portions of the stream have been substantially degraded as a result of channelization and historic overgrazing by livestock. This project involved restoring a 2,400-foot stream reach, as it flows through the Voyich Ranch, by reconstructing a relatively narrow, deep and sinuous channel and by re-vegetating the riparian corridor. The restored stream channel and streamside areas were protected with riparian fencing and the installation of off-site water for livestock. **Completed.**

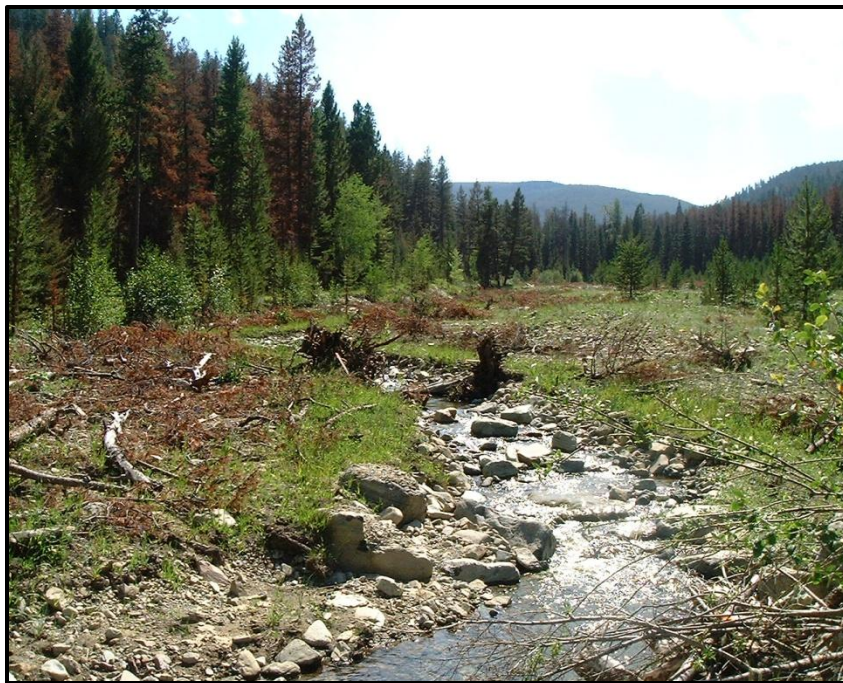
**Photo Illustration 6.** Channel restoration on Sauerkraut Creek, a tributary to the Blackfoot River located near the town of Lincoln. The stream supports fluvial westslope cutthroat trout and bull trout. This reach of stream has a long history of placer mining and has been channelized and disconnected from the floodplain with placement of an earthen berm. Population densities of fish have been documented to be substantially lower within this channelized reach than in less altered portions of the stream. This project involved restoring the dimensions, pattern and profile of a one mile reach of straightened channel and reactivating the floodplain by removing the berm. The upper left photo shows the old straightened channel with poor fish habitat, confined by the earthen berm on right hand side. The upper right photo shows workers removing the berm. The lower photo shows the very recently restored stream channel that now has connection with its floodplain. The upper two photos are courtesy of Ryen Aasheim, Big Blackfoot Chapter Trout Unlimited.

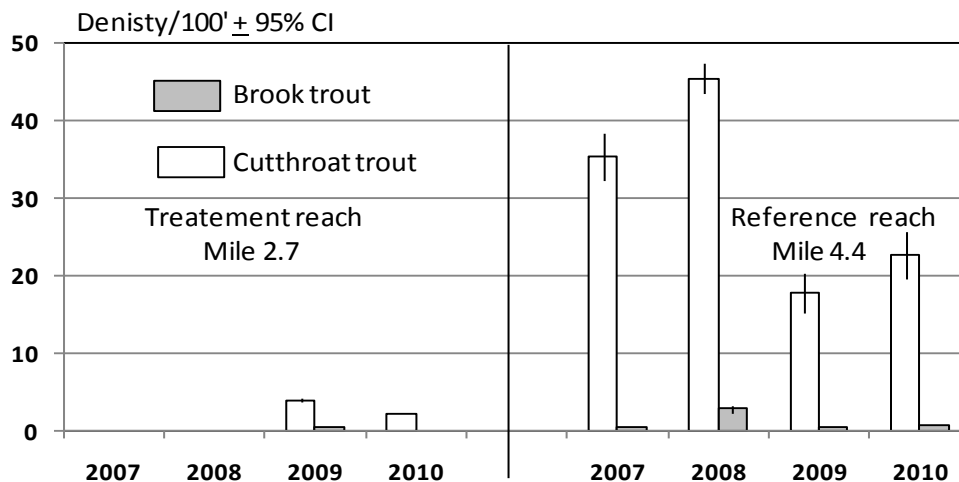
**Figure 14.** Estimated densities of age 1+ trout for two reaches of Ashby Creek.

**Monitoring:** In 2007 we established two fish population survey sites in the new channel at mile 2.7 and a downstream survey site at mile 2.0 as well as an upstream reference. During the first two years of population monitoring, fisheries surveys found no fish within either of the two new (treatment area) monitoring sites. However, WCT have begun to occupy the upper segment of the new channel during the more recent (2009 and 2010) monitoring efforts (Figure 14).

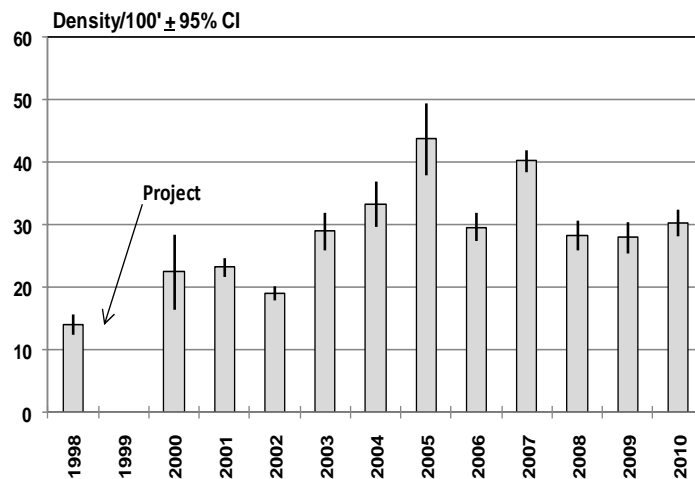
**Figure 15.** Estimated total trout densities of age 1+ fish in the reconstructed section of Bear Creek at mile 1.1.

**Monitoring:** Bear Creek supports predominately rainbow trout and lower numbers of brown trout and brook trout in the lower stream, along with WCT in the upper basin and very low densities of juvenile bull trout. In 2009 and 2010, we continued to monitor fish populations in a reconstructed section (mile 1.1) of Bear Creek. The monitoring shows an increasing trend in trout abundance 7-9 years post-treatment followed by stable densities at approximately double the pre-treatment densities (Figure 15).

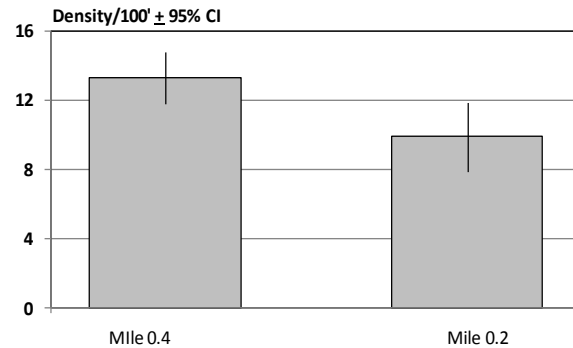
**Figure 16.** Density estimates for age 1+ cutthroat trout upstream of and within restoration treatment reach of Braziel Creek.

**Monitoring:** Braziel Creek currently supports a simple fish community of WCT and sculpin. Fish population survey sites were established in 2010 at two sites, (one 0.4 mile) upstream of the project and one (mile 0.2) immediately downstream of the project area (Figure 16). In addition, we also surveyed an unscreened irrigation ditch. This survey generated a catch of 11 age 1+ cutthroat trout/100' in the upper portion of the ditch. This pre-treatment survey will help test the efficacy of a Coanda fish screen installed as part of the larger project.

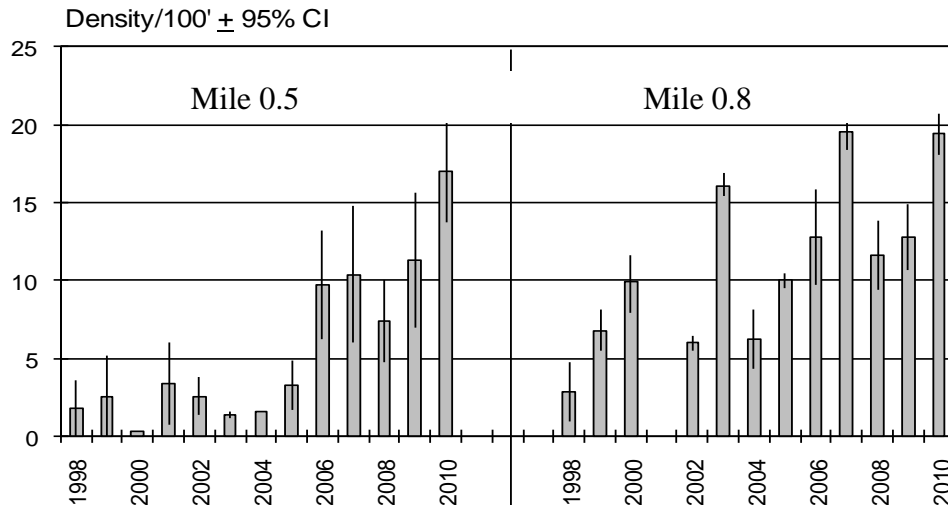
**Figure 27.** Estimated densities of age 1+ brown trout in two sections of Kleinschmidt Creek. The section at mile 0.5 lacks instream wood whereas the section at mile 0.8 includes instream wood.

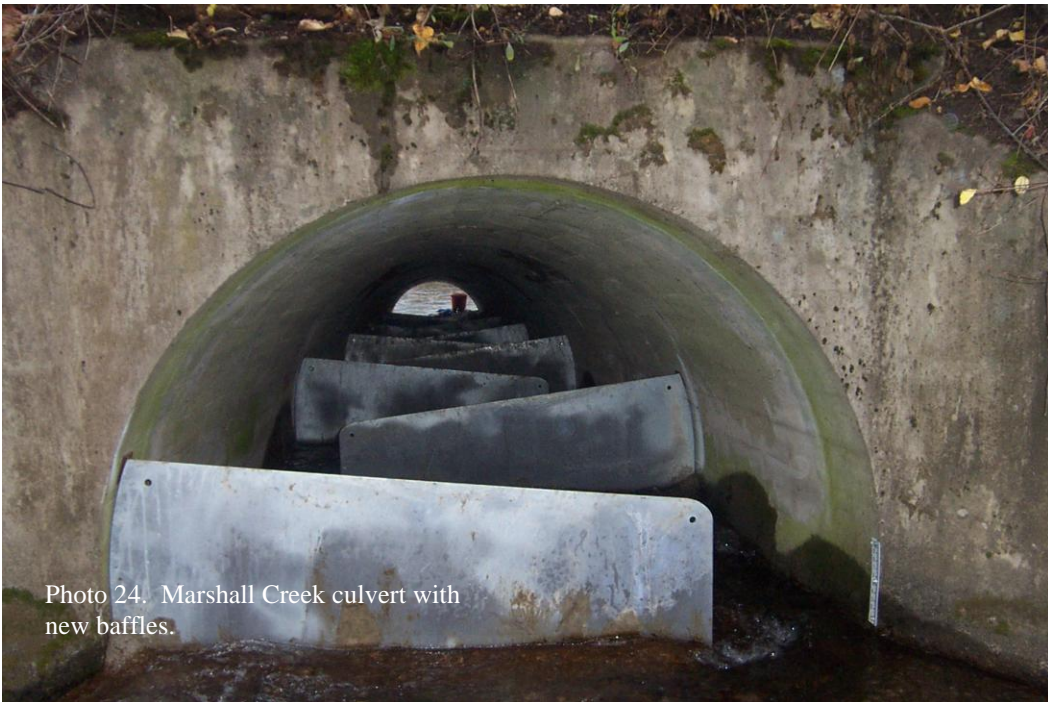
Photo 24. Marshall Creek culvert with new baffles.

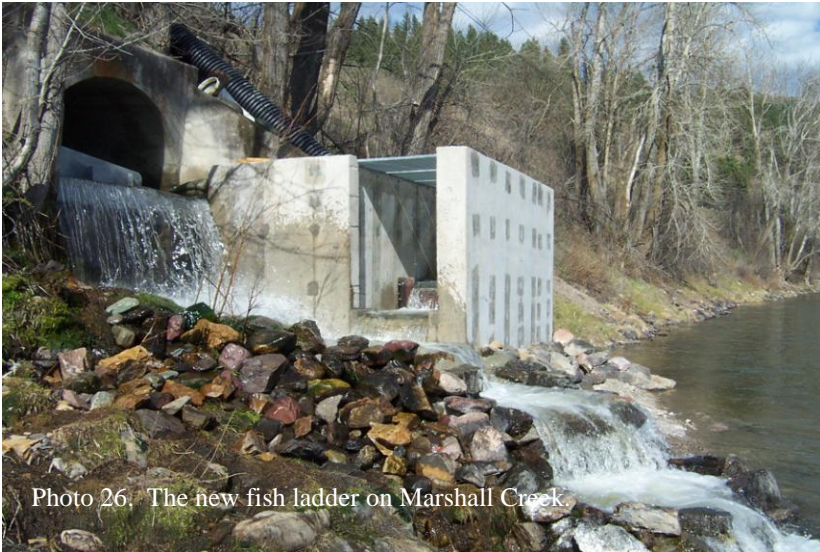
Photo 26. The new fish ladder on Marshall Creek.

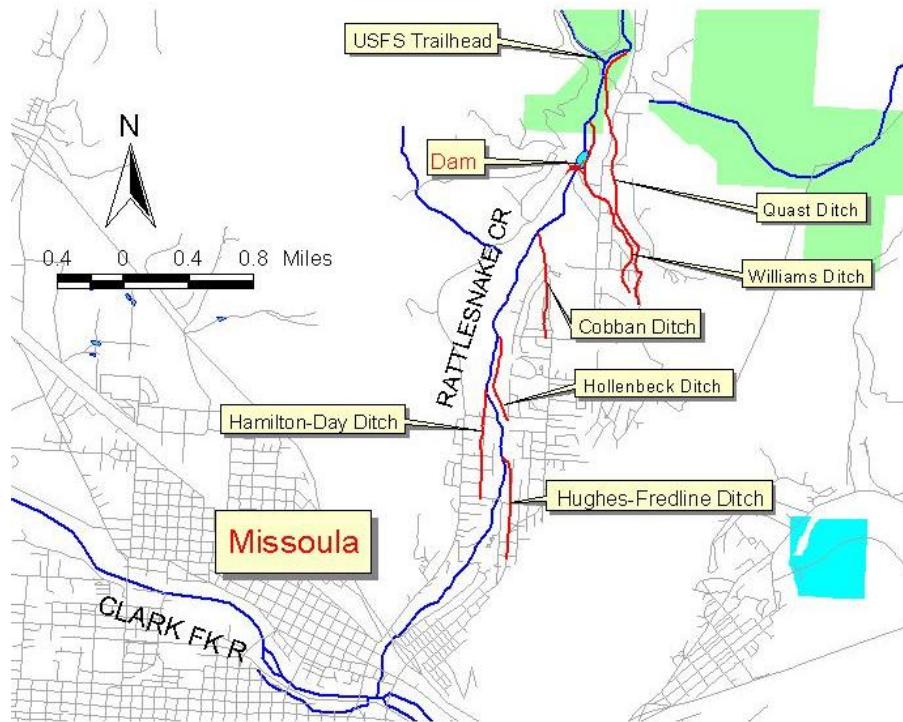
Figure 43. Irrigation diversions in lower Rattlesnake Creek.
